# 2016 Annual Inspection Report

for Compliance with the Coal  
Combustion Residuals Rule  
(40 CFR Part 257)

## **Pawnee Station**

***January 18, 2017***

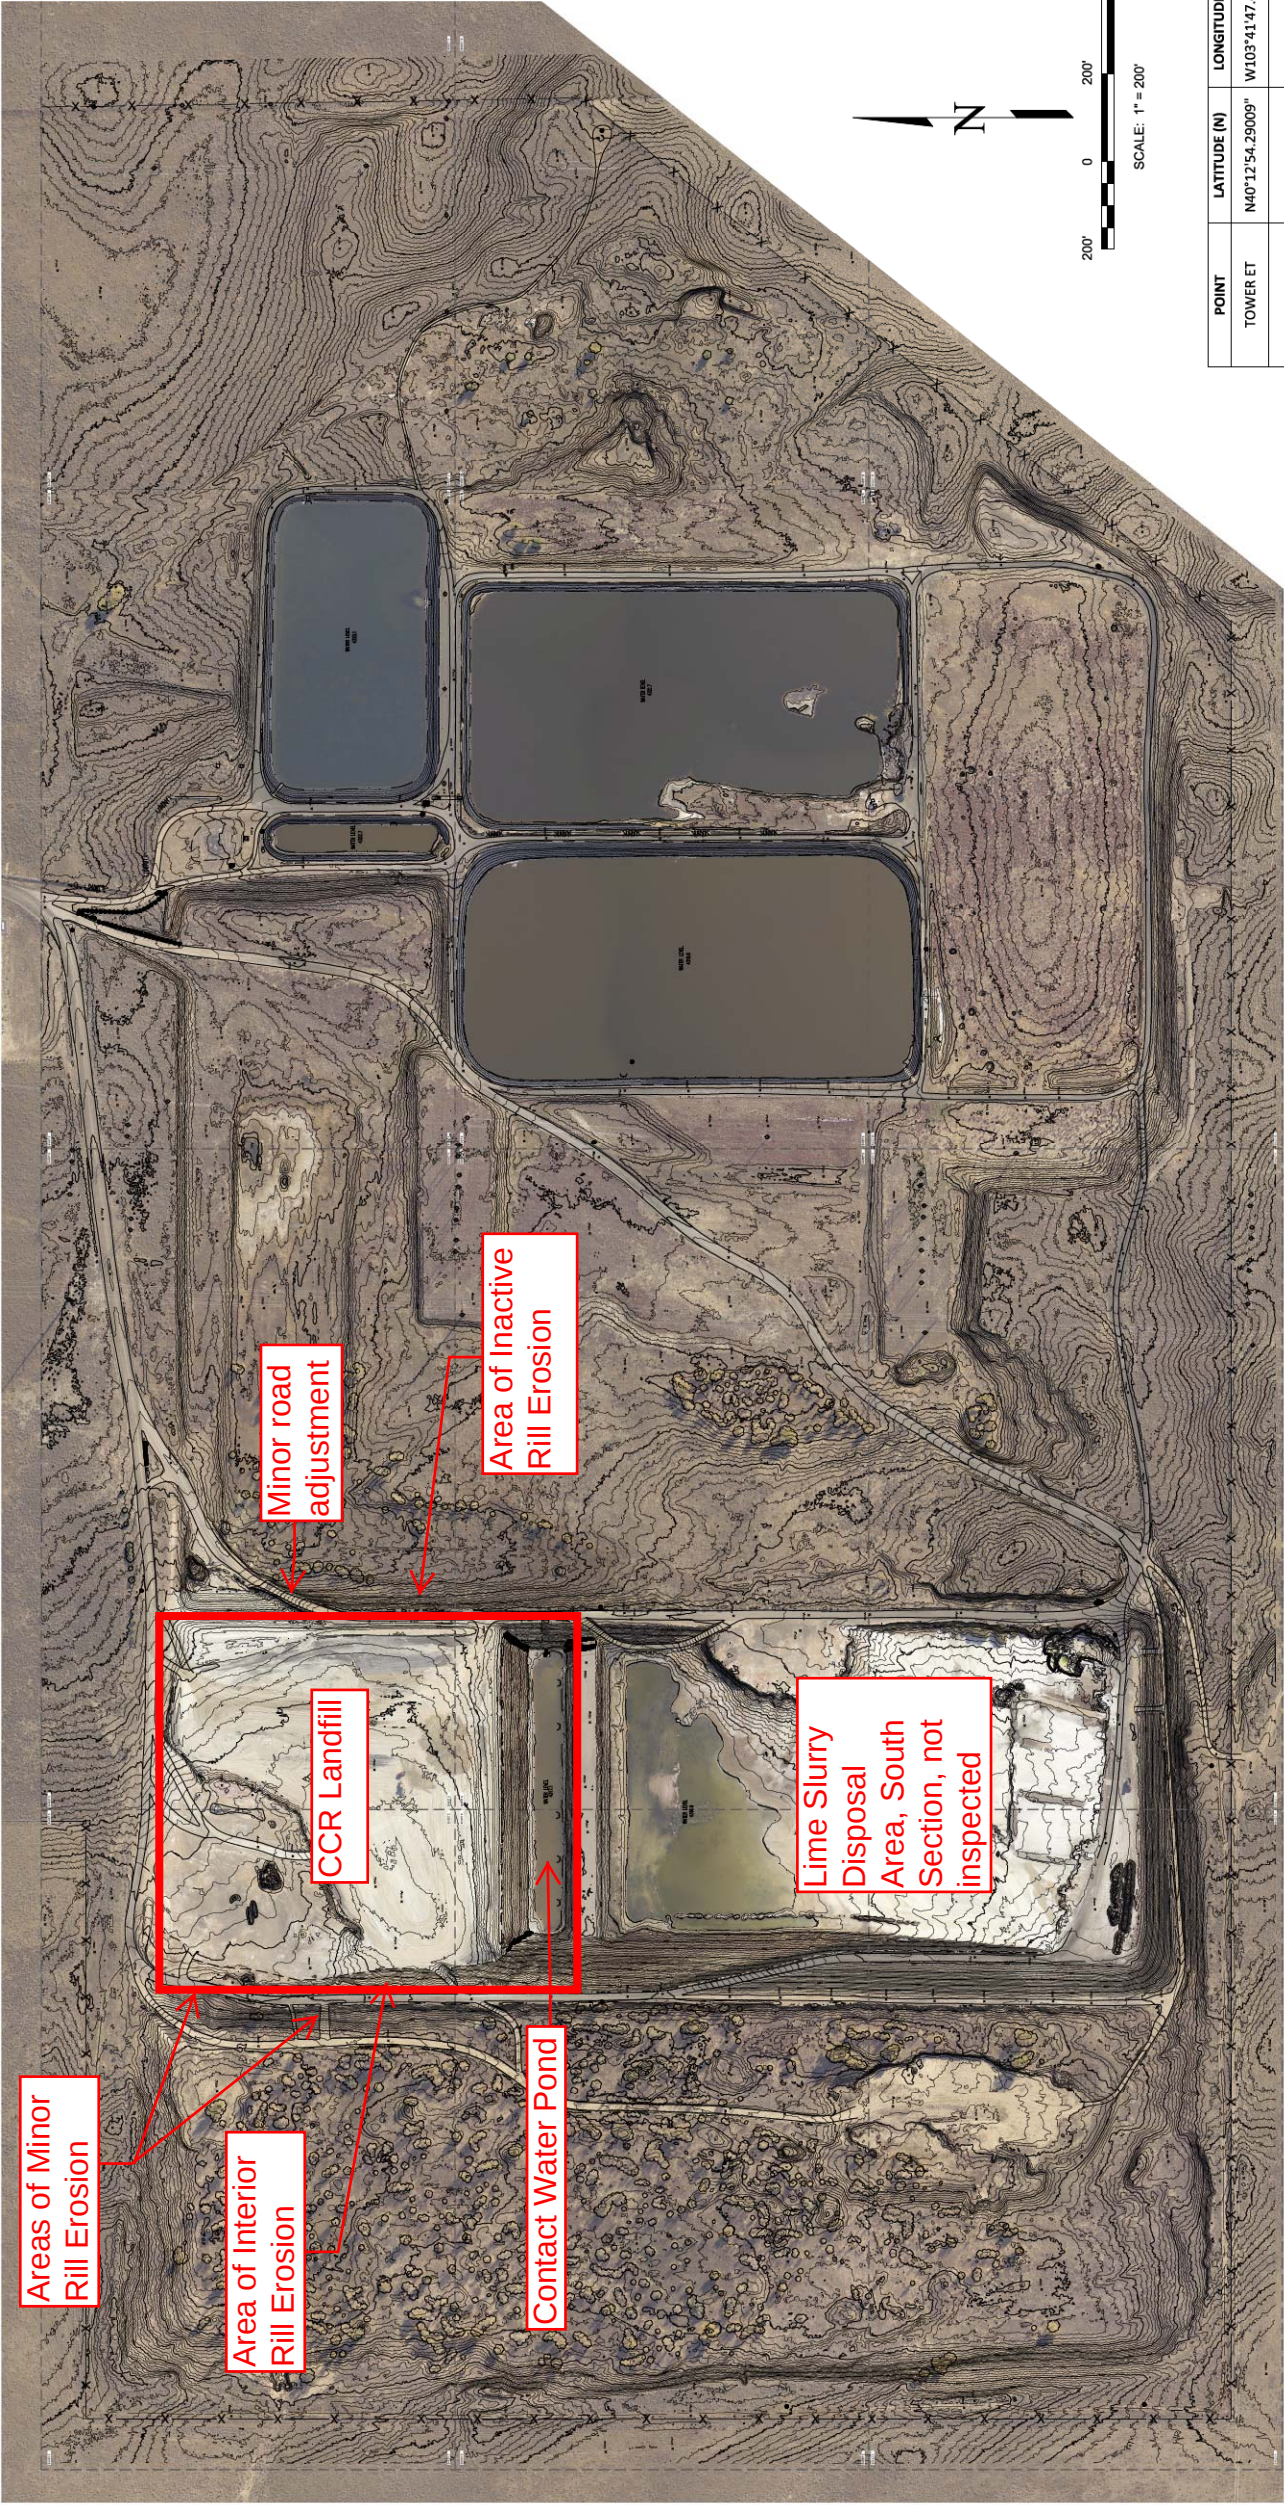
## Appendix A – Landfill Site Map

Notes in red added by HDR  
Engineering for CCR Annual  
Inspection Report, January 2017
