57-18-01 - Front Door(s) May Be Difficult to Close at Temperatures Below Freezing

Release date: 11/4/2020

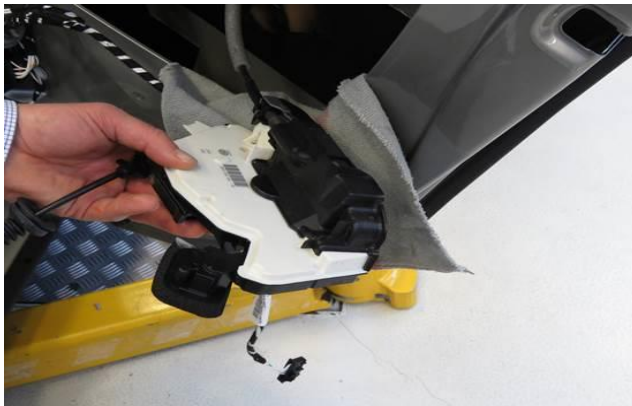
Figure 1: Door lock and cap assembled.

- Remove the affected door lock and cap. See Body Exterior. Repair Group 57 Front Doors and Central Locking Door Lock Removal and Installation in Elsa.
- Replace the door lock and the cap with new parts (See ETKA for the latest parts information).
- Assemble the new door lock and the new cap (Figure 1). See Body Exterior. Repair Group 57 Front Doors and Central Locking Door Lock Removal and Installation in Elsa.

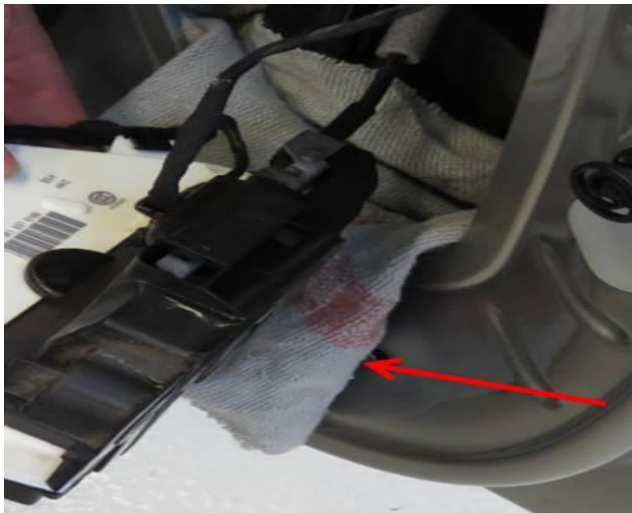
Figure 2: Example of protected lower door area.

- Using shop rags or suitable material, protect the lower section of the door against damage as shown in Figure 2.

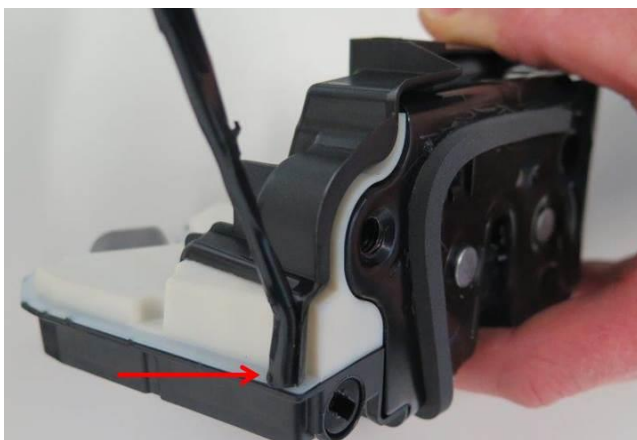
Figure 3: Starting position for routing Butyl sealing cord.

- Cut off a piece of Butyl sealing cord (part number AKL-450-005-05) to a length of about 160 mm (6 inches).
- Carefully route the butyl sealing cord, starting from position 1 (Figure 3, red arrow), along the cap (Figure 4, position 1 to 5) and press it down firmly.

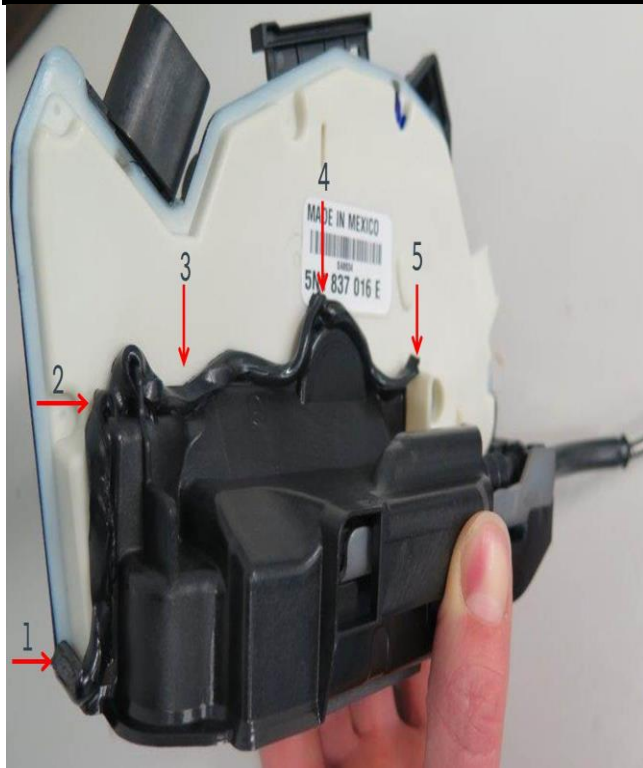
Figure 4: Area where Butyl sealing cord has to be routed.

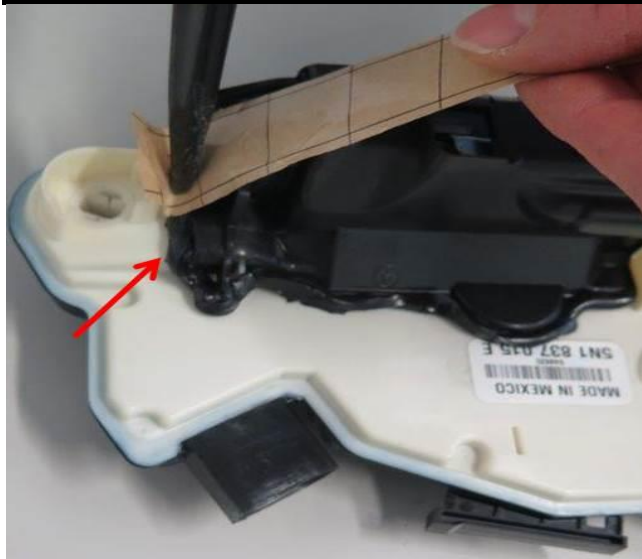
Figure 5: pressing down Butyl sealing cord with suitable tool.

On the driver door lock the Butyl sealing cord must be pressed down in the area of the follower with a suitable tool, for example a wedge (Figure 5, red arrow).

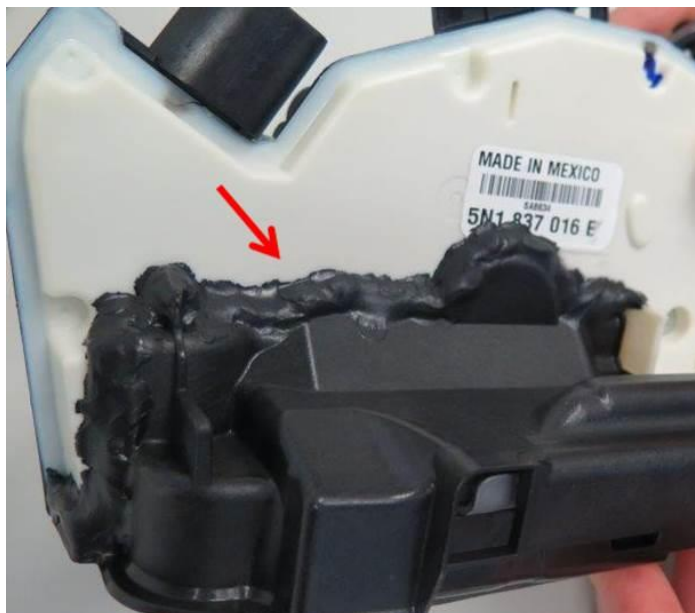
Figure 6: (Example: butyl sealing cord pressed down/spread out by hand).

- Press down again on the Butyl sealing cord (spread the Butyl) to ensure proper sealing between the cap and the door lock (Figure 6).
