# ODI RESUME

**Investigation:** PE 15-008  
**Date Opened:** 02/27/2015  
**Investigator:** Peter Kivett  
**Approver:** Otto Matheke  
**Subject:** Front suspension ball joint failure

**Manufacturer:** Pierce Manufacturing  
**Products:** 2004 - 2015 Pierce fire trucks with the TAK-4 suspension  
**Population:** 7,588  
**Problem Description:** Failure of front ball joints that can result in a wheel separation event.

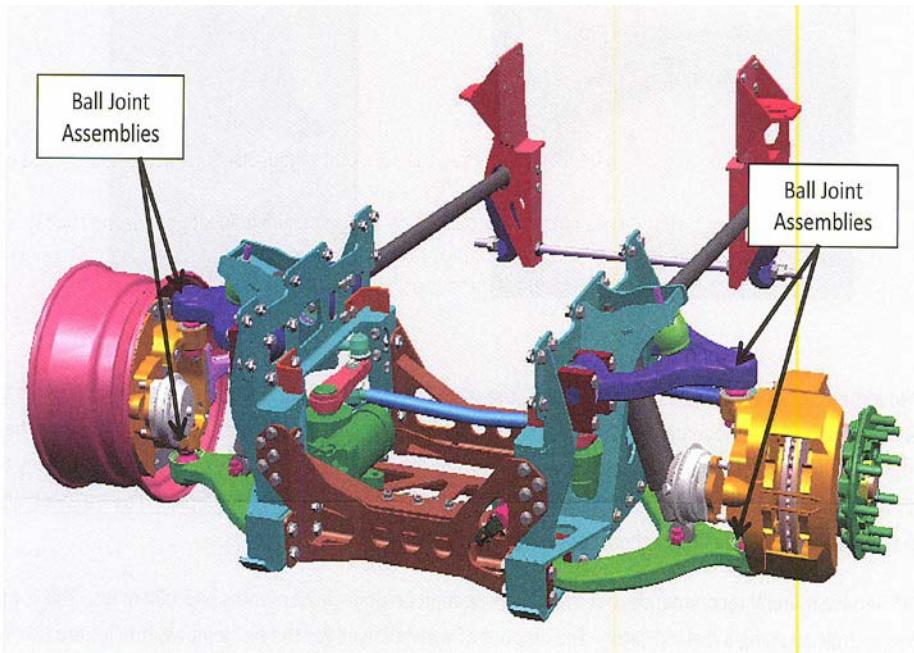
Figure 1

The consumer complaint (ODI #10671053), received on January 8th 2015, alleged a 2007 Pierce TAK-4 equipped fire truck "was not steering correctly". The three media reports of Pierce TAK-4 equipped fire trucks that experienced front steer wheel separation events included two in Baltimore, MD (July and August 2014) and a third in Anne Arundel County, MD (December 2014). The technical service bulletin (#355 issued 12/15/2014) was intended to be a reminder for subject vehicle owners to inspect their TAK-4 suspension and ball joints pursuant to Pierce's published maintenance schedule. The bulletin outlined how improperly maintained subject ball joints could wear or become damaged during normal use and then potentially separate. A diagram of the TAK-4 front suspension (Figure 1) illustrates the location of both ball-joint assemblies on the suspension that connect the wheel spindles to the A-arm assemblies.

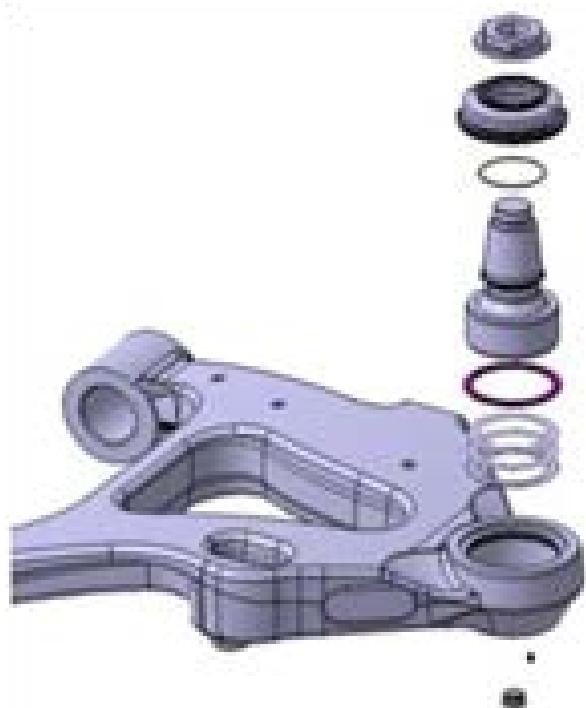
Figure 2

During the course of the investigation Pierce informed ODI that the TAK-4 suspension had been equipped with two different design ball joints since its inception. The first generation ball joint (Figure 2.) was installed on the subject vehicles from MY 2004 to MY 2013 and was designed to be serviceable. This design allowed maintenance personnel to adjust ball and socket endplay with stack-up shims. Starting MY 2014, a second generation ball joint was installed that implemented a sealed, pre lubricated, one piece, maintenance free design.

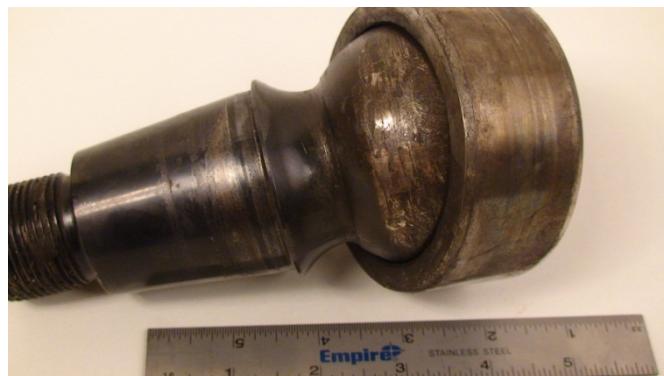
Figure 3

Pierce later informed ODI that two boot designs were used on the first generation ball joints. Pierce identified a defect that could occur in the earliest design ball joint boots. During the molding process when the boot was removed from the mold, some post molding work occurred – specifically removing the "flash" or waste left on the part that forms between the two molded halves. Pierce's stated the waste material was removed manually and this manual operation could cause damage to the part. Once the boot lost its integrity, it could allow water and other contaminants to enter the ball joint. The contaminants could ultimately create a corrosive and abrasive environment that accelerated the wear of the ball joint components. This accelerated wear could continue until a significant amount of material had worn from the joint components potentially resulting in a separation.

The photograph below (Figure 3) shows a first generation ball joint (removed from a subject vehicle) that demonstrates the premature wear that can result from a torn boot.

Although Pierce believes the ball joint failures could be prevented if maintenance was performed pursuant to their published maintenance schedule, due to the frequency and severity of the failing joints they have decided to conduct a safety recall (15V-615). The recall will include 910 vehicles manufactured during the 2006 and 2007 model years. Of the 307 boot warranty claims and 5 wheel separation events reported on the entire 12 model year subject vehicle population, 78% of the claims and 60% of the wheel separations occurred on the 2 model years of vehicles subject of the Pierce recall. The recall remedy includes inspecting and replacing torn boots and prematurely worn ball joints on the vehicles manufactured with first generation joints. If during the inspection, the joint wear level is within the expected range, Pierce will provide the customer information regarding the inspection and maintenance schedule.
