Device	XMC4700/XMC4800
Marking/Step	ES-AA, AA
Package	PG-LQFP-100/144, PG-LFBGA-196

Document ID is **056/18**.

This “Errata Sheet” describes product deviations with respect to the user documentation listed below.

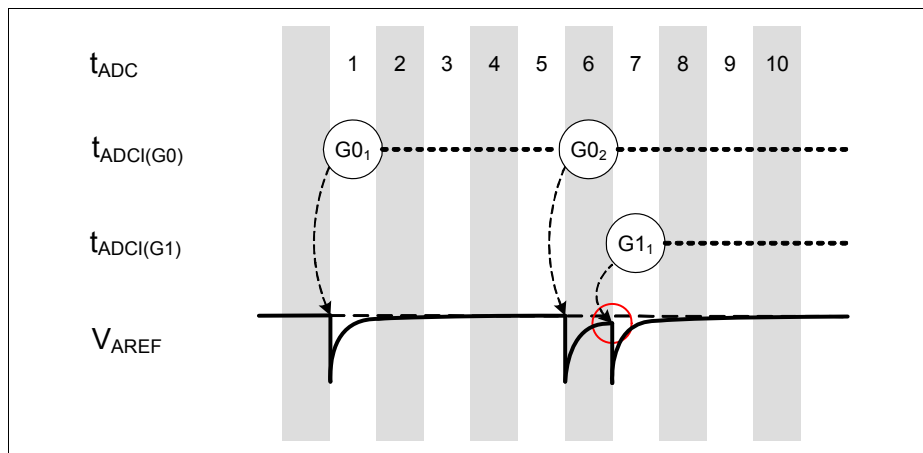
Figure 1 Influence of concurrent conversions on reference voltage

Due to this architecture, the individual prescalers may be displaced by one module clock as shown in the figure below for G0₂ and G1₁. In this example the division factor is 5 (DIVA=4).

In cycle 1 only the G0 conversion step is started. At start time the reference voltage is strobed and a certain amount of electric charge (see data sheet parameter Q_{CONV}) is consumed. This causes a drop of the reference voltage level V_{AREF} . Quantity of voltage drop depends on analog voltage level to convert.

In cycle 6 another G0 conversion step is starting and in cycle 7 a G1 conversion step. In this case the reference voltage may not yet be fully recovered when the G1 conversion step strobes V_{REF} . Consequently, the G1 conversion step yields an incorrect value.

In repeated measurements using the example setup errors up to 25 LSB have been observed in 10-16 of 4096 conversions. Magnitude of the error however depends on the system configuration and load. The workaround therefore should be applied for all applications.

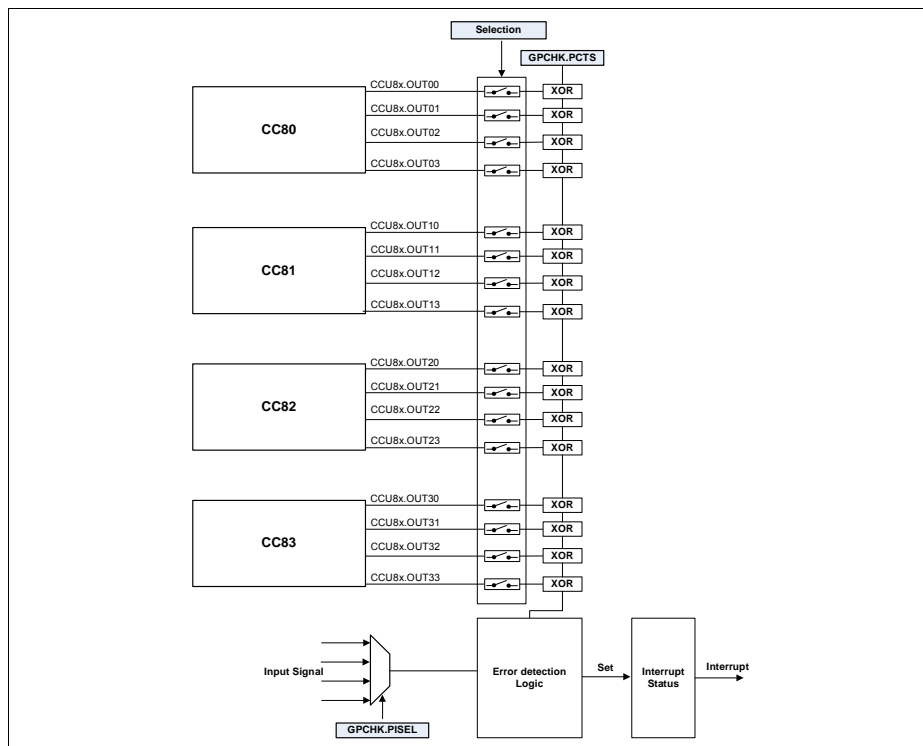
Figure 2 Parity Checker diagram

This means that if in the previous PWM cycle an error was detected and one interrupt was triggered, the software needs to read back the status register before the end of the immediately next PWM cycle.

This is indeed only necessary if multiple interrupt sources are ORed together in the same interrupt line. If this is not the case and the parity checker error source is the only one associated with an interrupt line, then there is no need to read back the status information. This is due to the fact, that only one action can be triggered in the software routine, the one linked with the parity checker error.

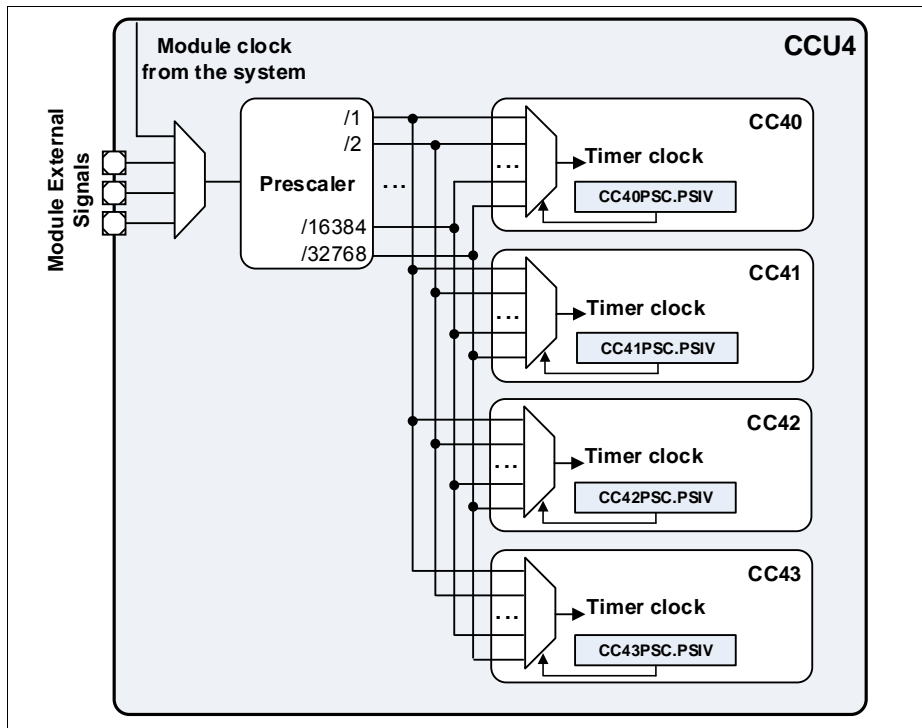
Figure 4 Clock Selection Diagram for CCU4

This is only applicable if the Module Clock provided by the system (the normal default configuration and use case scenario) is not being used. In the case that the normal clock configured and programmed at system level is being used, there is not any type of constraints.

One should not also confuse the usage of an external signal as clock for the module with the usage of an external signal for counting. These two features are completely unrelated and there are not any dependencies between both.

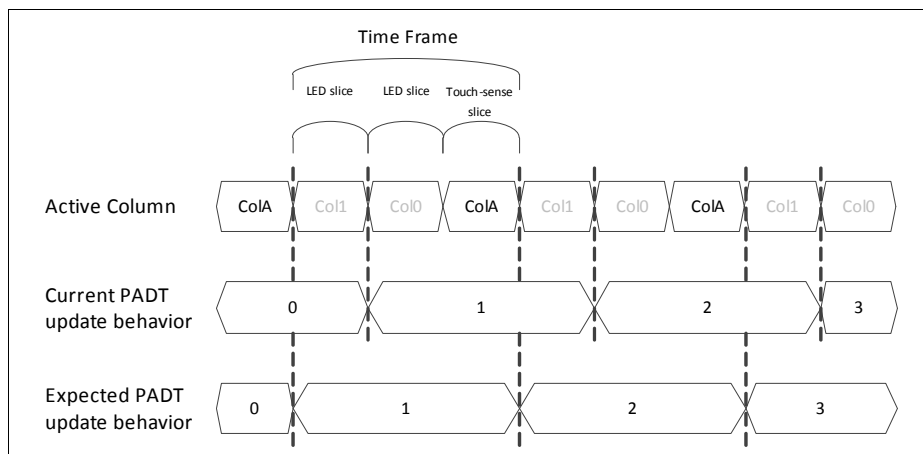
Figure 5 PADT update behavior

The touch-sense pad turn (PADT) value is updated, not at the end of the touch-sense time slice (ColA), but one time slice later (**Figure 5**).

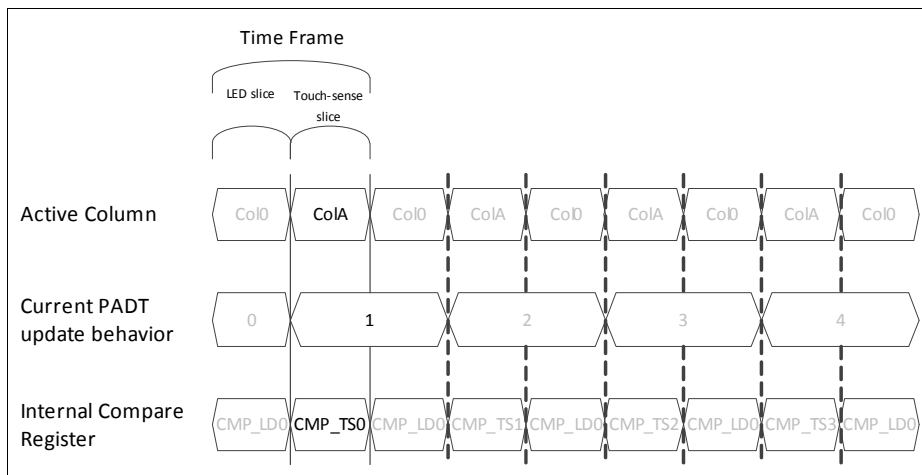
Figure 6 Effect of delay on the update of Internal Compare Register with 1 LED column enabled

If the number of LED columns enabled is smaller than 2, the delay will affect the activation period of the current active pad. At the beginning of every new Col A, the value of the current PADT's compare register is updated to the internal compare register. However, the delay causes the value of the previous PADT's compare register is updated to the internal compare register instead. This means that the current active pad would be activated with the duration of the previous pad's oscillation window (**Figure 6**). In addition to this, when no LEDs are enabled, pad turn 0 will prevail for one time slice longer before it gets updated (**Figure 7**).

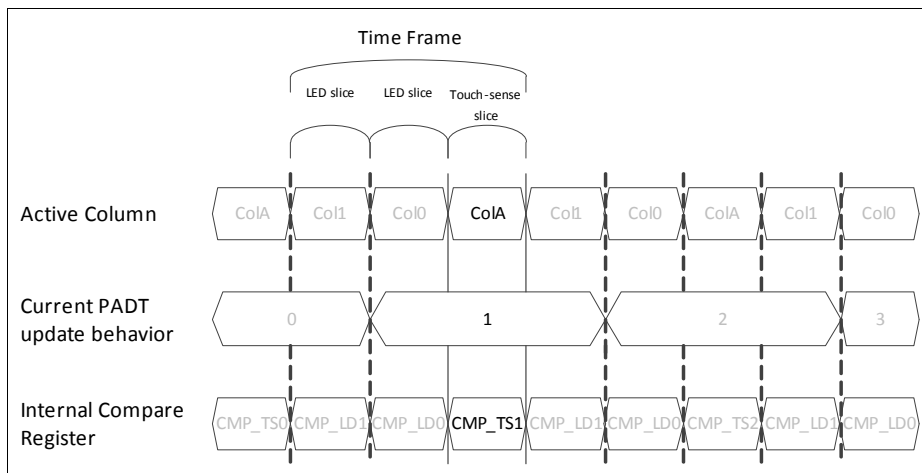
Figure 8 Internal Compare Register updated with correct compare register value with 2 LED columns enabled

If the number of LED columns enabled is 2 or more, the additional LED columns would provide some buffer time for the delay. So, at the start of a new touch-sense time slice, the update of PADT value would have taken place. Hence, the current active PADT compare register value is updated to the internal compare register (**Figure 8**).

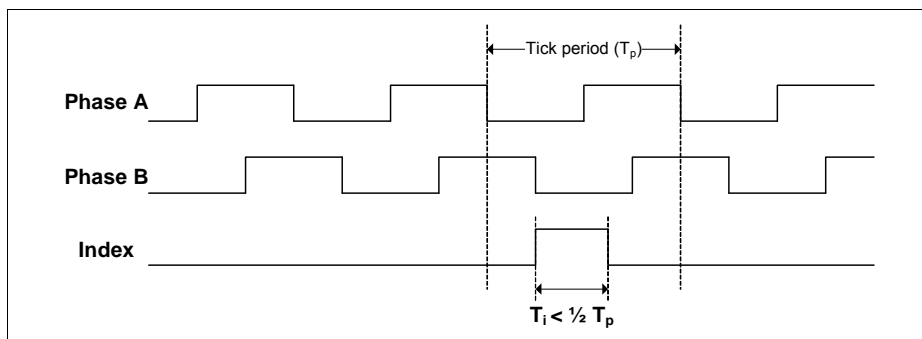
Figure 11 Different index signal types

When the index signal is smaller than 1/2 of the tick period, the POSIF module is not able to decode this signal properly, Figure 2 - notice that the reference edge of the index generation in this figure is the falling of Phase B, nevertheless this is an example and depending on the encoder type, this edge may be one of the other three.

Due to this fact it is not possible to use the POSIF to decode these type of signals (index with duration below 1/2 of the tick period).

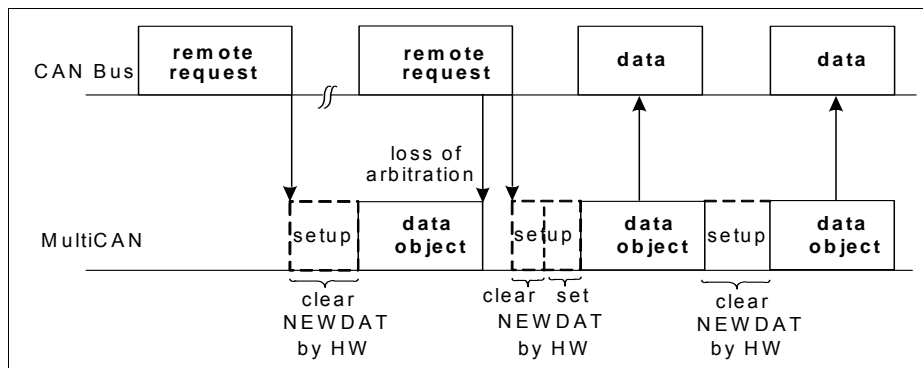
Figure 14 Loss of Arbitration

When the appropriate message object (data frame) triggered by the first remote frame wins the arbitration, it will be sent out and NEWDAT is not reset. This leads to an additional data frame, that will be sent by this message object (clearing NEWDAT).

There will, however, not be more data frames than there are corresponding remote requests.

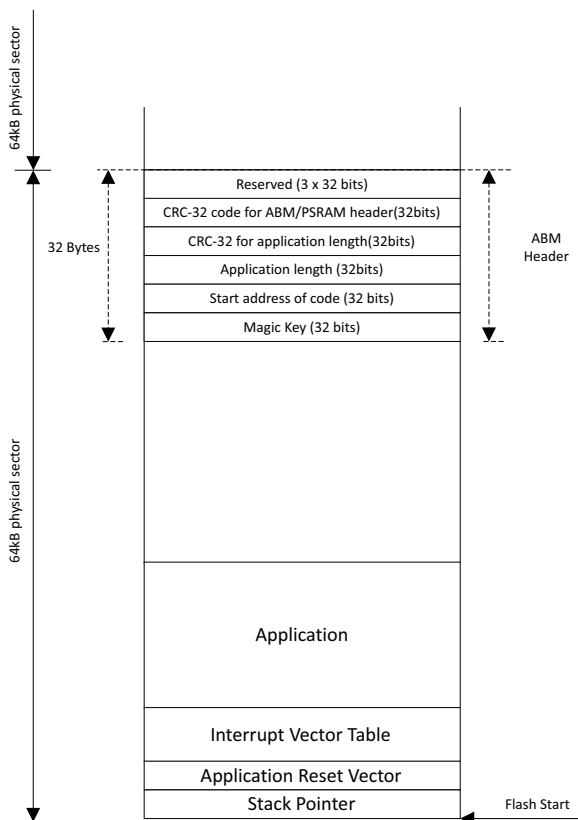
Figure 15 ABM/PSRAM Header - Location of reserved bytes

The reference manual is specifying PSRAM/ABM Header of 32 byte size. Only for 20byte of these 32 bytes the functionality is defined. The remaining 12bytes are reserved. Inside the chapter for Startup modes of the reference manual only the functional bytes are specified but not the location of the reserved bytes.

The following figure provides a detailed view on the location of the reserved bytes:
