# MCF5485 Chip Errata

**Silicon Revision: All**

**Supports: MCF5480, MCF5481, MCF5482, MCF5483, MCF5484, and MCF5485**

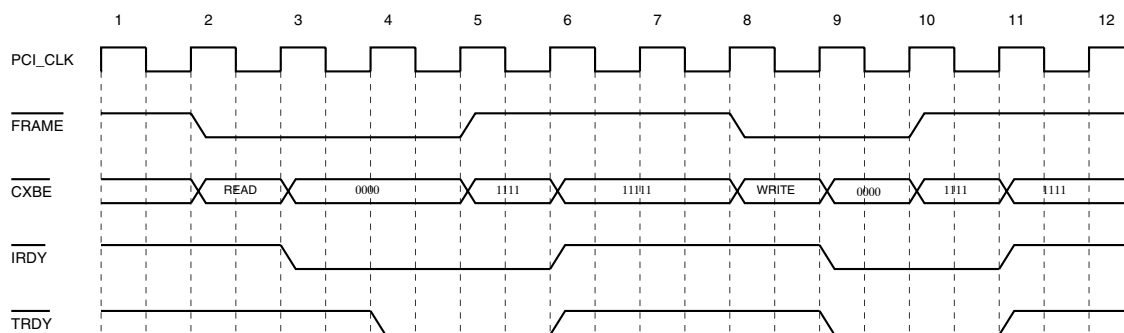
**Figure 1. PCI bus 2-beat transfer**

**Description:** As shown below, an unexpected 2-beat transfer is issued on the PCI bus when a Type 1 configuration PCI cycle is performed using the Configuration Mechanism and more than 3 bytes are being transferred. The byte enables are correctly driven, but a second false data transfer is issued.

For writes, there is no harm done other than one or more (if a disconnect occurs) wasted PCI cycles for the false data transfer. During reads, two beats of data, the good data and the false data, are pushed into an internal read data FIFO and only one is popped off the FIFO. The first 32-bit read completes as expected. Any read following this read, causes the transaction on the PCI bus as expected. However, internally the data returned for this next read is not new data but what remained in the FIFO from the first two-beat read, the second false data transfer. The addition of the false data in the read FIFO causes subsequent reads to be out-of-sync with the data in the FIFO.

**Workaround:** Only issue byte or 2-byte type 1 configuration reads. Addresses at byte offsets retrieve the correct bytes. This avoids the two-beat read transactions.

**Workaround:** Use the SPCPI RX interface to issue 32-byte type 1 configuration reads to PCI.

**Workaround:** After issuing a 32-bit type 1 configuration read via the configuration mechanism (using PCICAR), clear the read data FIFO of the false data by immediately issuing an XLB transaction that results in a master abort. For instance, after a type 1 configuration read (to bridge), change the bus number in the PCICAR to an unused bus and issue another type 1 configuration transaction (read or write). A read returns all 1s. The master abort status bits flag, PCISCR[MA] and PCIISR[IA]. If subsequent configuration reads across the bridge are needed, reprogram the bus number to the valid value and continue interleaving the master abort transaction between each.
