Wayne E. Bahr, Global Director
Automotive Safety Office
Sustainability, Environment & Safety Engineering

Subject: 49 CFR Part 579.5 Monthly Communications – February 2016

**INDEX OF SERVICE BULLETINS,
NOTICES, AND COMMUNICATIONS TO DEALERS**

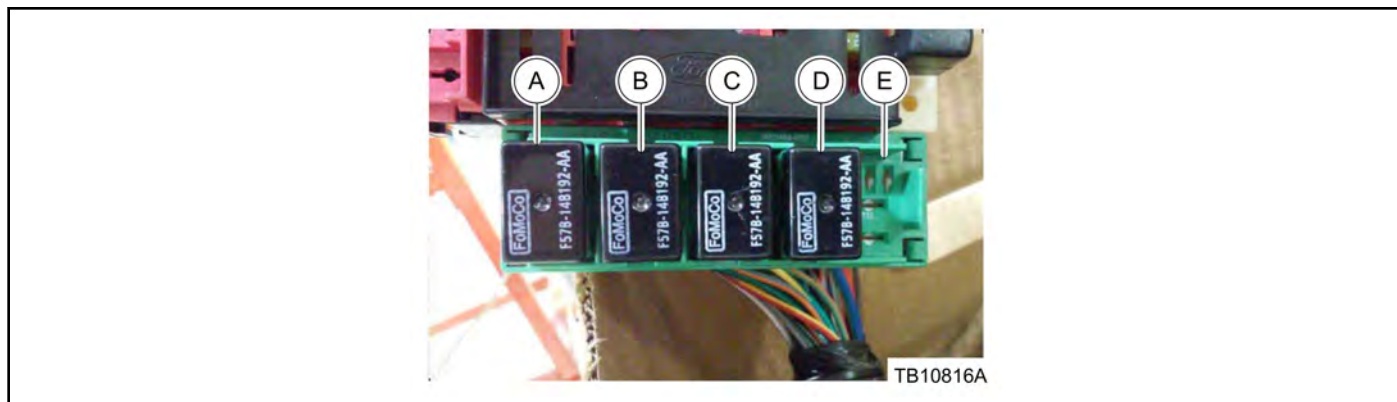
Figure 1 - Article 16-0014

Some 2011-2015 F-59 Commercial Stripped Chassis vehicles built on or before 5/29/2015 may experience hazard lighting, turn signal operation or trailer tow (TT) lighting that is not functioning properly. Vehicle vibrations may internally damage the relays that control the lighting circuits.

1. Is the hazard lighting, turn signal operation or TT lighting not functioning properly?
 - a. Yes - proceed to step 2.
 - b. No - this article does not apply. Refer to Workshop Manual (WSM), Section 417-01 for normal diagnostics.
2. Locate the central junction box (CJB) in the lower left side of dash. Remove and discard the following relays: (Figure 1)

- A - Trailer Tow Right Turn
 - B - Trailer Tow Left Turn
 - C - Right Turn
 - D - Left Turn
 - E - Empty
3. Install new 4-terminal relays in the CJB in positions A, B, C and D. (Figure 1)

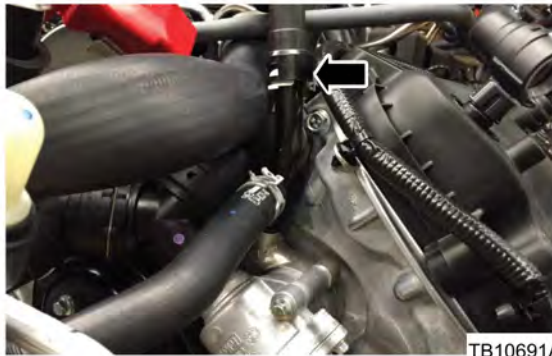
Figure 1 - Article 16-0019

Some 2015 F-150 and Mustang vehicles equipped with a 5.0L Dual Overhead Camshaft (DOHC) engine may exhibit a coolant leak caused by a heater outlet hose becoming disconnected at the heater outlet tube on the coolant pump.

1. Check the engine build date. Refer to Workshop Manual (WSM), Section 303-01. Was the engine built on 11/20/2014 and through 1/26/2015?
 - a. No - this procedure does not apply. Refer to WSM, Section 303-03 for normal diagnosis.
 - b. Yes - proceed to Step 2.
2. Is the heater outlet hose disconnected from or leaking at the heater outlet tube on the coolant pump? (Figure 1)

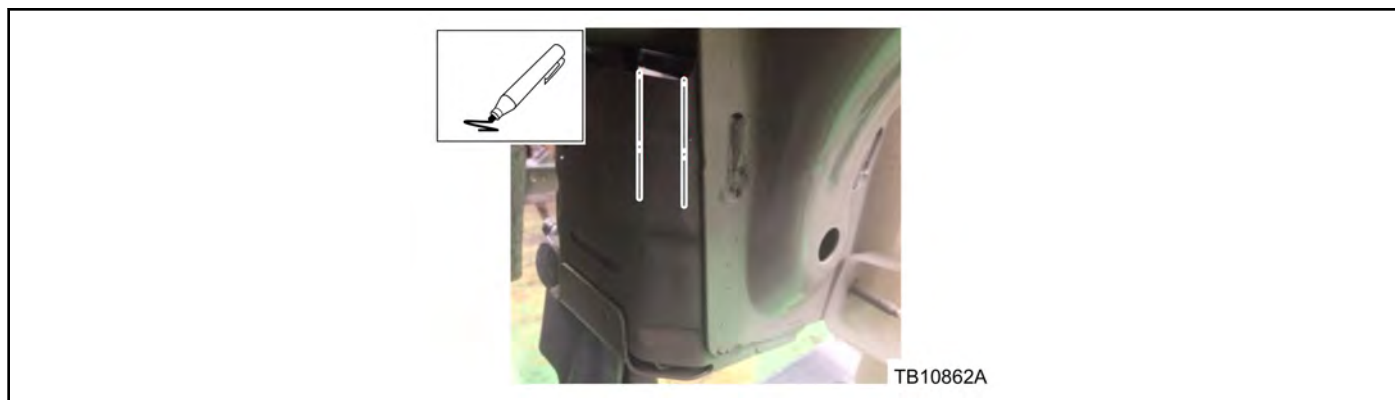
Figure 1 - Article 16-0021

The steps below will add an additional weld to eliminate the possibility of the barrel nut creak/pop noise.

1. Attach Rotunda Wireless Chassis Ears JSP97202 or equivalent. Does diagnosis with chassis ears indicate the noise is originating from the right front mounting bolt of the front subframe?
 - a. Yes - proceed to Step 2.
 - b. No - this article does not apply. Refer to Workshop Manual (WSM), Section 100-04 for normal diagnostics.
2. Disconnect the negative battery cable. Refer to WSM, Section 414-01.
3. Remove the right front wheel and tire assembly. Refer to WSM, Section 204-04.
4. Remove the right side fender splash shield. Refer to WSM, Section 501-02.
5. Locate the front subframe bolt mounting tower bracket on the right side frame member and mark 2 cut lines approximately 63 mm (2.50 in) long as shown. (Figure 1)
