PIC32MZ Graphics (DA) Family

PIC32MZ Graphics (DA) Family Silicon Errata and Data Sheet Clarification

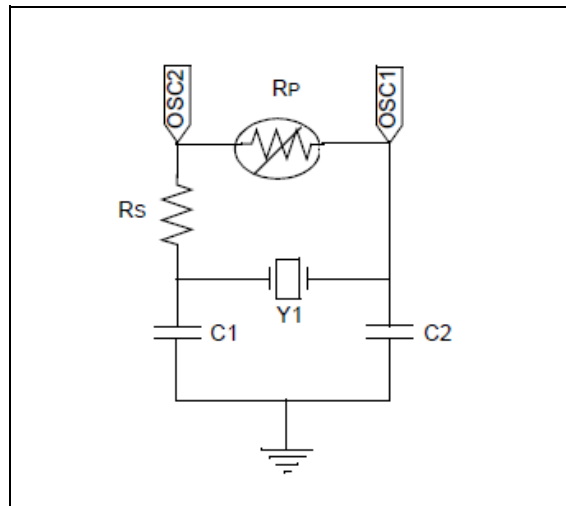
FIGURE 1: Posc CRYSTAL CIRCUIT

The POSC has been tested in a normal power-up sequence and supports specific crystal operation.

The Primary Oscillator (POSC) has been characterized to operate at 8 MHz and 12 MHz when the circuit shown in Figure 1 is implemented, and the operating conditions listed in Table 3 are met.

TABLE 3: CRYSTAL SPECIFICATION

Crystal Frequency (See Note 1)	Series Resistor Rs	Posc Gain Setting POSCGAIN<1:0> (DEVCFG0<20:19>)	Posc Boost Setting POSCBOOST (DEVCFG0<21>)
8 MHz	2 kΩ	'0b00 (GAIN_0)	'0b1
12 MHz	1 kΩ	'0b00 (GAIN_0)	'0b1

Note 1: Using any other crystal frequency will require special component selection and characterization.

2: A parallel register (Rp) should not be used to increase the gain of the Posc.
