February 2018

Dealer Service Instructions for:

## **Safety Recall T79 / NHTSA 17V-821 Brake Transmission Shift Interlock**

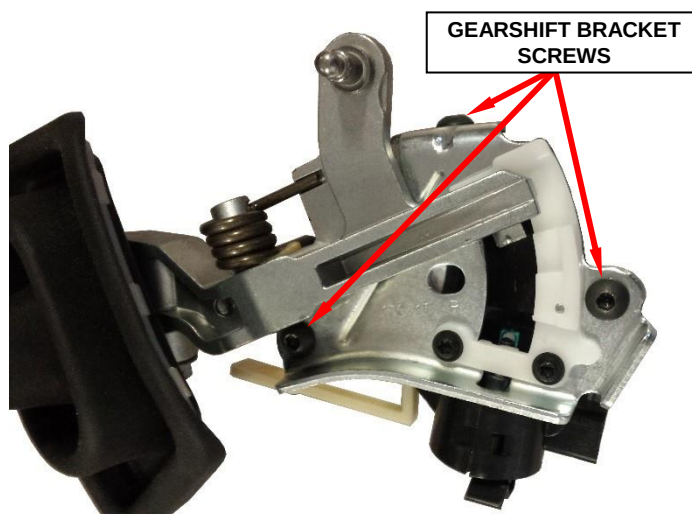
**Figure 12 – Gearshift Bracket / BTSI Assembly Screws**

18. Remove and save the three T27 star-head screws securing the gearshift bracket / BTSI assembly to the steering column (Figure 12).
19. Remove the gearshift bracket / BTSI assembly with shift lever from the steering column then transfer to bench (Figure 13).
20. Remove the upshift/downshift electrical harness from the retaining clip (Figure 13).
21. Release the upshift/downshift electrical harness retainer from the gearshift bracket / BTSI assembly (Figure 13).
22. Remove and save the E10 star-head pinch bolt securing the shift lever to the gearshift bracket / BTSI assembly (Figure 13).
23. Remove and save the gearshift lever from the gearshift bracket / BTSI assembly (Figure 13).

31. Install the three T27 star-head screws securing the gearshift bracket / BTSI assembly to the steering column. Tighten the screws to 10 N·m (89 in. lbs.) (Figure 12).

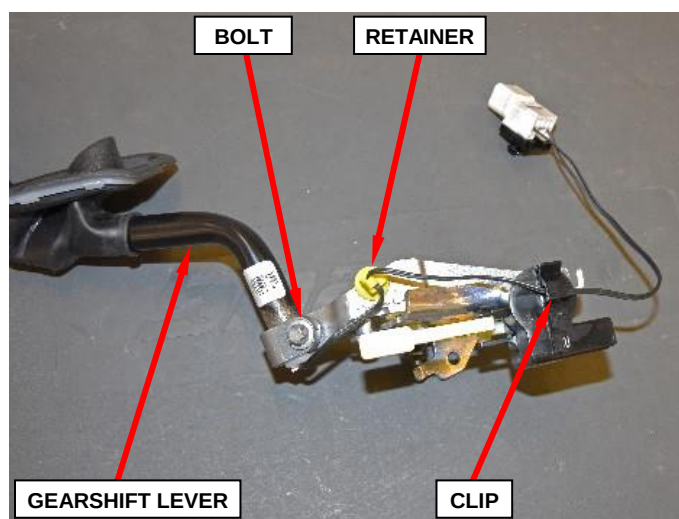
**Figure 13 – Gearshift Lever**

27. Install the E10 star-head pinch bolt securing the shift lever to the gearshift bracket / BTSI assembly. Tighten the pinch bolt to 11 N·m (97 in. lbs.) (Figure 13). Ensure shift lever is properly seated and not loose after tightening.
28. Attach the upshift/downshift electrical harness retainer to the gearshift bracket / BTSI assembly (Figure 13).
29. Install the upshift/downshift electrical harness to the retaining clip (Figure 13).
30. Install the gearshift bracket / BTSI assembly with shift lever to the steering column.

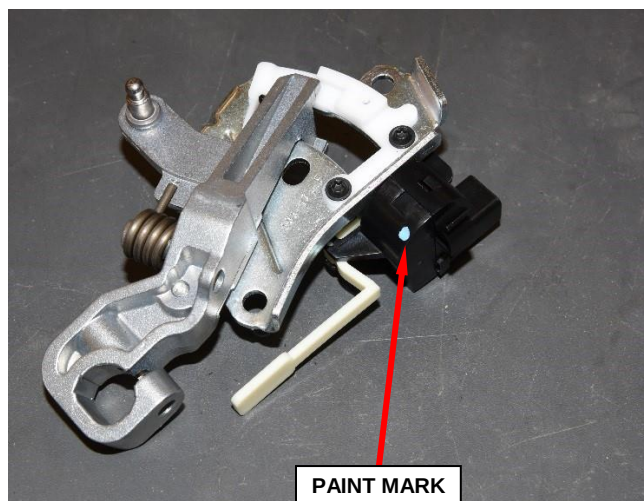
**Figure 14 – Gearshift Bracket / BTSI Assembly Paint Mark Verification**

24. Discard the old gearshift bracket / BTSI assembly.
25. Verify the **new** gearshift bracket / BTSI assembly to be used has a paint mark on the BTSI solenoid (Figure 14).
26. Install the gearshift lever to the **new** gearshift bracket / BTSI assembly and ensure the gearshift lever is fully inserted into the gearshift bracket (Figure 15).

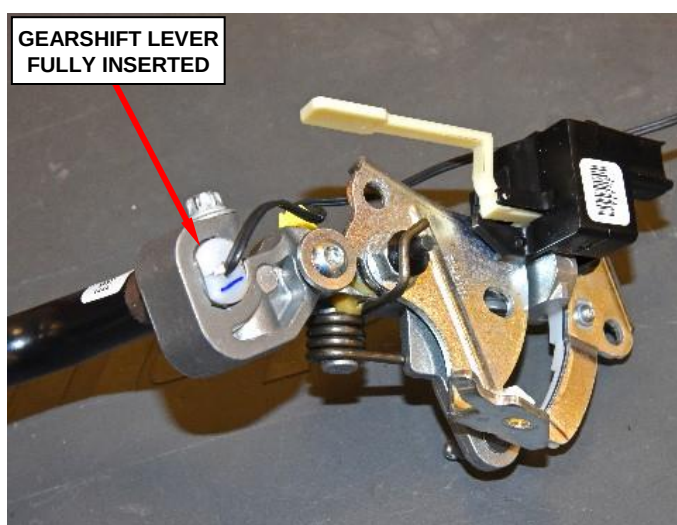
**Figure 15 – Gearshift Lever Insertion**
