Assessment Summary Report
**Hillsboro Airport Seismic
Resilience Assessment**
Hillsboro, Oregon

Prepared for
Port of Portland

February 4, 2019
154-035-006

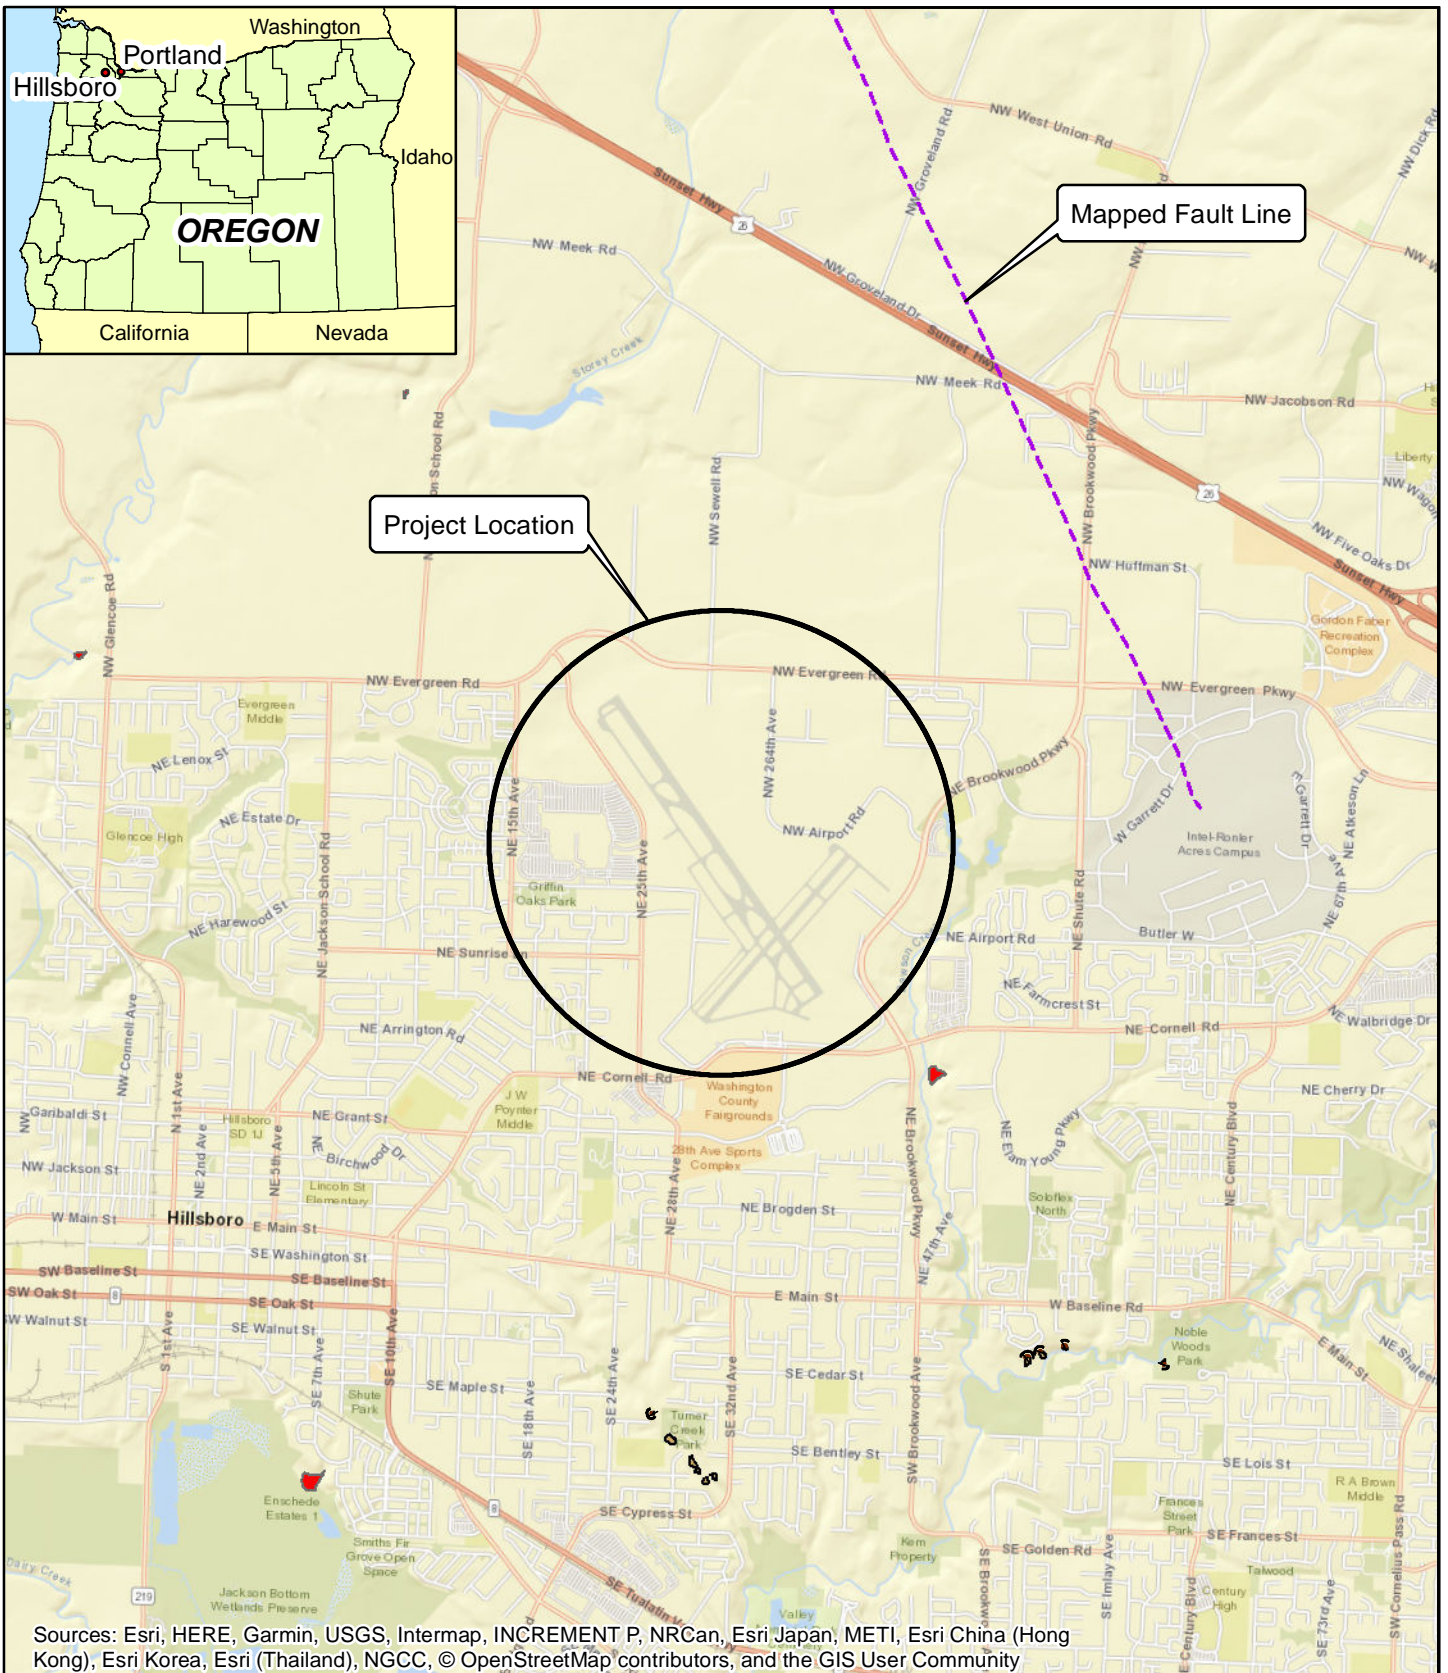
The study team reviewed mapped geologic hazards including: discrete landslides, landslide susceptibility, earthquake shaking, and relative liquefaction. Landslide mapping is provided by the Statewide Landslide Information Database for Oregon (SLIDO). No mapped or historically active landslides are recorded within the airport boundaries; however, a debris flow estimated to be over 150 years old is mapped southeast of the airport, south of NE Cornell Road (SLIDO 2016). The immediate area of HIO is mapped as predominately low risk for landslides, with a few areas of moderate landslide susceptibility. It is also mapped to be at risk for “very strong” expected earthquake and expected Cascadia earthquake shaking, and low to high liquefaction potential (HAZVU 2016). Additionally, the U.S. Geologic Survey (USGS) maps a low slip rate Quaternary active fault approximately 1 to 1.5 miles northeast of the site (USGS 2006). SLIDO mapped landslides are shown on Figure 1. Liquefaction hazard is shown on Figure 2 .

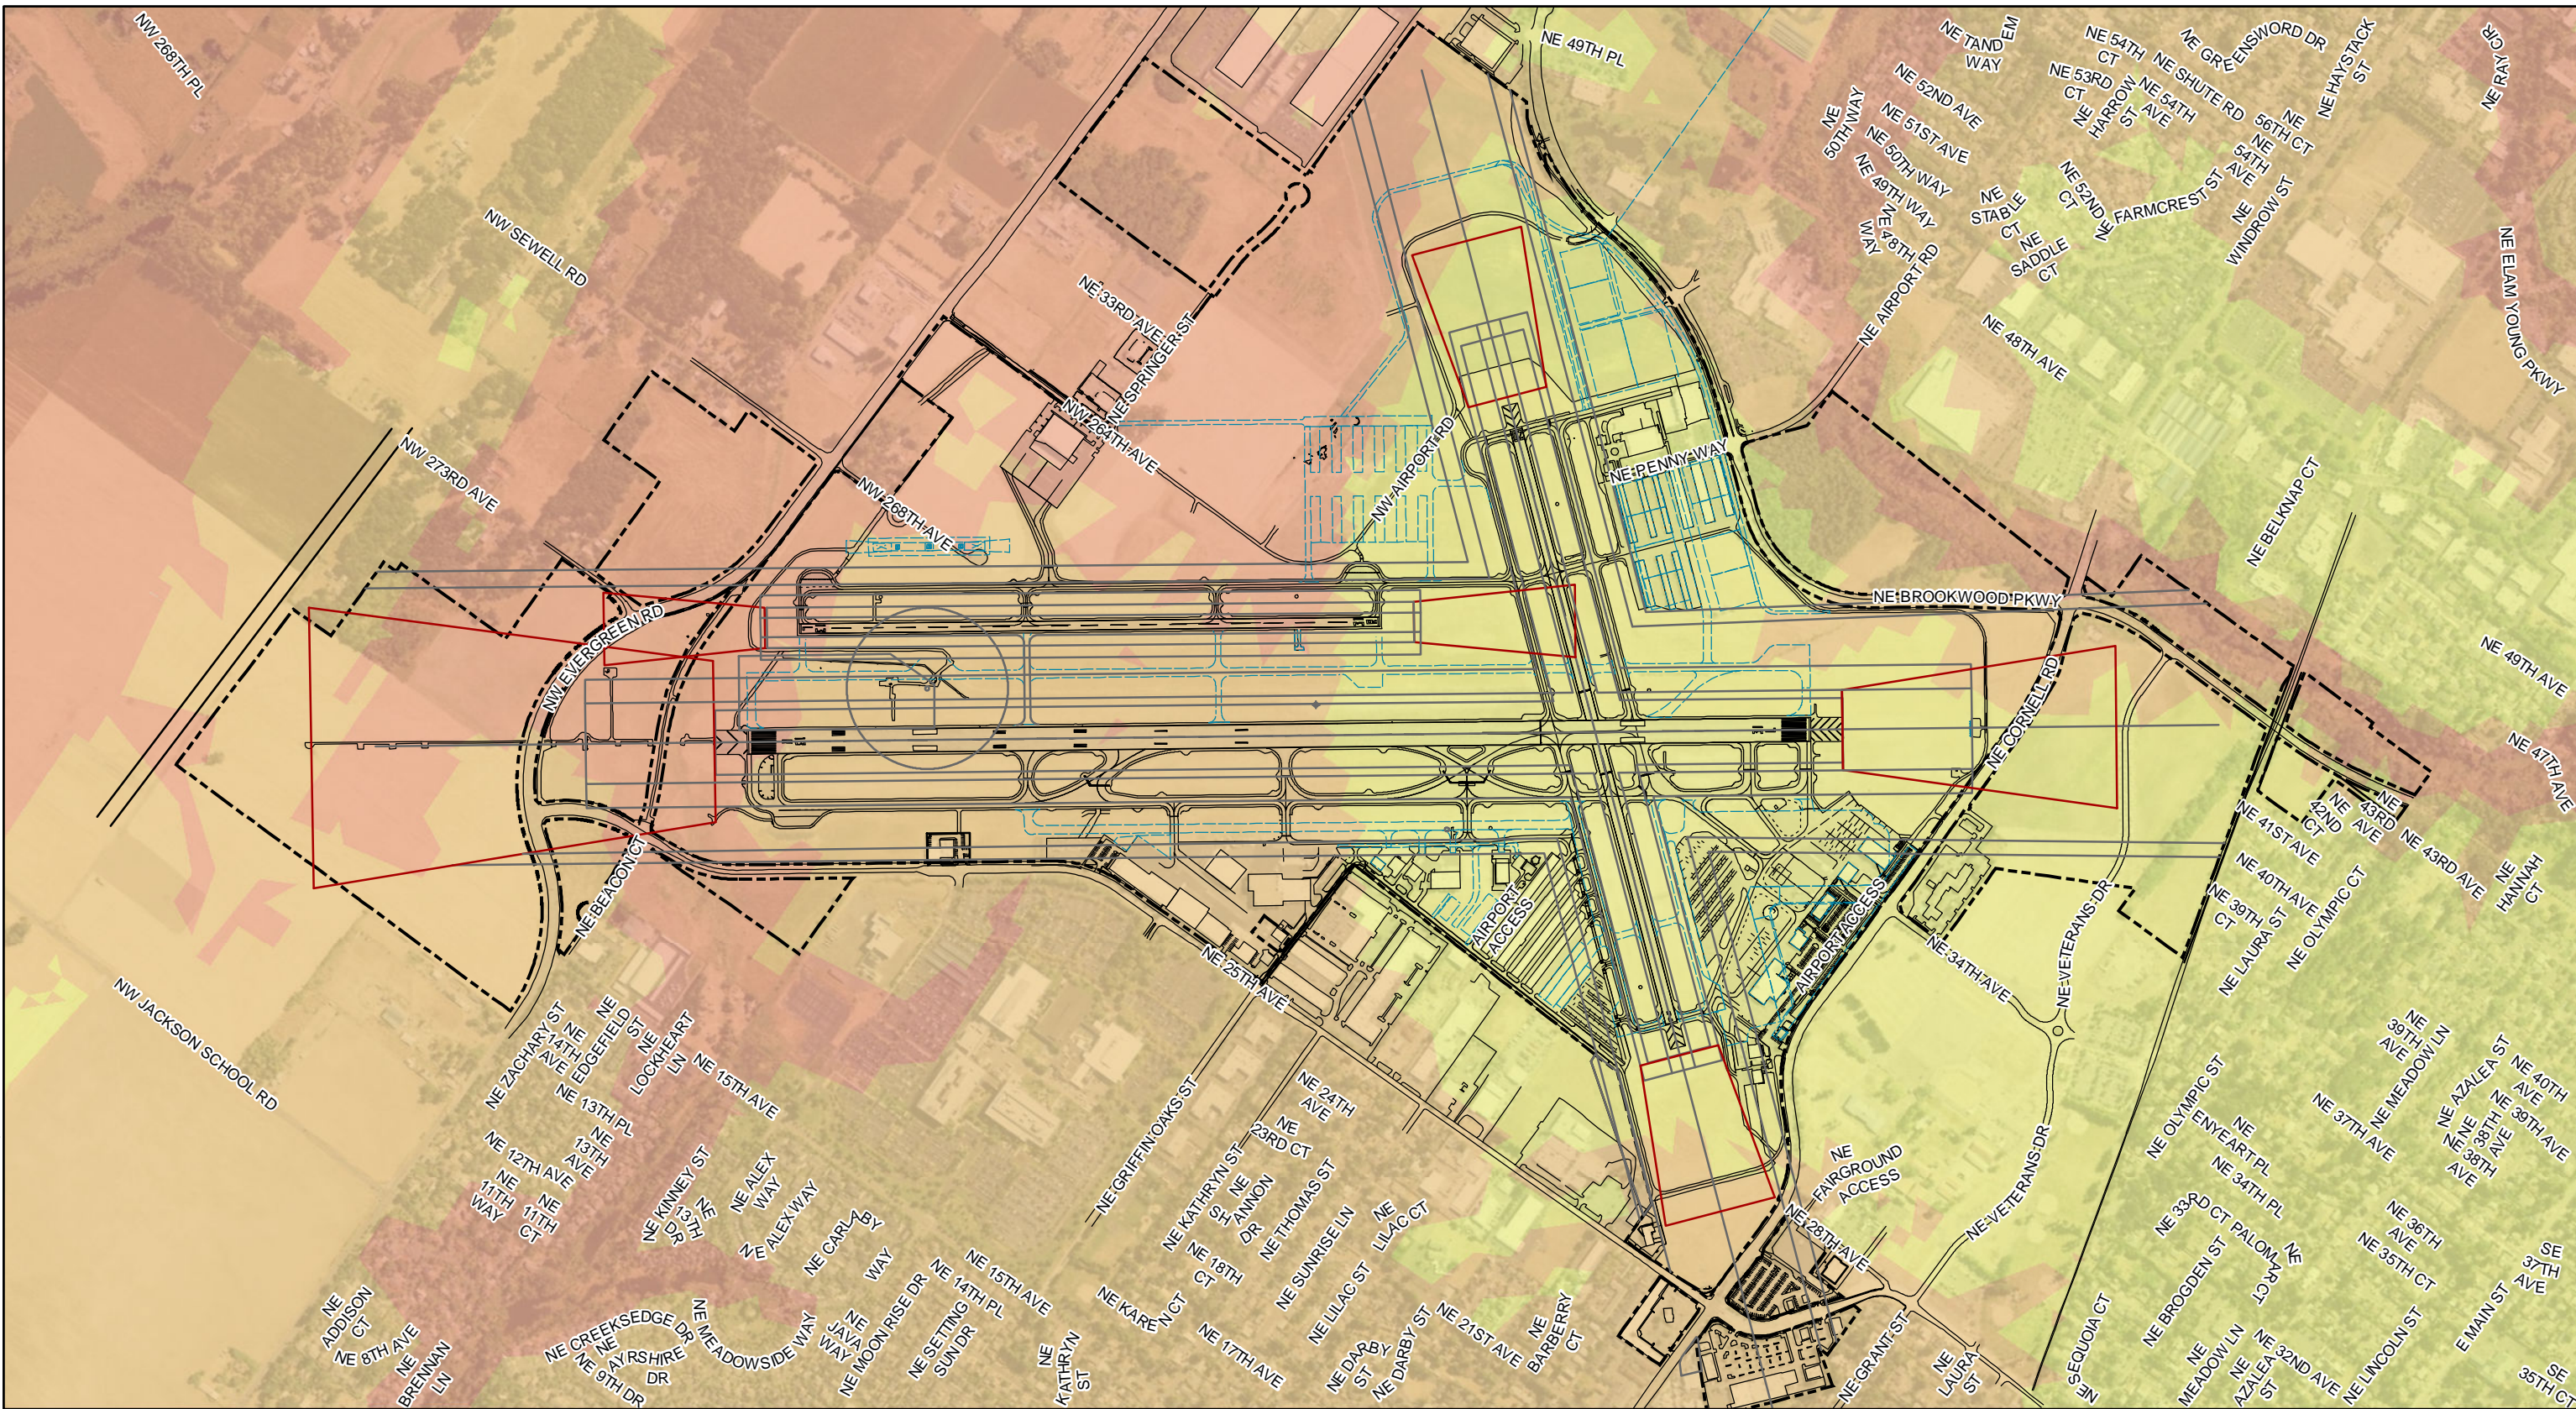
Based on our review of the existing data, the risk for landslide and fault rupture at HIO is minimal. However, very strong shaking and liquefaction are expected at the site. Between 1 and 7 inches of liquefaction settlement should be expected across the site. Differential settlement will damage pavements and structures. This is specifically true for the runways and aprons. Pavement cracking and settlement could damage runways preventing fixed wing air traffic from using the runways until extensive repairs can be made. If desired to maintain normal operations after an earthquake, liquefaction mitigation under runways and critical aprons would be required.
