Dealer Service Instructions for:

Safety Recall T79 / NHTSA 17V-821 Brake Transmission Shift Interlock

The Brake Transmission Shift Interlock (BTSI) locking pin on about 1,482,400 of the above vehicles may become stuck in the open position. A BTSI locking pin stuck in the open position may allow the transmission to be shifted out of PARK and to any gear position without depression of the brake pedal and/or without the key in the ignition, if a key is applicable. The ability to shift the transmission out of the PARK position without a key in the ignition or a brake pedal application, increases the risk for an unintended vehicle rollaway that may result in a vehicle crash or injury without prior warning.

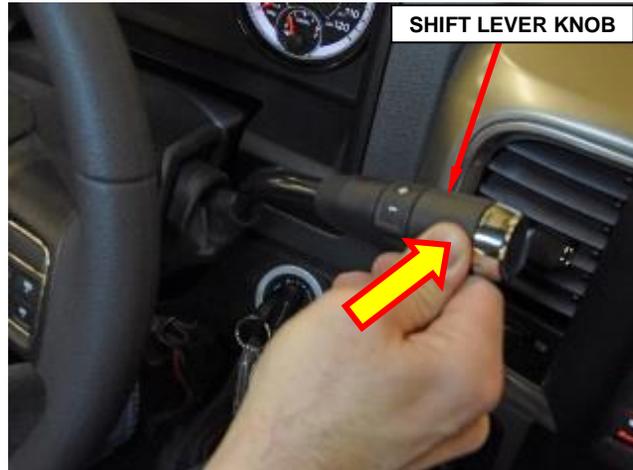
5. Place your hand on the shift lever knob and push lightly on the shift lever toward the instrument panel. This will allow you to feel a click sensation from BTSI solenoid pin movement when the brake pedal is applied and released (Figure 1).

Figure 1 – Push Lightly On Shift Lever Knob Toward Instrument Panel To Feel BTSI Solenoid Pin Movement

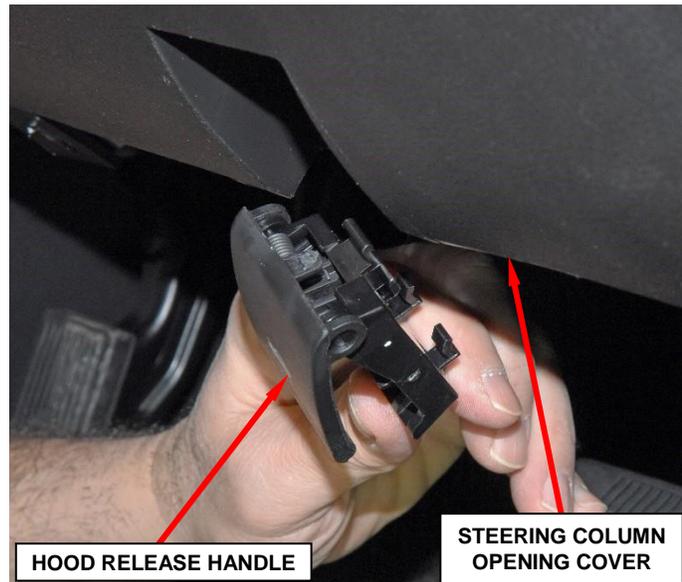
1. Open the vehicle hood
2. Disconnect the negative battery cable terminal from the battery(s).
3. Using a trim stick C-4755 or equivalent, disengage the retainer clip that secures the hood release handle to the steering column opening cover, and remove the hood release handle from the cover (Figure 2).

**Figure 2 – Hood Release Handle**

45. Position the hood release handle onto the steering column opening cover and fully engage the retainer clip that secures the hood release handle to the steering column opening cover (Figure 2).

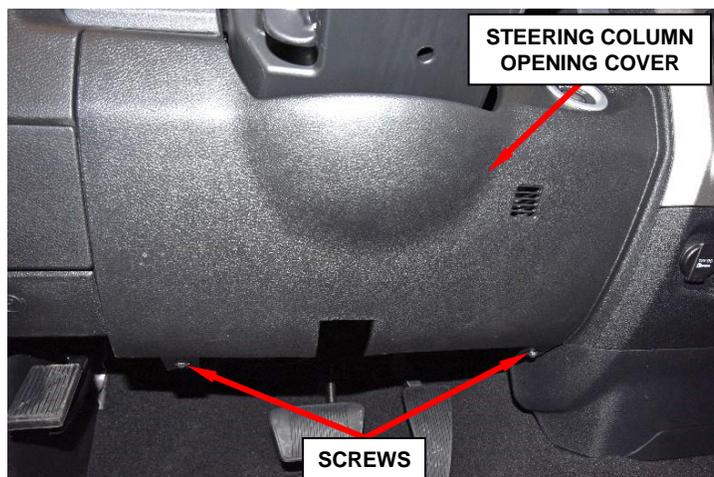
4. Remove and save the two screws that secure the bottom of the steering column opening cover to the instrument panel (Figure 3).
5. Using a trim stick C-4775 or equivalent, release the eight spring clips that attach the steering column opening cover to the instrument panel (Figure 3)

**Figure 3 – Steering Column Opening Cover**

43. Attach the steering column opening cover to the instrument panel with the eight spring clips (Figure 3).
44. Install the two screws that secure the steering column opening cover to the instrument panel. Tighten the screws to 3.6 N·m (32 in. lbs.) (Figure 3).

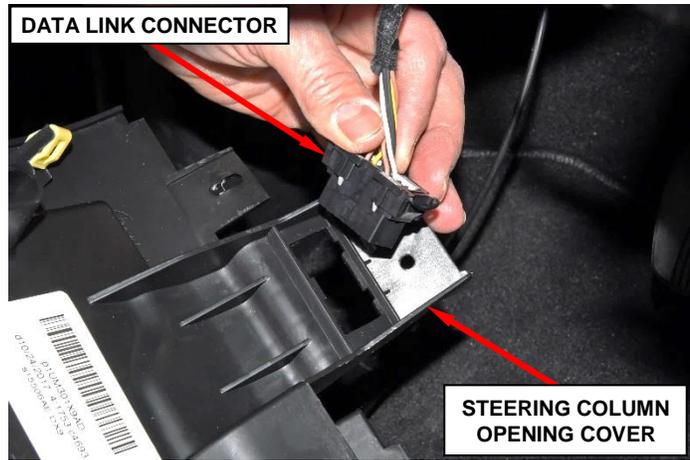
- Remove the data link connector from the steering column opening cover by pressing in the tabs and pushing the connector through the opening on the back side of the cover (Figure 4).

Figure 4 – Data Link Connector

41. **If equipped:** Connect the electrical connectors for any electrical devices to the steering column opening cover.
42. Install the data link connector to the steering column opening cover by pushing the connector through the opening on the back side of the cover and fully engaging the lock tabs of the connector (Figure 4).

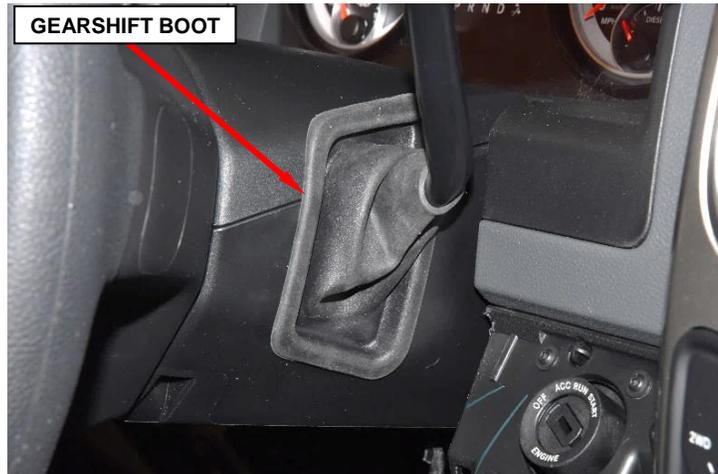
Figure 5 – Gearshift Boot

- Using a trim stick, disengage the gearshift boot from the steering column shrouds (Figure 5).

40. Attach the shift boot to the upper and lower steering column shrouds (Figure 5).

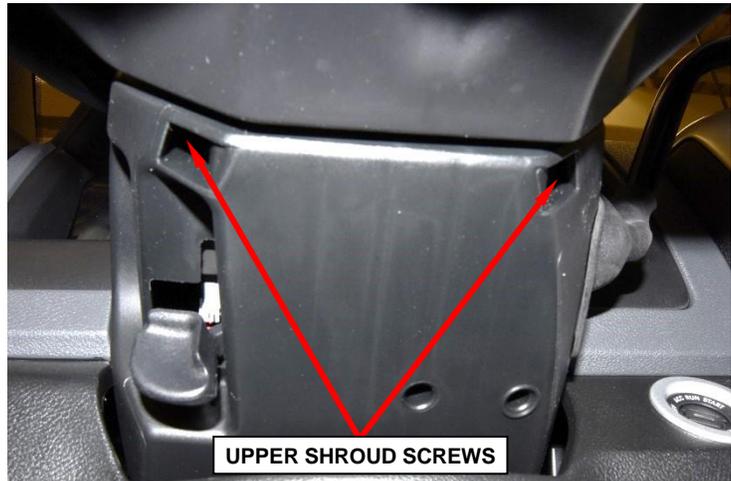
10. Remove and save the two T20 star-head screws that attach the upper steering column shroud to the lower steering column shroud. The screws are located on the underside of the lower steering column shroud (Figure 6).

**Figure 6 – Upper Shroud Screws**

39. Install the two T20 star-head screws that attach the lower steering column shroud to the upper shroud. Tighten the screws to 1.3 N·m (12 in. lbs.) (Figure 6).

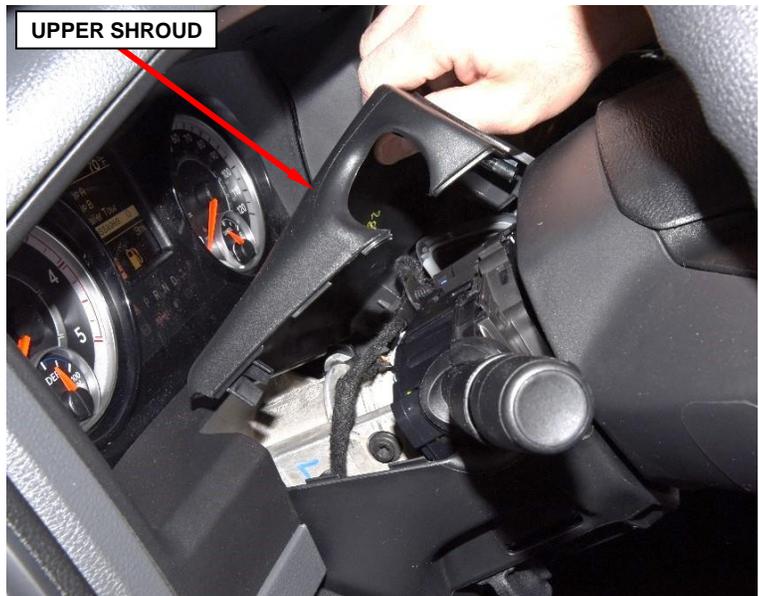
11. Remove and save the upper steering column shroud by pushing gently inward and upward on both sides of the upper shroud just above the joint line to the lower shroud to release the snap features that secure the shrouds together (Figure 7).

**Figure 7 – Steering Column Upper Shroud**

37. Install the T20 star-head screw that retains the lower shroud to the steering column. Tighten the screw to 2.3 N·m (20 in. lbs.) (Figure 8).
38. Attach the upper steering column shroud by pushing gently inward on both sides of the upper shroud just above the joint line to the lower shroud and attach to the lower shroud using the snap features (Figure 7).

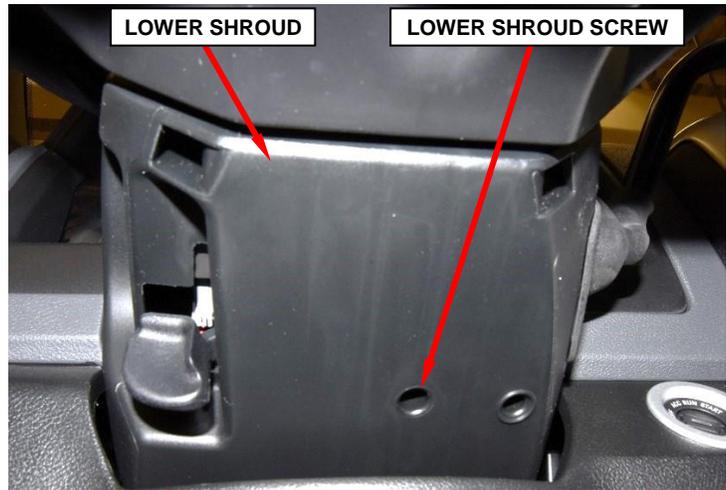
12. Remove and save the T20 star-head screw that retains the lower shroud to the steering column (Figure 8).

Figure 8 – Steering Column Lower Shroud

35. Connect the shift cable to the gearshift bracket (Figure 9).
36. Carefully position the lower shroud over the steering column tilt lever and onto the steering column (Figure 8).

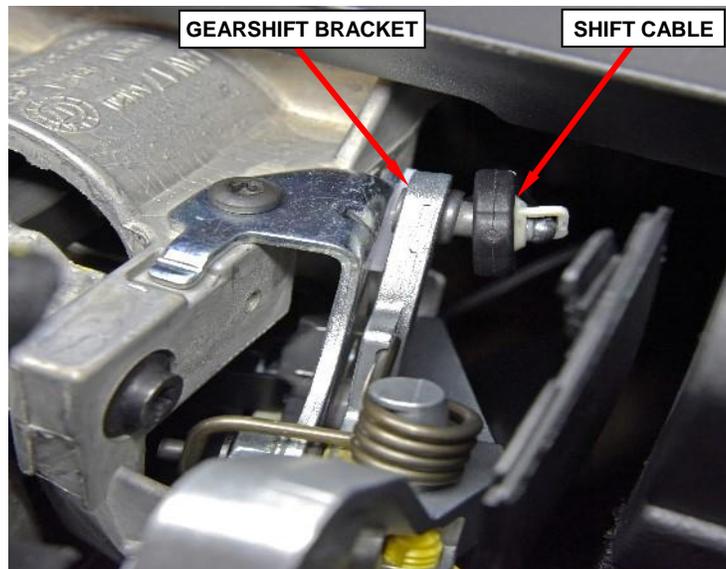
14. Disconnect the shift cable from the gearshift bracket (Figure 9).

Figure 9 – Shift Cable

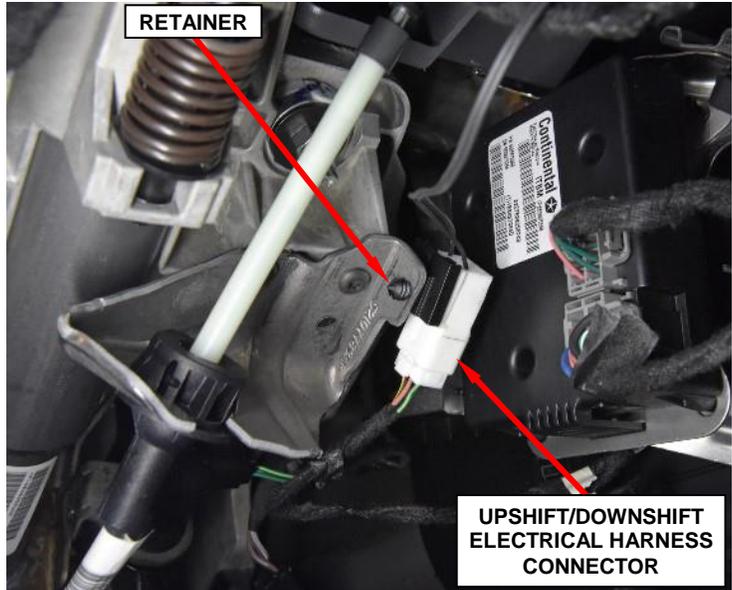
15. Disconnect the upshift/downshift electrical harness connector (Figure 10).

Figure 10 – Upshift/Downshift Electrical Harness

32. Connect the BTSI electrical harness connector (Figure 11).
33. Install the upshift/downshift electrical harness connector retainer (Figure 10).
34. Connect the upshift/downshift electrical harness connector (Figure 10).

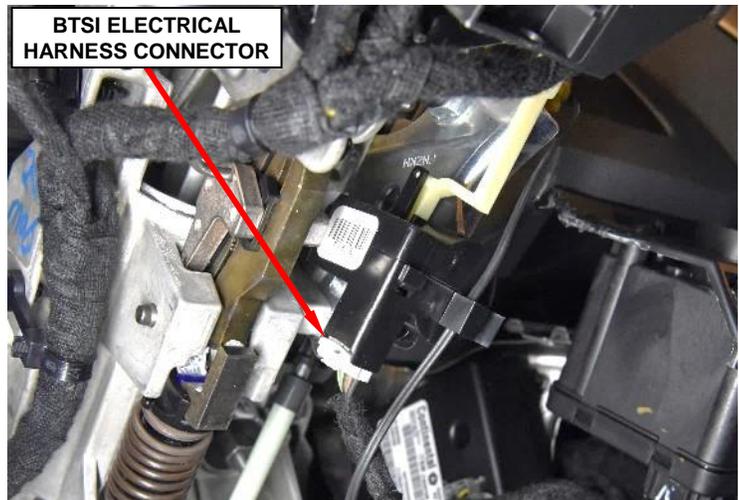
17. Disconnect the BTSI electrical harness connector (Figure 11).

Figure 11 – BTSI Electrical Harness

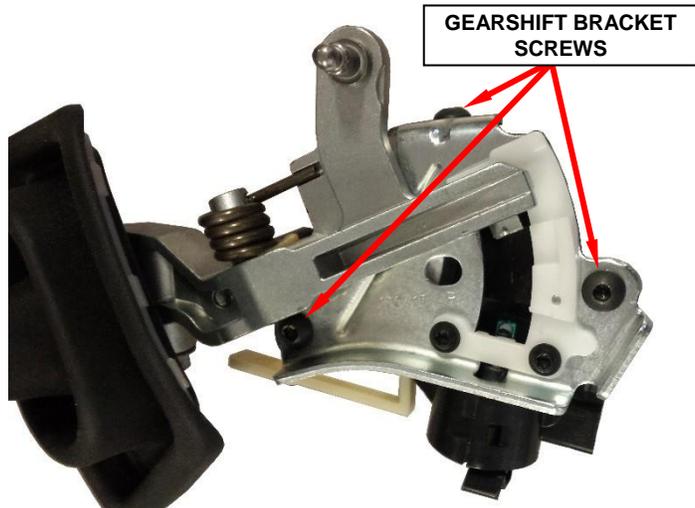
18. Remove and save the three T27 star-head screws securing the gearshift bracket / BTSI assembly to the steering column (Figure 12).

Figure 12 – Gearshift Bracket / BTSI Assembly Screws

31. Install the three T27 star-head screws securing the gearshift bracket / BTSI assembly to the steering column. Tighten the screws to 10 N·m (89 in. lbs.) (Figure 12).

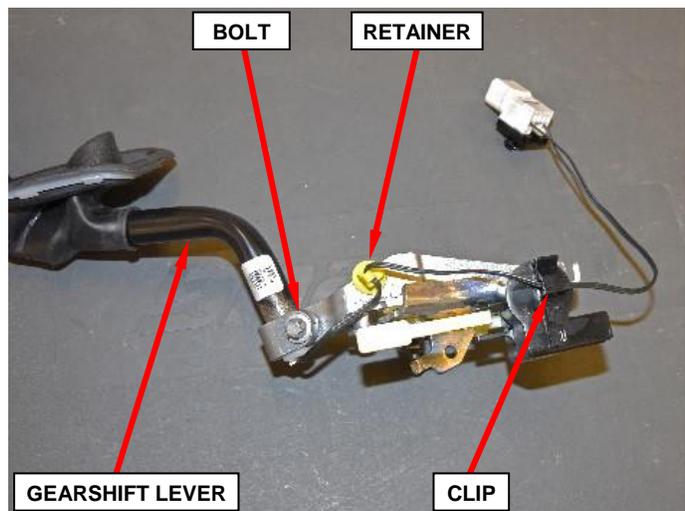
19. Remove the gearshift bracket / BTSI assembly with shift lever from the steering column then transfer to bench (Figure 13).

Figure 13 – Gearshift Lever

27. Install the E10 star-head pinch bolt securing the shift lever to the gearshift bracket / BTSI assembly. Tighten the pinch bolt to 11 N·m (97 in. lbs.) (Figure 13). Ensure shift lever is properly seated and not loose after tightening.
28. Attach the upshift/downshift electrical harness retainer to the gearshift bracket / BTSI assembly (Figure 13).

29. Install the upshift/downshift electrical harness to the retaining clip (Figure 13).

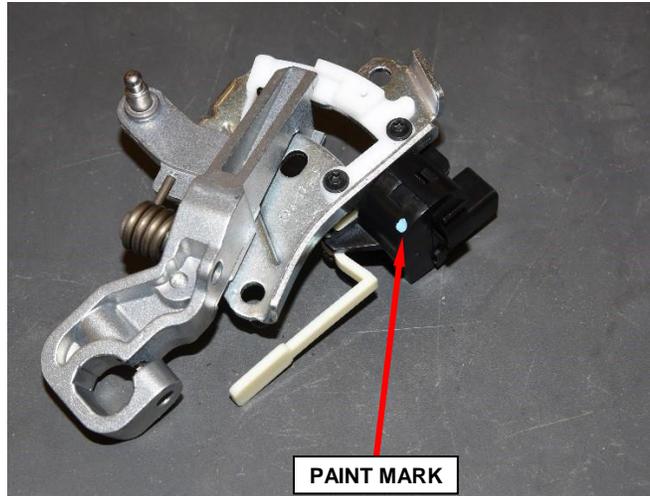
24. Discard the old gearshift bracket / BTSI assembly.
25. Verify the **new** gearshift bracket / BTSI assembly to be used has a paint mark on the BTSI solenoid (Figure 14).
26. Install the gearshift lever to the **new** gearshift bracket / BTSI assembly and ensure the gearshift lever is fully inserted into the gearshift bracket (Figure 15).

Figure 14 – Gearshift Bracket / BTSI Assembly Paint Mark Verification

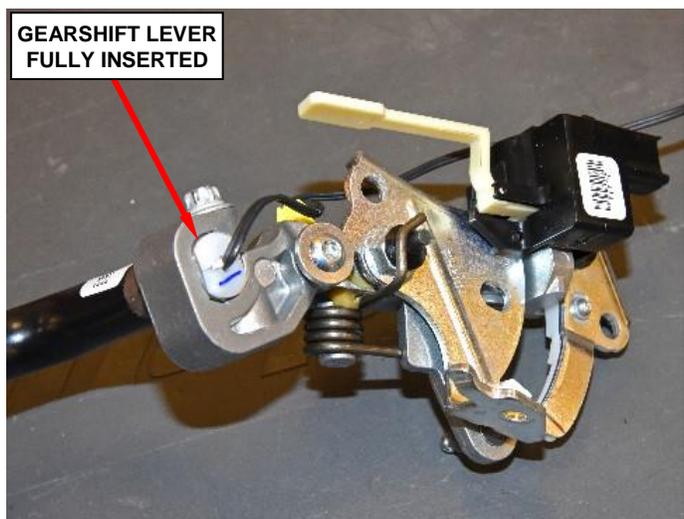
Figure 15 – Gearshift Lever Insertion
