# 2018 Annual Inspection Report

for Compliance with the Coal  
Combustion Residuals Rule  
(40 CFR Part 257)

## **Hayden Station**

**January 18, 2019**

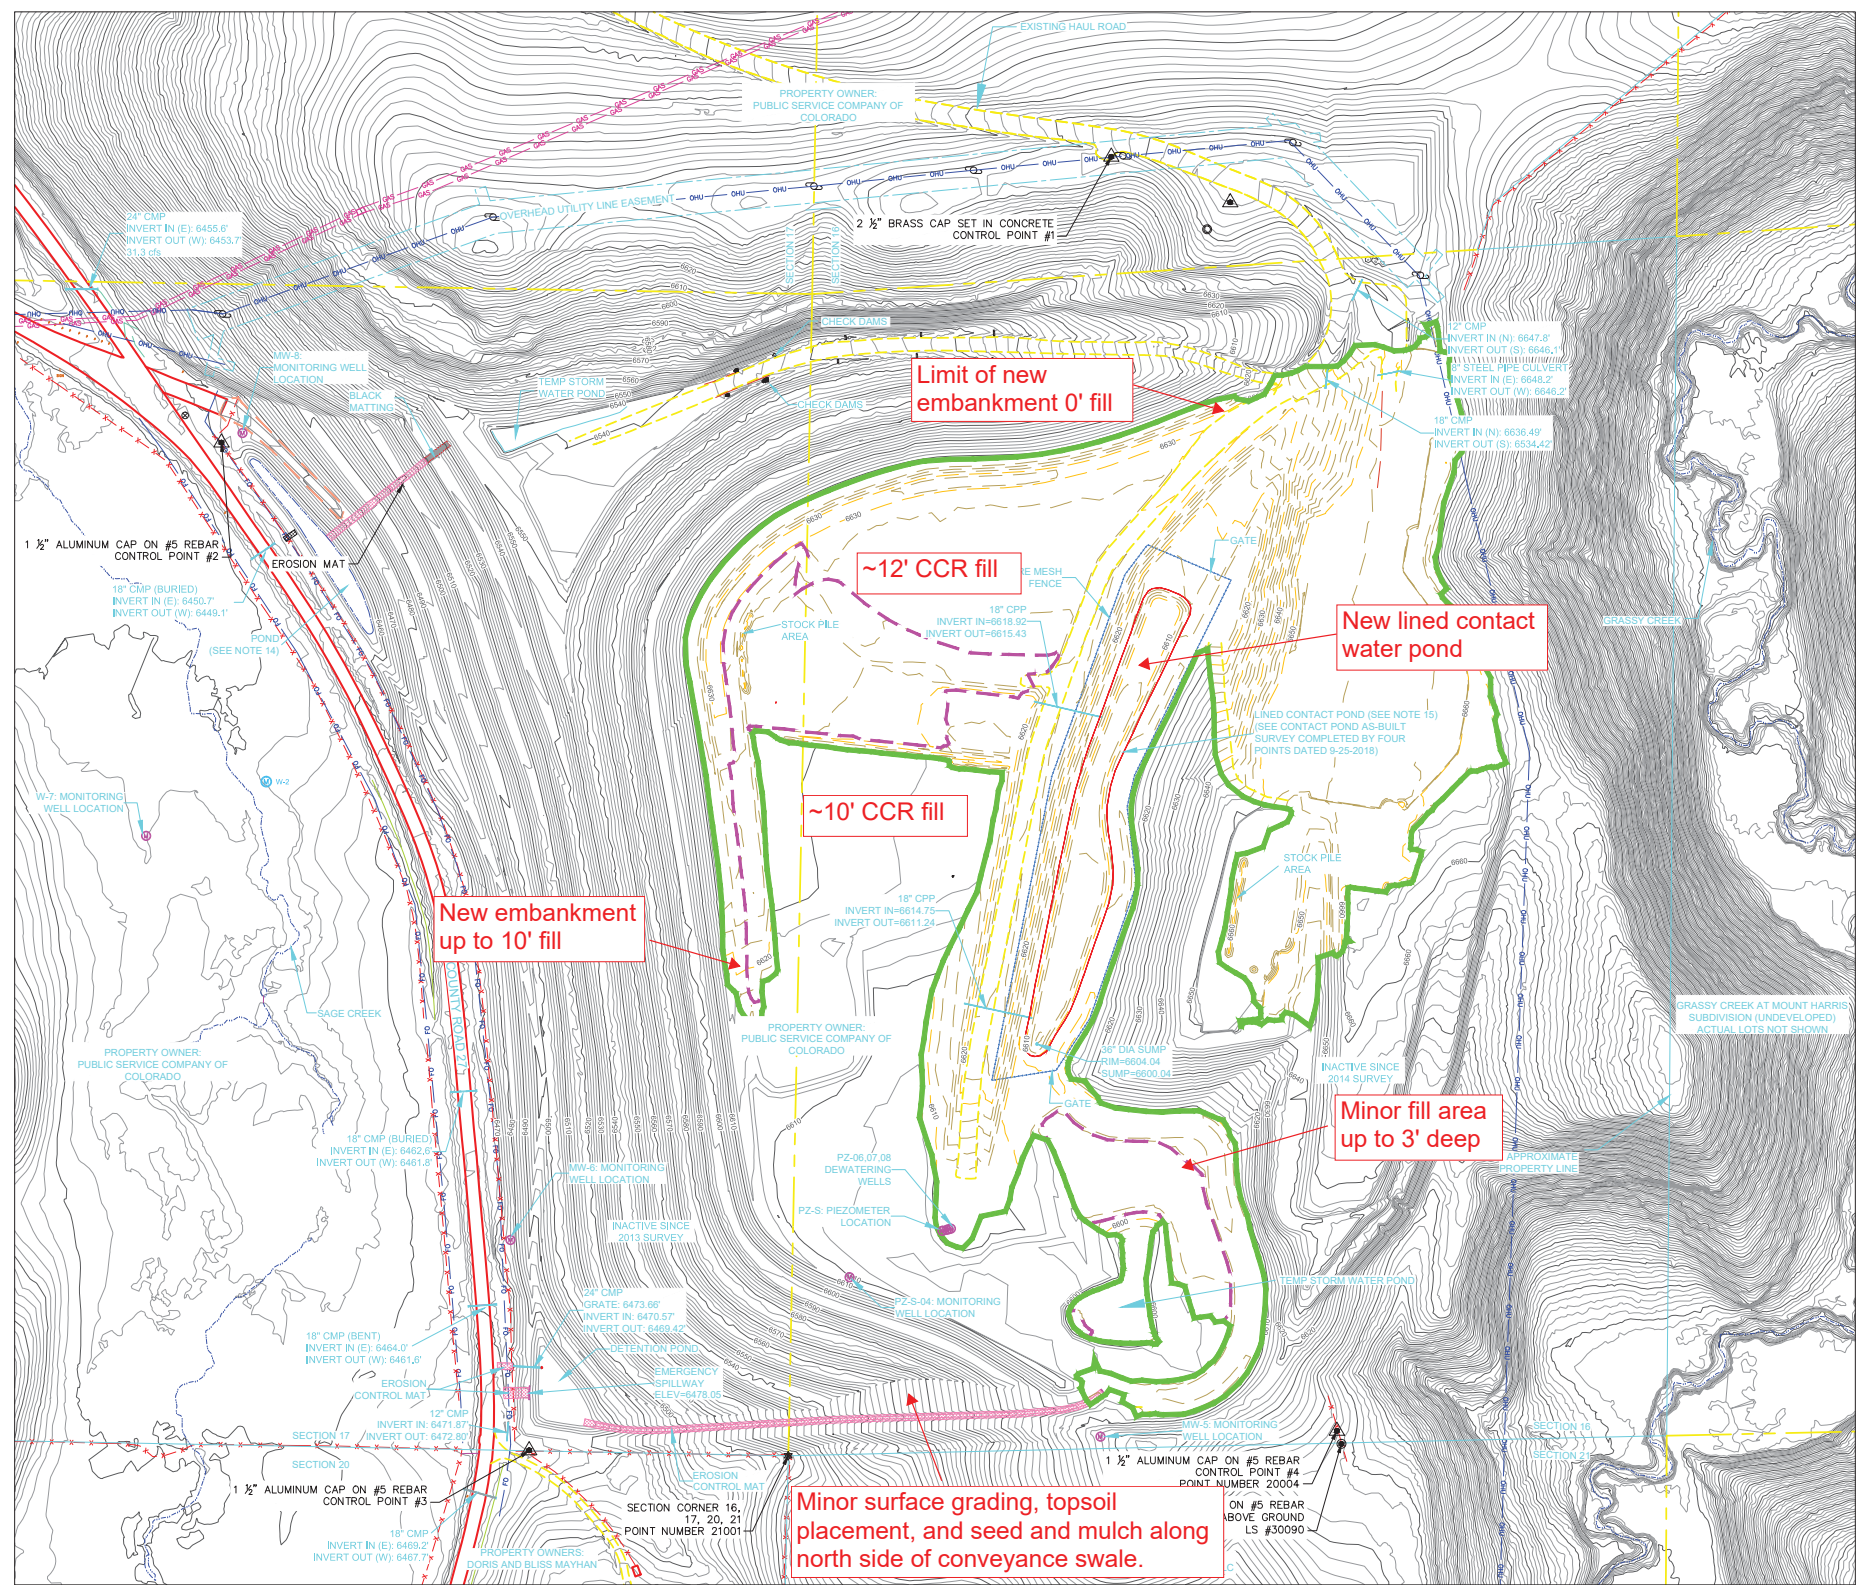
## Appendix A – Landfill Site Map

Notes in red text boxes added by HDR Engineering for CCR Annual Inspection Report, January 2019.
