## PRODUCT CAMPAIGN BULLETIN

**APPLICABILITY:** 2003-2004 Baja  
 2003-2004 Legacy and Outback  
 2004-2005 Impreza, WRX, STI

**SUBJECT:** Takata Front Passenger Air Bag  
 Inflator Replacement

**NUMBER:** WQR-53R

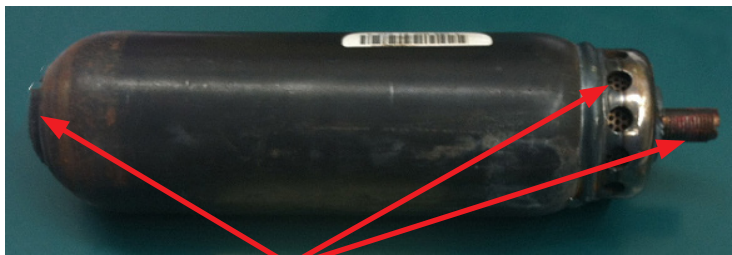
The shape, holes, and copper-colored stud indicate this not a Genuine Subaru inflator.

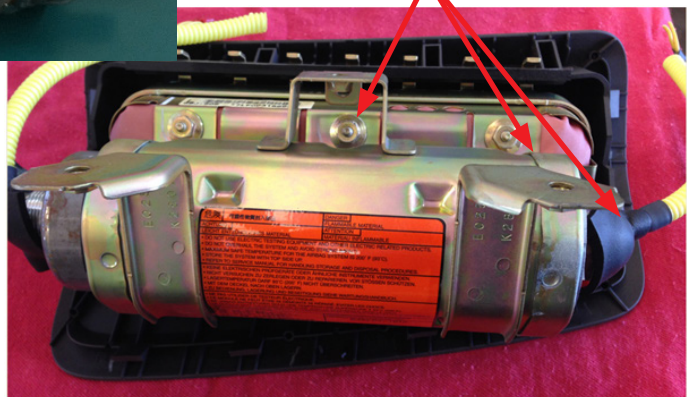
No visible stopper plates, a 6-nut configuration and rubber harness boots are other examples to indicate this is not a Genuine Subaru airbag module.
