## MPC8308 Chip Errata

This document details all known silicon errata for the MPC8308. The following table provides a revision history for this document.

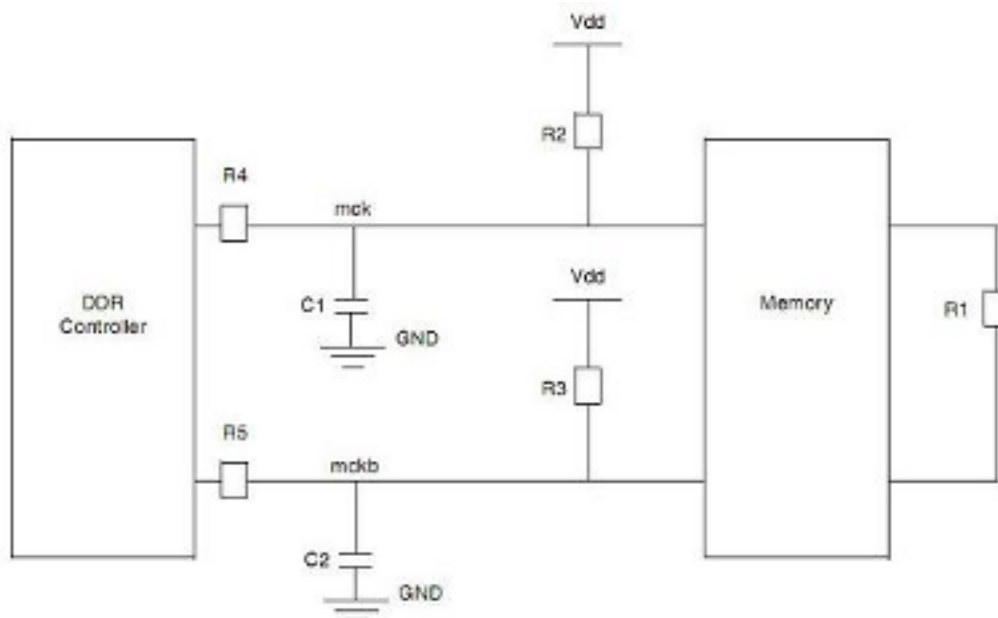
**Figure 1. Recommended connections for DDR controller and memory**

**Impact:** Disagreement with the JESD79-2C standard.

**Workaround:** To meet the JESD79-2C crosspoint voltage specifications, we recommend implementing the following connections between the DDR controller and DDR2 memory:

We recommend varying termination resistor R1 first. Lowering R1 can help increase the voltage levels up. The only disadvantage is that it may add up more reflections. Therefore, the user must decide accordingly. If it does not give sufficient margin, the user can add the pull-up resistor (R3 and R4) option to further increase the voltage levels.

Exact values of components vary from design to design and some of them may not be required for all designs. We recommend that you make provisions for all these options in your design.
