TDA2x SoC for Advanced Driver Assistance Systems (ADAS) Silicon Revision 2.0, 1.1

Errata

This document describes the known exceptions to the functional specifications for the device.

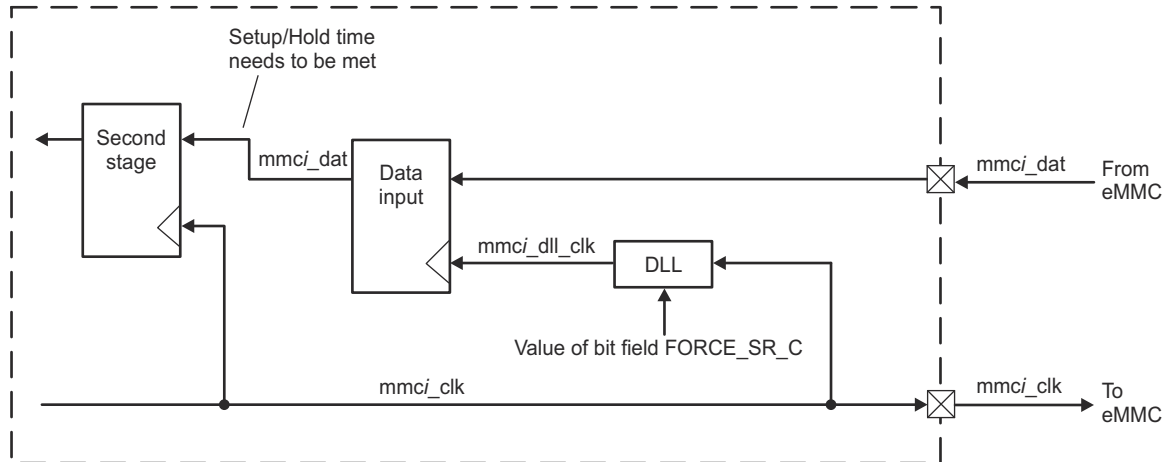
Figure 2-2. Simplified SoC 192-MHz Mode DLL Block Diagram

Internal to the MMC module, a second stage latch is used to recapture data captured by DLL delayed CLK, MMC_DLL_CLK. The second stage latch captures with the original transmitting clock, MMC_CLK.

MMC_DLL_CLK and MMC_CLK both run at the same clock frequency. This results in a narrow range of tuning ratio elements, where the delayed MMC_DLL_CLK comes in phase with MMC_CLK. If the clocks are in phase, the data captured by the first clock violates the setup and hold time requirements needed for the second stage latch, resulting in incorrectly read data. This is known as tuning re-timing errors.

A DLL tuning algorithm has been implemented that can avoid the tuning re-timing errors. More details on this can be found in App Note [SPRACA9](#). The following notes summarize the updated algorithm:

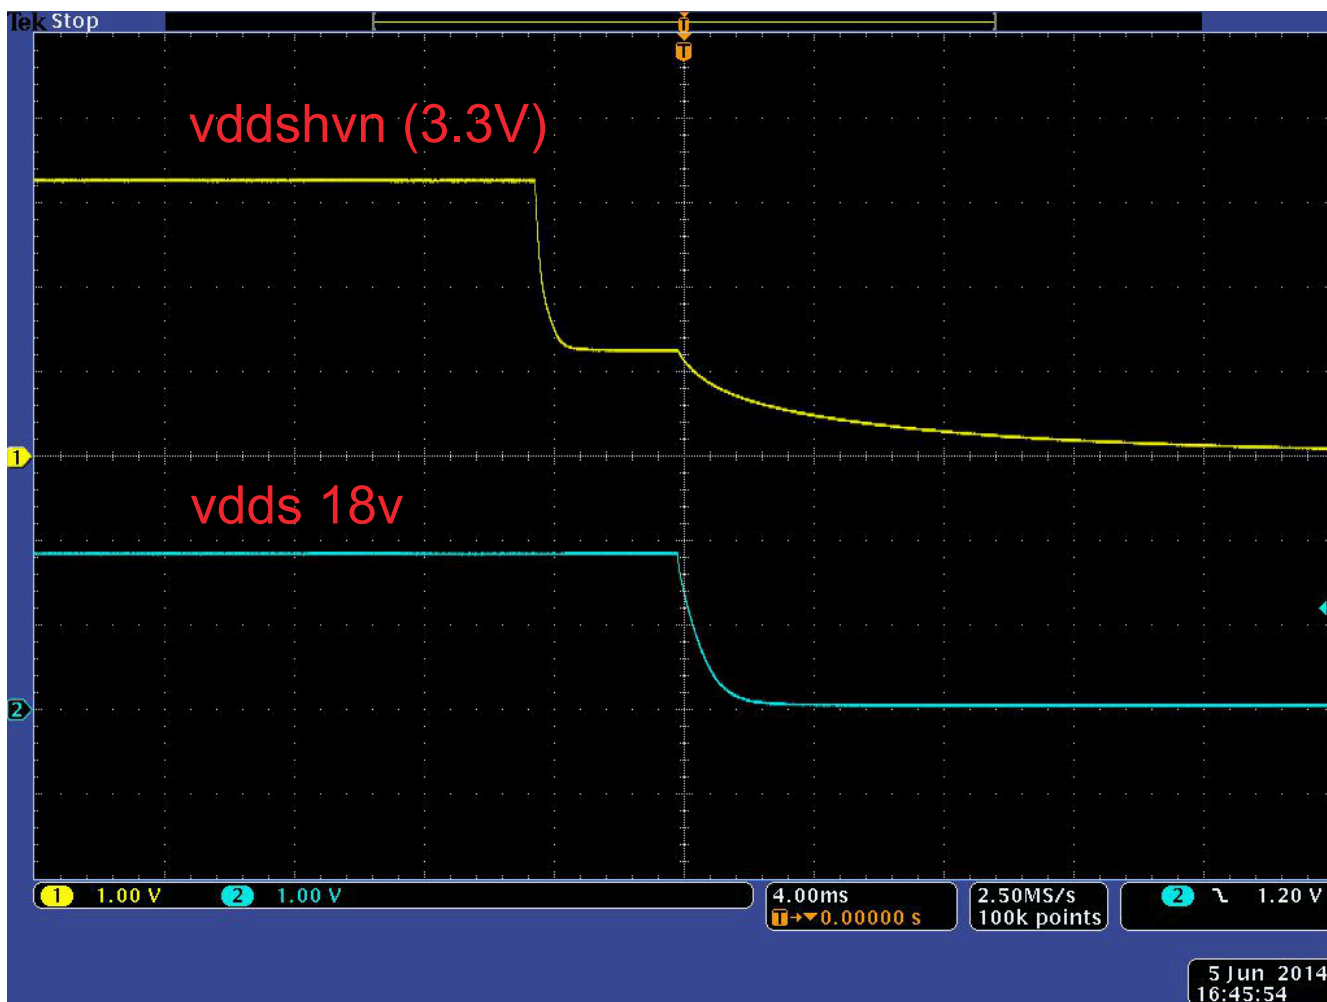
Figure 4-1. PAB_RevA

The Data Manual allows the vddshvn rail (in either 3.3V or 1.8V mode) to power down at the same time or before the vdds18v rail. When the vddshvn rail is powered down before the vdds18v rail, the vddshvn rail stays at Plateau Level (<1.5V) until the vdds18v rail is disabled, as shown in the waveform below.

A subset of the SOC's LVCMOS IOs (refer to DM for details) have a pull-up resistor that is active by default, including during reset and power-down. The SOC's IOs that have internal or external pull-ups will stay at Plateau Level (<1.5V) during the power-down. If other ICs on the board that are interfaced to the SOC's LVCMOS signals use a separate supply then it's possible that the other IC's signals can be pulled to the Plateau Level while its power supply is off.

The root cause of the plateau is related to the LVCMOS IO buffer Dual Voltage detection circuitry. The LVCMOS Dual Voltage IO includes voltage comparator circuitry to determine if the IO is in 3.3V mode or 1.8V mode. During powerdown of vddshvn domains, a current path in the internal bias transistors results in the vddshvn rail being held to an

In general, TI recommends using the same supply source for connected components. E.g., a single LDO should drive vddshvn and the related 3.3V external components.

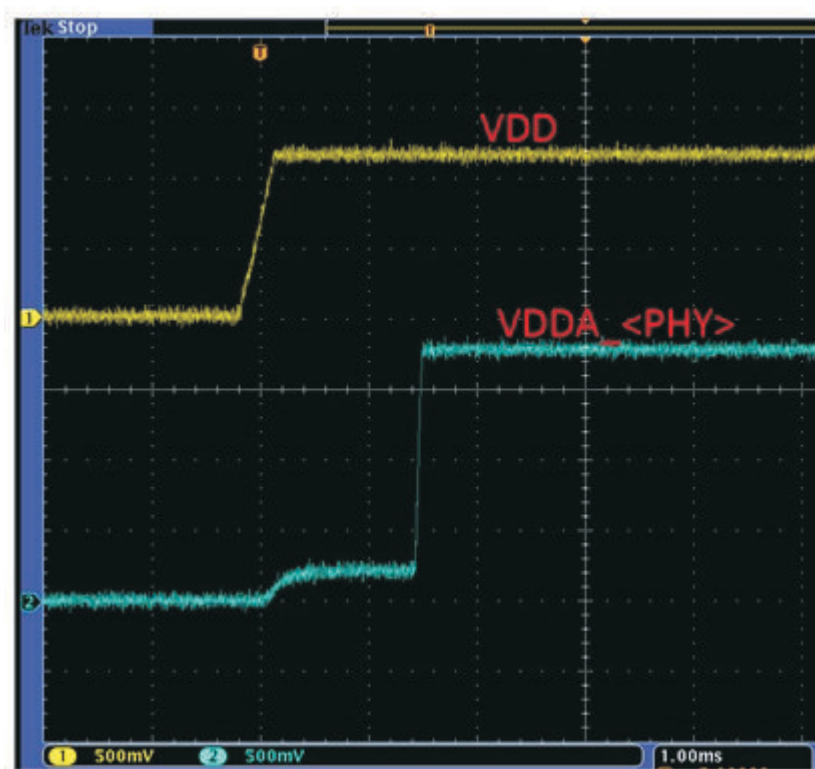
Figure 4-2. Leakage Voltage

A current path exists between VDD and the high speed analog PHY domain (VDDA_HDMI, VDDA_PCIE, VDDA_SATA, VDDA_USB2/3) during the supply power up and power down sequences.

The device-specific Data Manual requires Core AVS rail (VDD) to power up before the 1.8 V high speed analog PHY domain(s). When this sequence is followed, the high speed analog PHY domain will have a small step-up to a voltage plateau (< 0.5 V) that aligns to the beginning of the VDD ramp-up, and is maintained until the ramp-up of high speed analog PHY rail, as shown in [Figure 4-2](#). Note the leakage value will differ from system to system, but will be less than 500 mV. The leakage voltage in the provided capture is approximately 250 mV.

A similar condition exists during supply power down sequence. The high speed analog PHY domain(s) are required to be powered down prior to Core AVS rail (VDD), and may cause a small plateau to exist until Core AVS rail (VDD) is ramped down.

The root cause of the voltage plateau during power-up/down sequencing is related to the parasitic diodes in logic blocks which have multiple power sources. This leakage path is not a reliability concern for this device.
