# 2017 Annual Inspection Report

for Compliance with the Coal  
Combustion Residuals Rule  
(40 CFR Part 257)

## **Hayden Station**

**January 18, 2018**

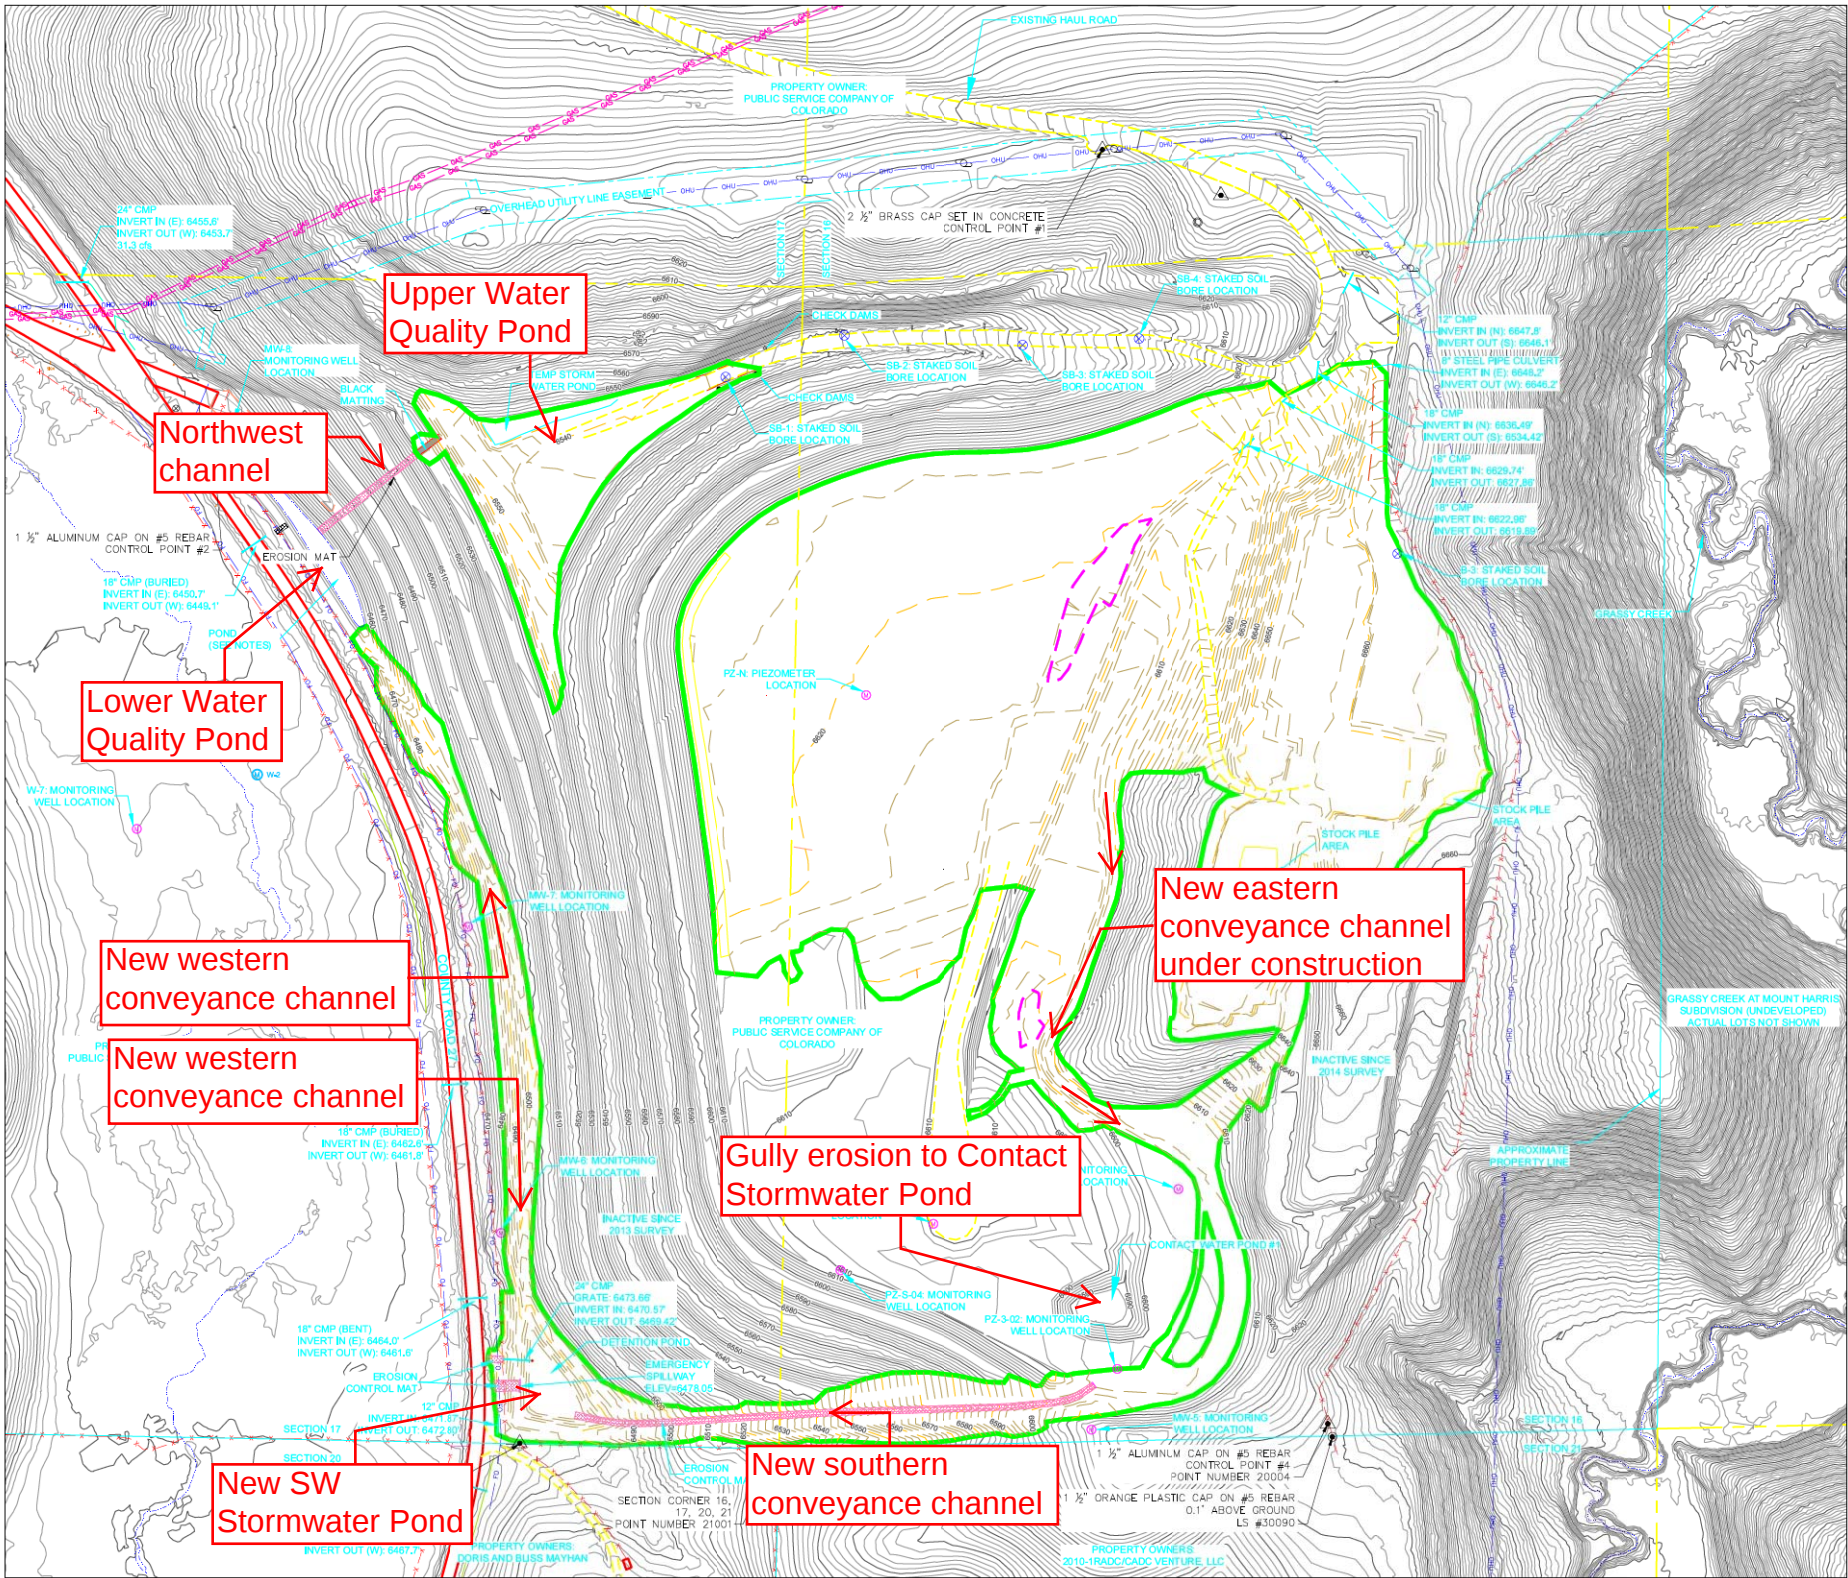
# TOPOGRAPHIC EXHIBIT

The Federal CCR Rules require that site geometry changes be identified since the last inspection. The site geometry changed in three areas since the initial inspection due to continued CCR disposal, stormwater grading modifications, and soil cover placement:

1. The Upper Water Quality Pond did not have additional CCR placed in the area draining to this pond, but the down-gradient berm on the western edge of the pond was raised by

approximately five feet. The western berm height increase is stepped to match the remainder of the western landfill face.

2. The top plateau of the main landfill area continued to accept CCR on the northern half of the plateau in a lift of roughly eight feet. This lift continues to be constructed with CCR placement, followed by top soil cover to create a stepped slope that matches the remainder of the western face.
3. Minor surface geometry changes were created on the eastern, southern, and western sides of the site with the construction of the stormwater conveyance swales.

Notes in red text boxes added by  
HDR Engineering for CCR Annual  
Inspection Report, January 2018
