J721E DRA829/TDA4VM Processors Silicon Revision 1.1/1.0

ABSTRACT

This document describes the known exceptions to the functional specifications (advisories). This document may also contain usage notes. Usage notes describe situations where the device's behavior may not match presumed or documented behavior. This may include behaviors that affect device performance or functional correctness.

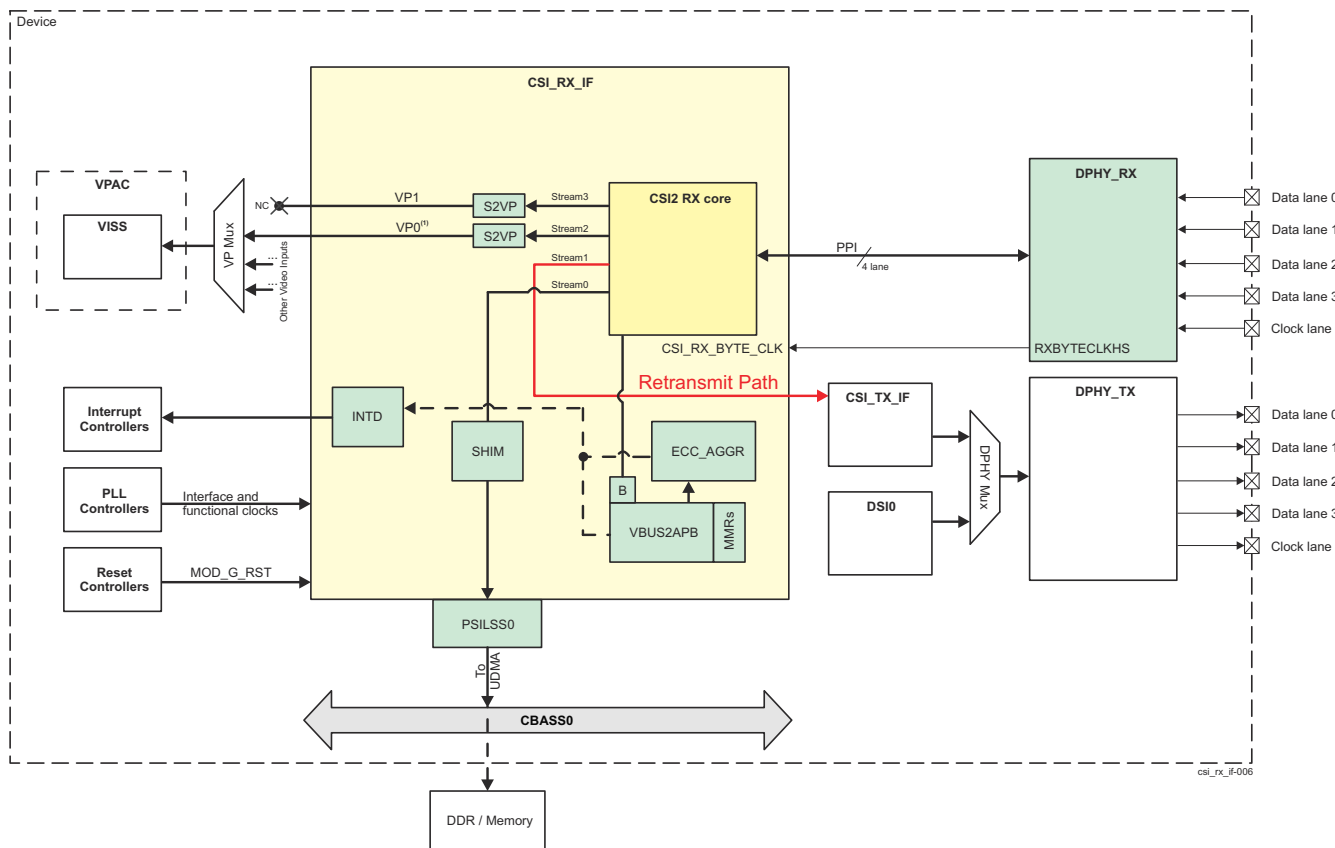
Figure 3-1. CSI_RX_IF Block Diagram

CSI_TX_IF module does not recognize blanking in input data. Given all sensors are expected to have blanking, the re-transmit path between CSI_RX_IF module and CSI_TX_IF module cannot be used.

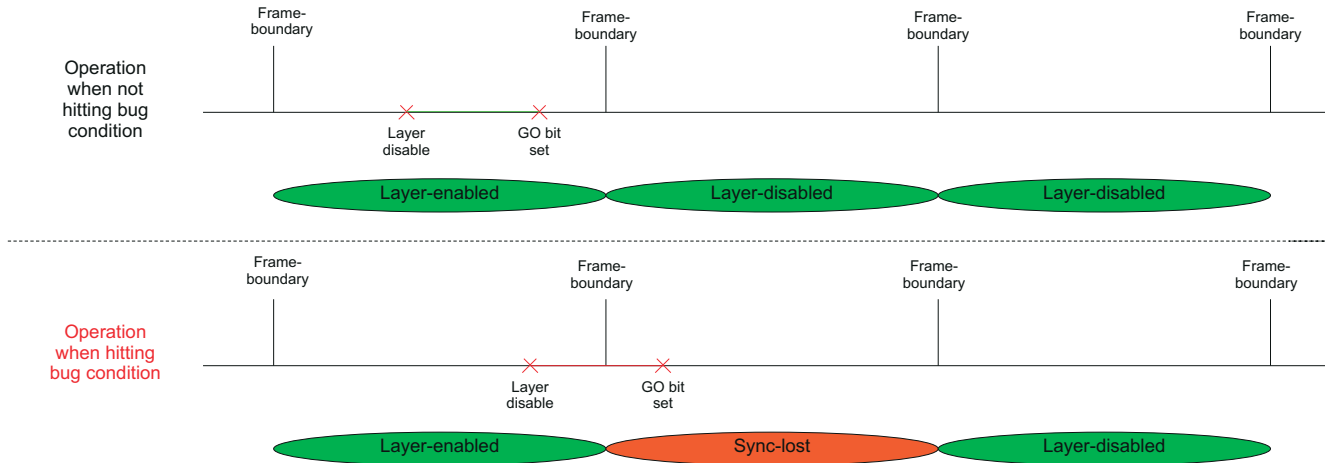
Figure 3-2. Bug Condition

Details: Disabling a layer (for example VID1) connected to an OVR (that is toggling DSS_VID_ATTRIBUTESx[0] ENABLE from 1 to 0) may result in synclost during the next frame. The synclost may result in a corrupted or blank frame (all pixel data sent out of DSS during the frame is 0x0). The occurrence of synclost is dependent on the timing of setting the GO bit (that is DSS_VP_CONTROL[5] GOBIT to 1) vis-à-vis the disabling of the layer. If the “disable layer” MMR write operation and “set GO bit” MMR write operation happens within the same frame boundary, no synclost occurs. If the operations happen across the frame boundary, then synclost occurs (for one frame). The design automatically recovers and returns to normal operation from the next frame after GO bit is set, see Figure 3-2.

Workaround(s): A simple software workaround exists. In the workaround, prior to disabling a layer on the OVR, it is moved to the “non-visible” area of the OVR (for example: DSS_OVR_ATTRIBUTES_x[17-6] POSX = max_value_of_posx or DSS_OVR_ATTRIBUTES_x[30-19] POSY = max_value_of_posy). This avoids the synclost when the layer is disabled.
