A report from the NIOSH Fire Fighter Fatality Investigation and Prevention Program

Career Female Fire Fighter Dies After Becoming Lost and Running Out of Air in a Residential Structure Fire—Pennsylvania

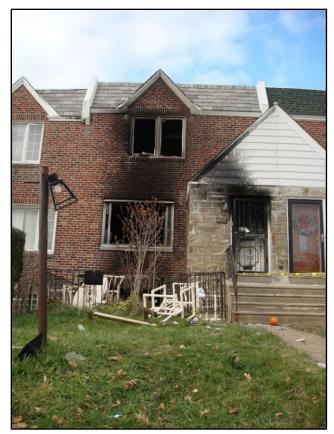
Photo 1. Front of row house. (NIOSH photo.)

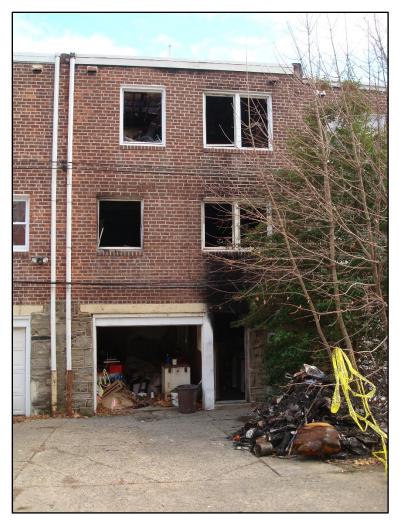
Photo 2. Rear of row house. (NIOSH photo.)

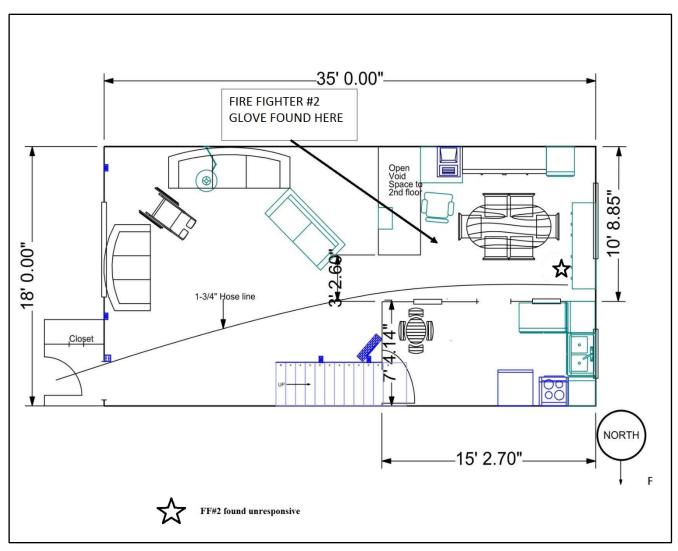
Ladder 29 fire fighter entered dining room through window from ground ladder. Squad 72 officer followed the Engine 73 hoseline, removed an office chair in the way, and found Engine 73 fire fighter/EMT slumped over against a buffet under the dining room window. Squad 72 reported bringing out the fire fighter/EMT. Squad 72, Ladder 29, and Ladder 8 carried the fire fighter/EMT out.

Diagram 5. Location of missing fire fighter. (Courtesy of fire department.)
