January 2020

Volume 20, Issue 1

The MedSun Program, which was launched in 2002 by the U.S. Food and Drug Administration (FDA) Center for Devices and Radiological Health (CDRH), involves the reporting of problems with medical products from a network of approximately 300 hospitals, nursing homes and home health facilities around the United States. MedSun sites work collaboratively with the FDA to assist in detecting, understanding, and sharing information concerning the safety of medical products. MedSun utilizes a secure, on-line system for reporting problems with the use of medical devices. MedSun plays a critical role in FDA's postmarket surveillance efforts.

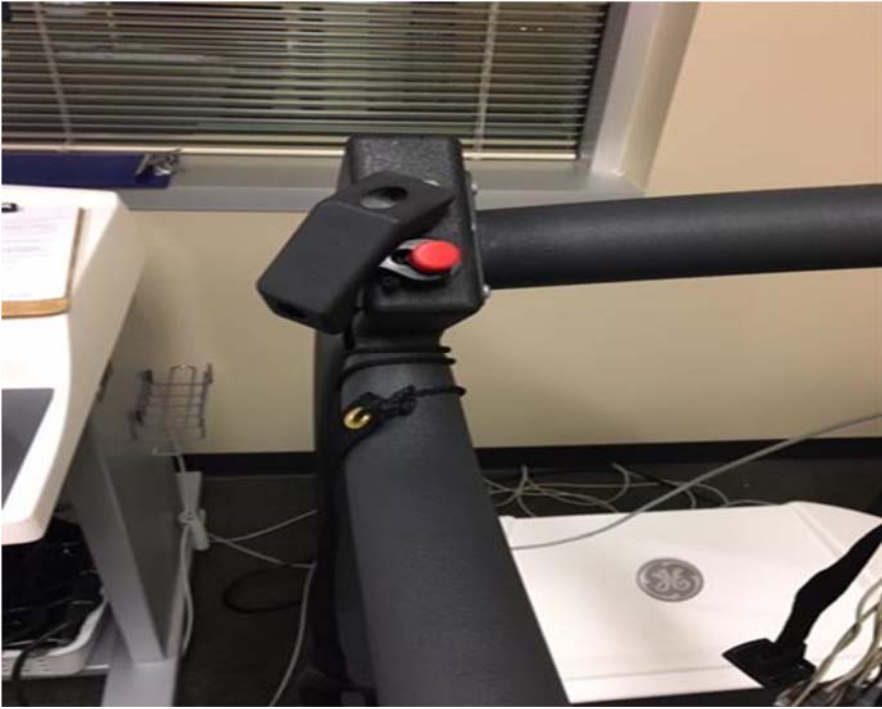
Device	Manufacturer	Problem
<p><b>Treadmill, Powered</b></p> <p>Brand: Ge T2100 Treadmill</p> <p>Model#: T2100 Cat #: T2100-ST2</p>	<p>GE MEDICAL SYSTEMS INFORMATION TECHNOLOGIES, INC.</p>	<p>Patient was having exercise stress test. After 12:02 minutes the stop button was accidentally deployed on patient's Left grab bar as RN was taking BP while patient was walking on TM (Tread Mill). The Left grab bar has an automatic stop button in addition to a pull cord from underneath the bar. This caused treadmill to suddenly stop which did not cause patient harm. This caused the treatment portion of the test to be reordered and restarted.</p> <p>This design appears to be a poor design when staff approach patient from the patient's Left side. Clinical Engineering staff attached a plastic button cover with Velcro to prevent the automatic stop button from accidentally being pushed while nurses are attending to the patient.</p> <p>Please see picture below:</p>
