Device	XMC4500
Marking/Step	EES-AA, ES-AA
Package	PG-LQFP-100/144, PG-LFBGA-144

Document ID is **02462AERRA**.

This “Errata Sheet” describes product deviations with respect to the user documentation listed below.

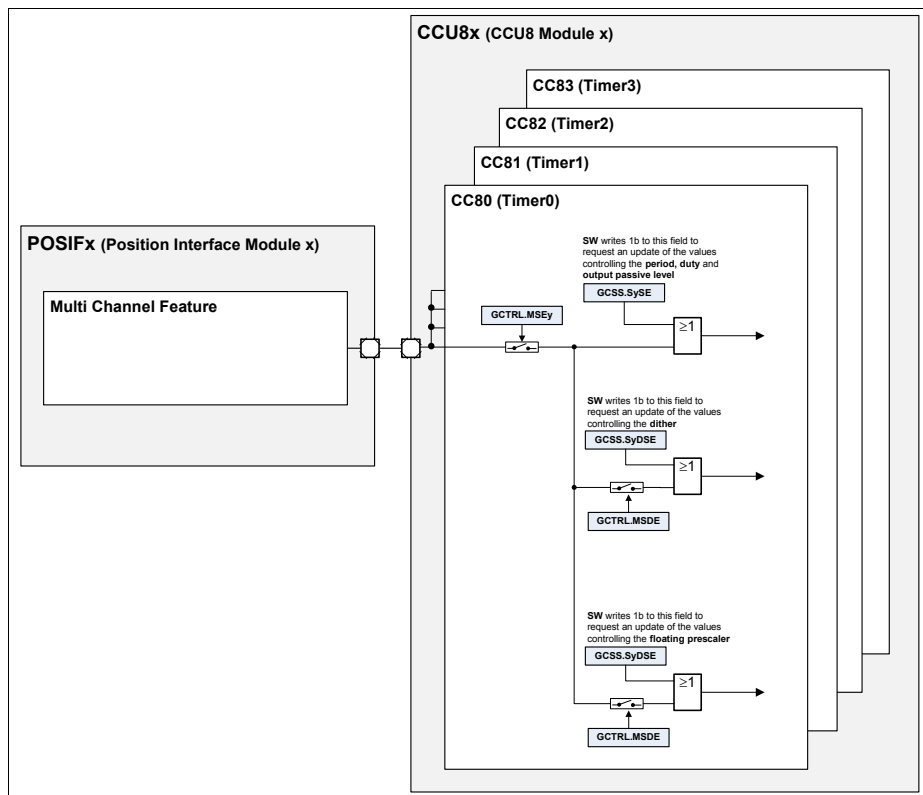
Figure 3 Value update trigger connection between CCU8x and POSIFx

CCU8_AI.002 CC82 Timer of the CCU8x module cannot use the external shadow transfer trigger connected to the POSIFx module

This feature cannot be used with the Timer2 (defined as CC82 in the documentation) of the CCU8x module(s) (more than one CCU8 module can be contained on a specific device).

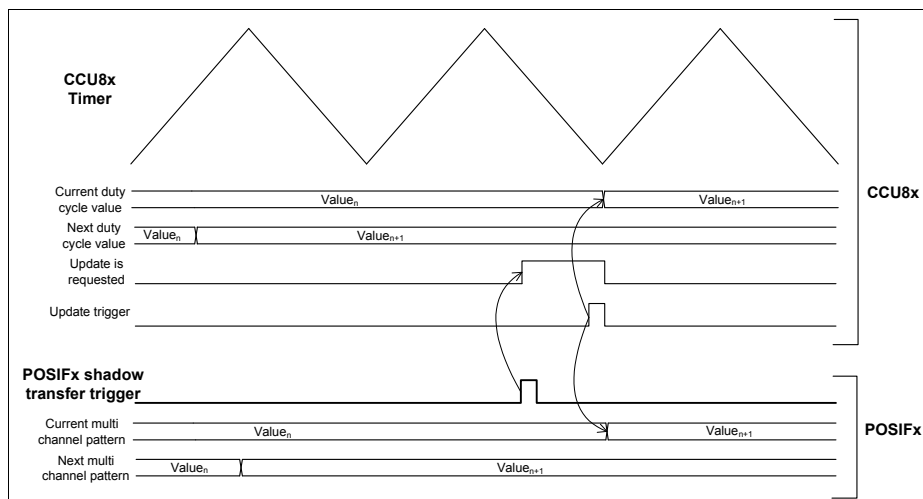
Figure 4 Value update handshake between CCU8x and POSIFx

value needs to be done. After that timeframe, the POSIFx waits for the handshake trigger of the CCU8x Timer to indicate that an update is going to be performed. At this specific time, both the values of the CCU8x Timer and POSIFx are update completely synchronous.

All the other 3 Timers (defined as CC80, CC81, CC83) inside the CCU8x modul are not affected by this issue.

Workaround

None

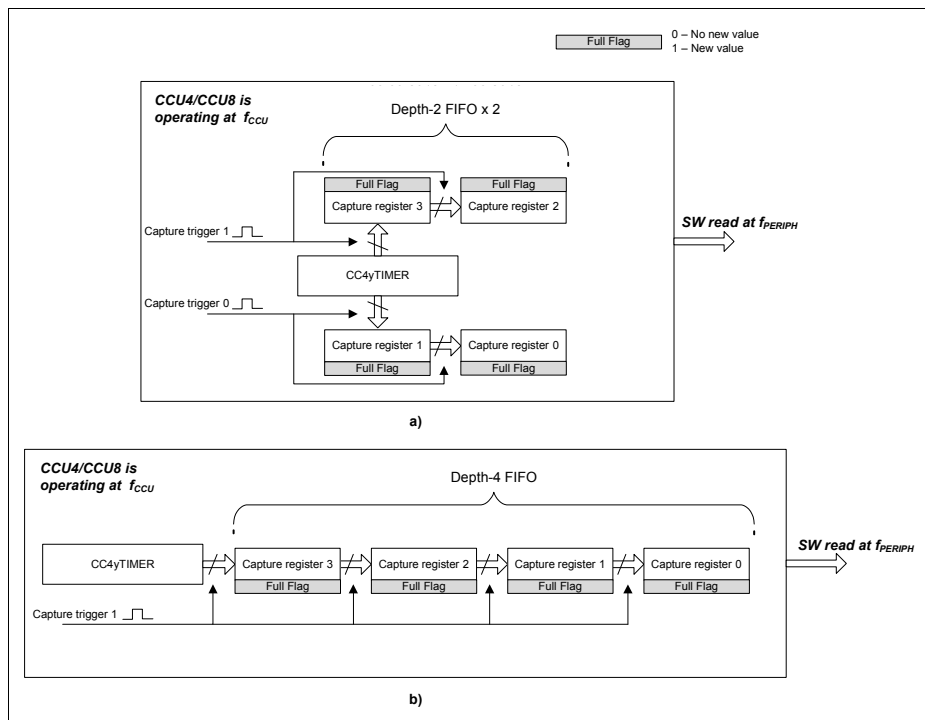
Figure 6 Capture Modes Structure - a) Depth-2 x2 Capture; b) Depth-4 Capture

CCU_AI.001 CCU4 and CCU8 capture full flags do not work when module clock is faster than peripheral bus clock

When the peripheral bus clock frequency is smaller than the CCU4/CCU8 module clock frequency, $f_{\text{periph}} < f_{\text{CCU}}$, the read back of the full flag is inconsistent. Sometimes it returns the information that a new value has been captured and sometimes it does not.

Workaround

When the usage of the FFL field is needed, the module clock of the CCU4/CCU8 module should be equal to the peripheral bus clock frequency:

To do this, the following SCU (System Control Unit) registers should be set with values that force this condition: CCUCLKCR.CCUDIV, CPUCLKCR.CPUDIV and PBCLKCR.PBDIV.

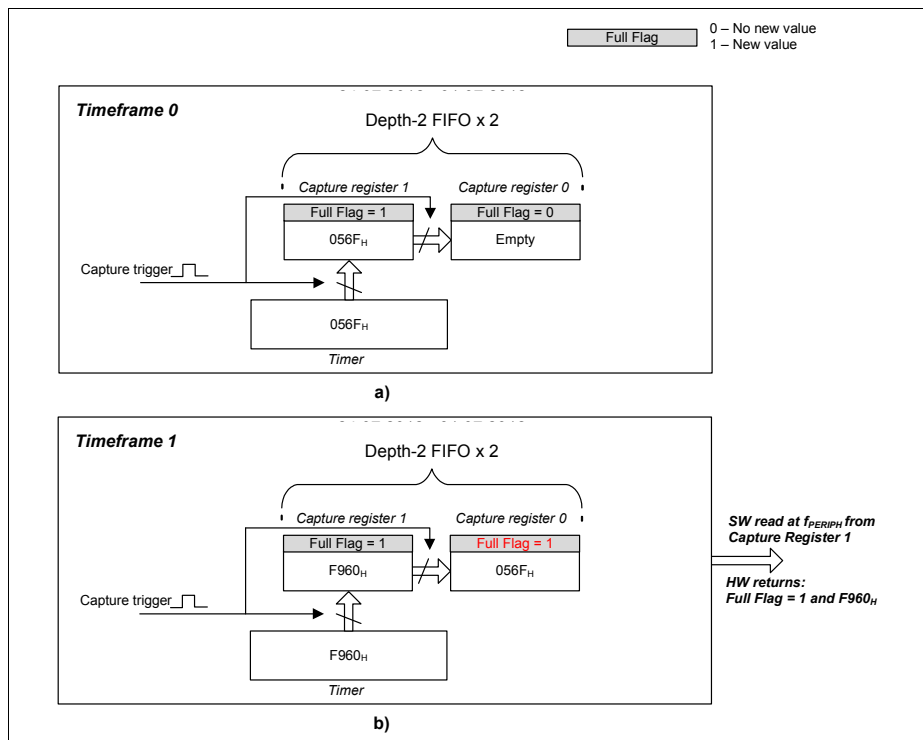
Figure 8 Capture shift during read back phase - a) Capture trigger without collision with read back; b) Capture trigger collision with read back

CCU_AI.003 CCU4 and CCU8 capture full flag is not cleared if a capture event occurs during a bus read phase

When a capture event collides with a read back on the data bus, the proper data is read by the software, but this data is shifted to the immediately capture register and the associated full flag is set, [Figure 8](#) - for simplification purposes a 2 depth capture scheme is shown.

Referring to [Figure 8](#), it can be understood that the proper data is sent to the software when it reads back the capture register 1, nevertheless this same data is shifted to the next capture register (capture register 0) and the full flag of this register is set.

After this if the software reads back capture register 0, a value is going to be returned with a full flag set (indicating that this is a new value - that has not yet been read, which is not true).

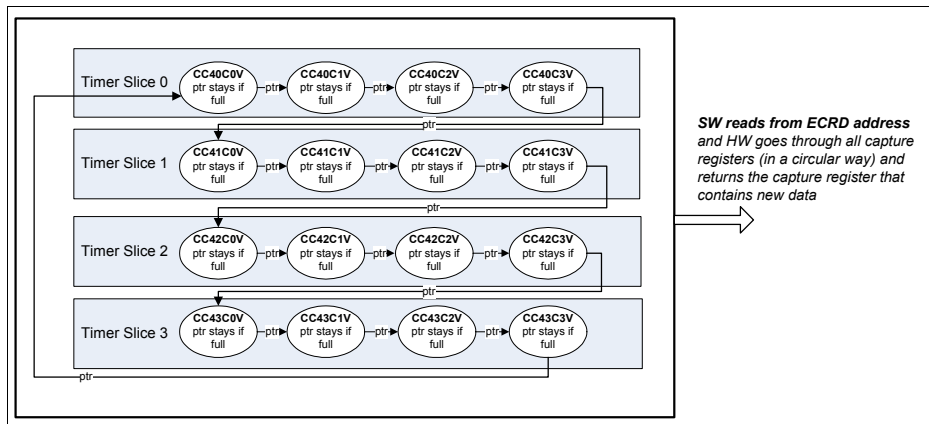
Figure 9 Extended Read Back access - example for CCU4 (CCU8 structure is the same)

- Timer X has 4 capture registers and is the only Timer set with $ECM = 1_B$. At the moment that the software starts reading the capture registers via the ECRD address, we have already capture two values. The ECRD read back will output CC4xC2V -> CC4xC2V (CC4xC3V value is lost)

- Timer X and Timer Y have 4 capture registers each and they are both configured with $ECM = 1_B$. At the moment that the software starts reading the capture registers via the ECRD address, we have already capture two values on Timer X and 4 on Timer Y. The ECRD read back will output CC4xC0V -> CC4xC1V -> CC4xC2V -> CC4xC3V -> CC4yC2V -> CC4yC2V (CC4yC3V value is lost)

Workaround

None.

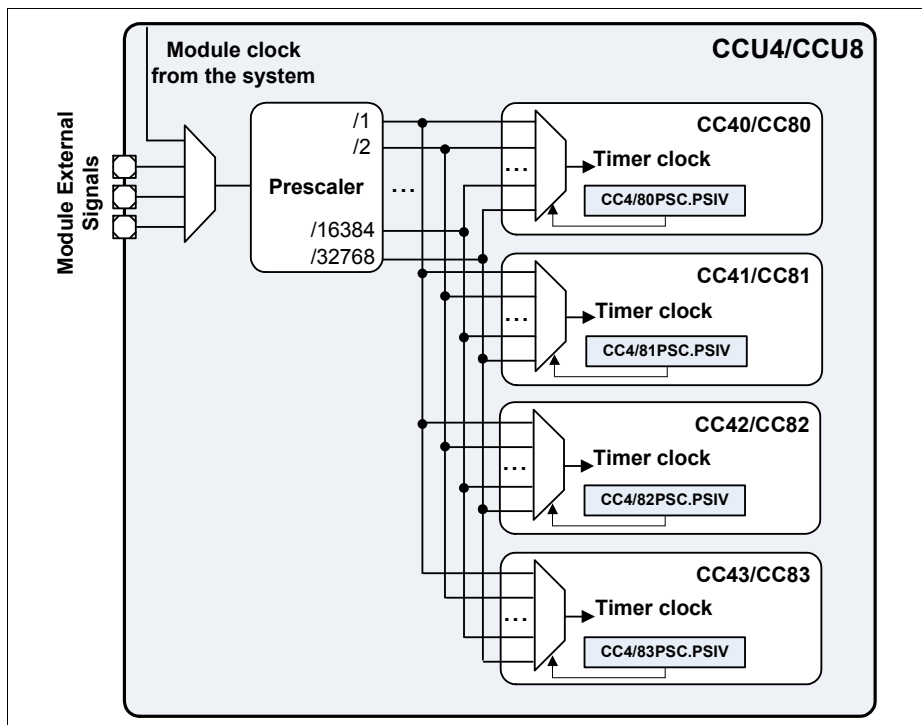
Figure 10 Clock Selection Diagram for CCU4/CCU8

This is only applicable if the Module Clock provided by the system (the normal default configuration and use case scenario) is not being used. In the case that the normal clock configured and programmed at system level is being used, there is not any type of constraints.

Workaround

None.

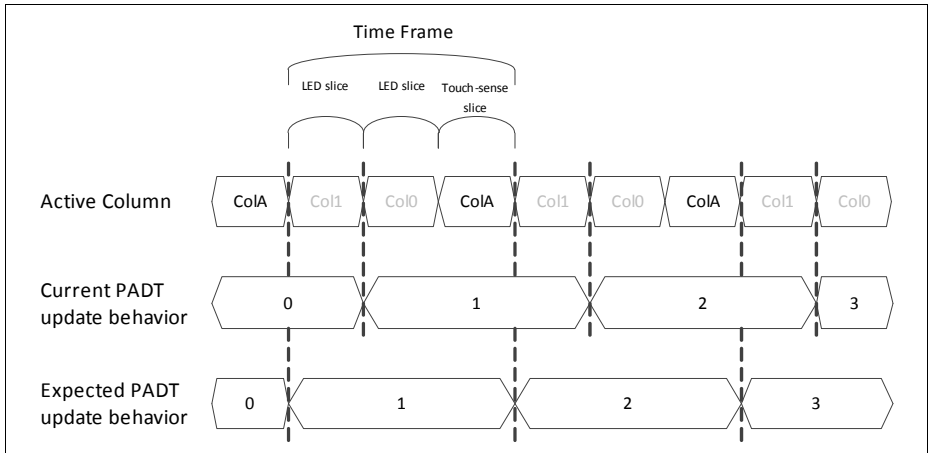
Figure 11 PADT update behavior

LEDTS_AI.001 Delay in the update of FNCTL.PADT bit field

The touch-sense pad turn (PADT) value is updated, not at the end of the touch-sense time slice (CoIA), but one time slice later ([Figure 11](#)).

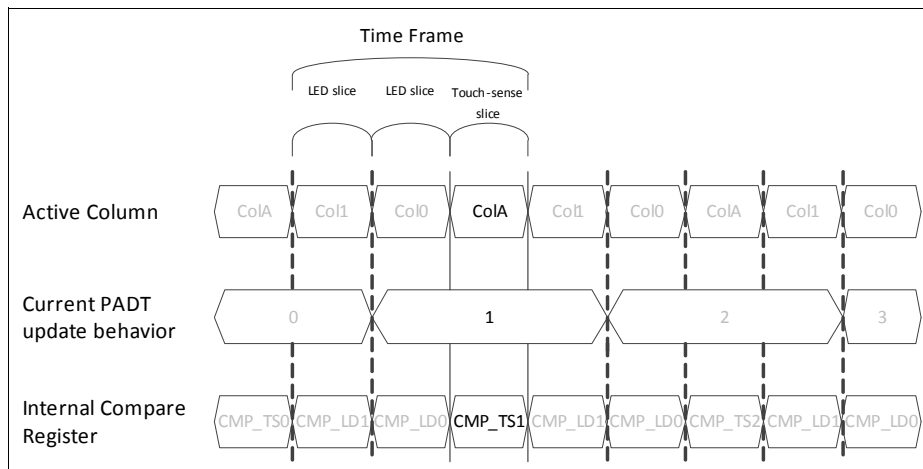
Figure 14 Internal Compare Register updated with correct compare register value with 2 LED columns enabled

If the number of LED columns enabled is 2 or more, the additional LED columns would provide some buffer time for the delay. So, at the start of a new touch-sense time slice, the update of PADT value would have taken place. Hence, the current active PADT compare register value is updated to the internal compare register ([Figure 14](#)).

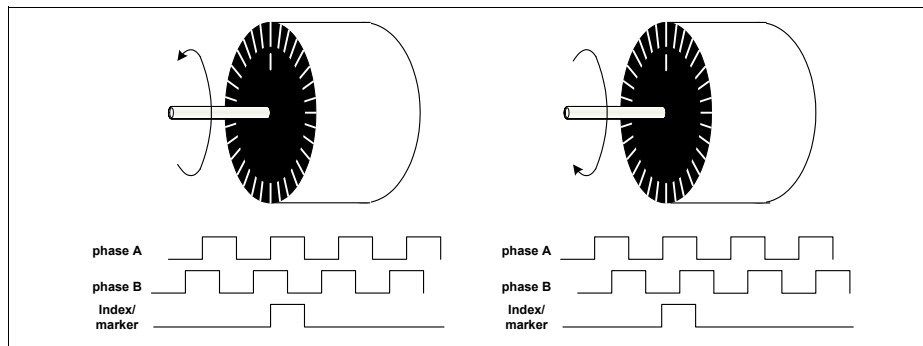
Figure 16 Rotary Encoder outputs - Phase A, Phase B and Index

POSIF_AI.001 Input Index signal from Rotary Encoder is not decoded when the length is 1/4 of the tick period

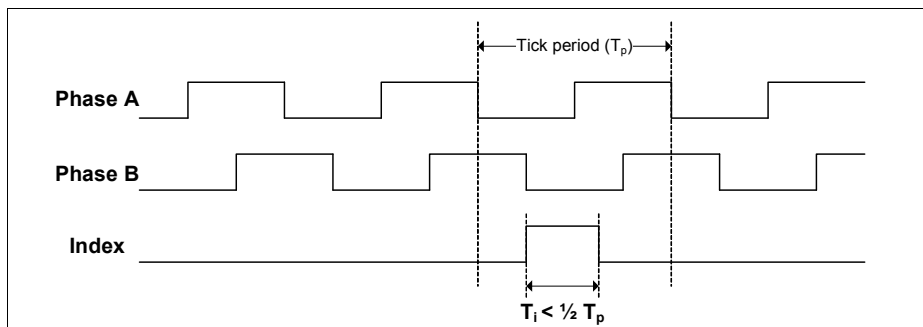
Figure 17 Different index signal types

When the index signal is smaller than 1/2 of the tick period, the POSIF module is not able to decode this signal properly, Figure 2 - notice that the reference edge of the index generation in this figure is the falling of Phase B, nevertheless this is an example and depending on the encoder type, this edge may be one of the other three.

Due to this fact it is not possible to use the POSIF to decode these type of signals (index with duration below 1/2 of the tick period).

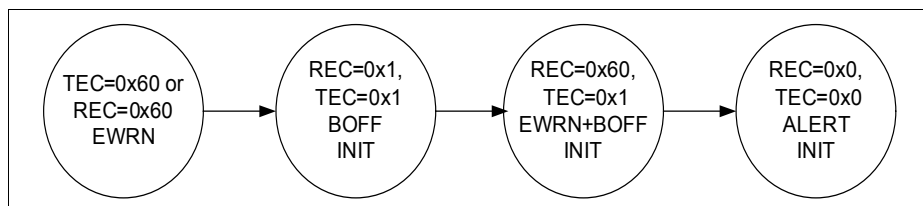
Figure 19 Alert Interrupt Behavior in case of Bus-Off

MultiCAN_AI.H007 Alert Interrupt Behavior in case of Bus-Off

When the threshold for error warning (EWRN) is reached (default value of Error Warning Level EWRN = 0x60), then the EWRN interrupt is issued. The bus-off (BOFF) status is reached if TEC > 255 according to CAN specification, changing the MultiCAN module with REC and TEC to the same value 0x1, setting the INIT bit to 1_B, and issuing the BOFF interrupt. The bus-off recovery phase starts automatically. Every time an idle time is seen, REC is incremented. If REC = 0x60, a combined status EWRN+BOFF is reached. The corresponding interrupt can also be seen as a pre-warning interrupt, that the bus-off recovery phase will be finished soon. When the bus-off recovery phase has finished (128 times idle time have been seen on the bus), EWRN and BOFF are cleared, the ALERT interrupt bit is set and the INIT bit is still set.

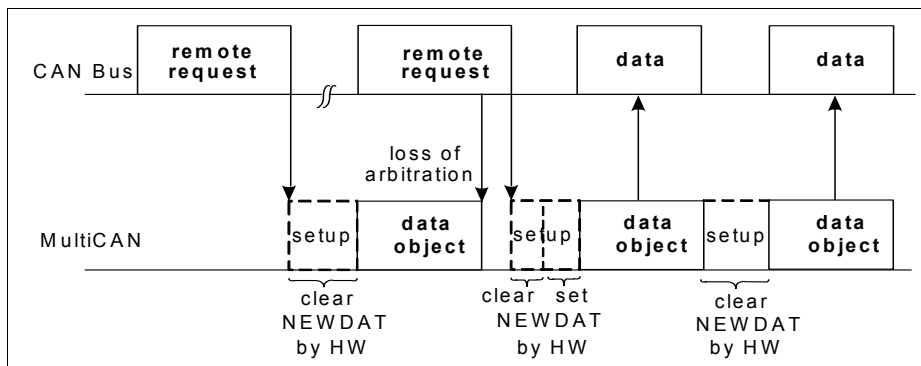
Figure 20 Loss of Arbitration

When the appropriate message object (data frame) triggered by the first remote frame wins the arbitration, it will be sent out and `NEWDAT` is not reset. This leads to an additional data frame, that will be sent by this message object (clearing `NEWDAT`).

There will, however, not be more data frames than there are corresponding remote requests.
