**TMS320C6747**  
**Fixed- and Floating-Point**  
**Digital Signal Processor**  
**Silicon Revisions 3.0, 2.1, 2.0, 1.1, and 1.0**

**Silicon Errata**

Literature Number: SPRZ284G  
May 2009–Revised June 2014

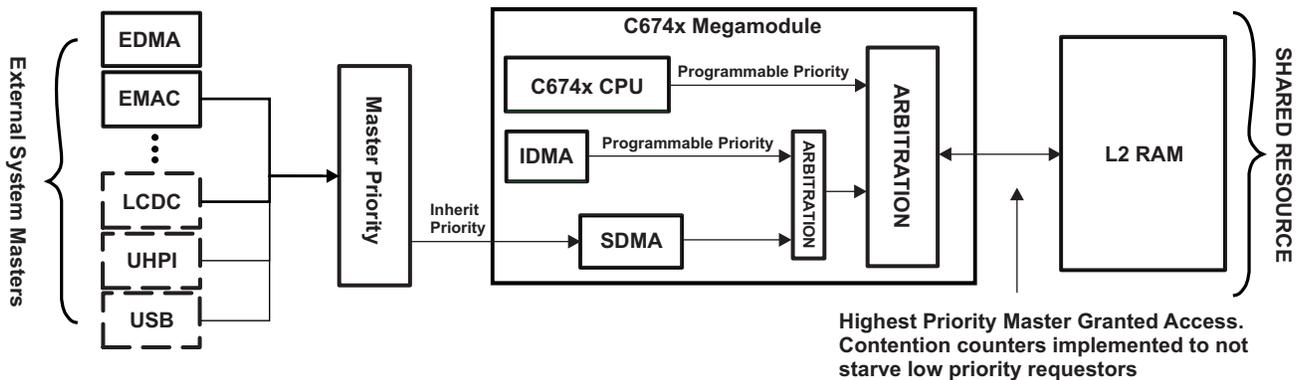
**Figure 2. Priority Arbitration Scheme for L2 RAM**

Ideally, the BWM arbitration will grant equal L2 bandwidth between equal priority DMA and CPU requests. Instead, when equal priority DMA and CPU requests arrive at the BWM, bandwidth is always granted in favor of the CPU over DMA. In the case of successive CPU requests, it is possible for the CPU to block all DMA requests until CPU traffic subsides. Additionally, some command logic in the BWM uses priority level 7, which can also result in SDMA stalls when the CPU is also programmed to priority level 7. [Figure 2](#) shows a high level diagram of the arbitration scheme used for L2 RAM requests.

**Workaround(s)** Configure DMA and CPU requests to different priority levels. The CPU should not be set to priority level 7. There is no penalty for setting the IDMA and SDMA priorities equal to each other.

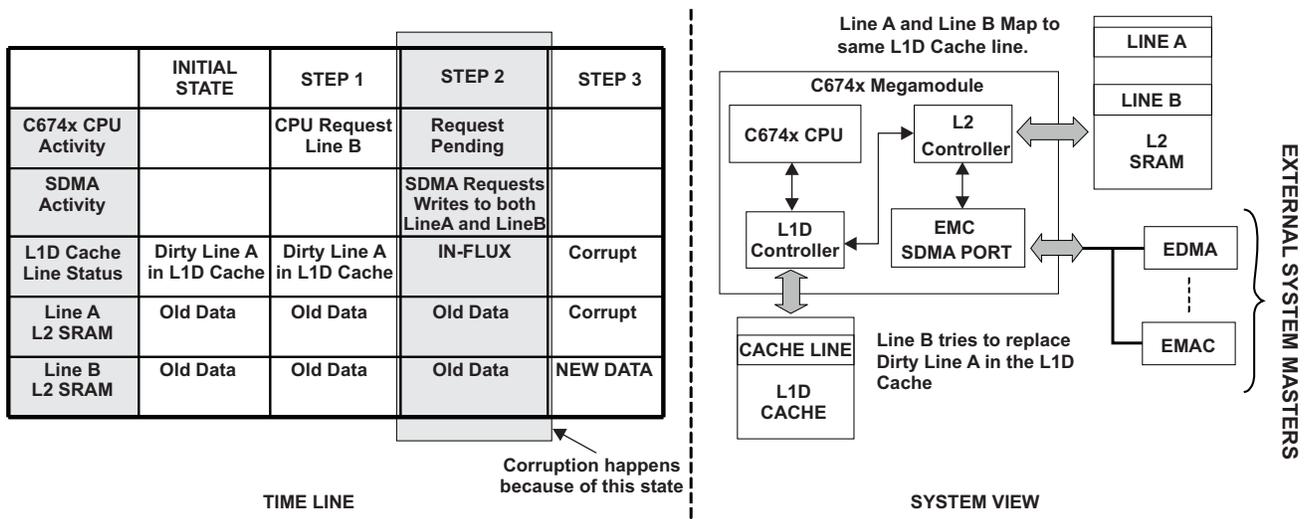
**Figure 4. Example of L1D Cache and L2 RAM Corruption**

1. L1D cache evicts a dirty line (Line A) while allocating a new line (Line B) in the same set/way (cache Lines A and B consist of 64-bytes each). In order for this to happen, the following will have taken place:
  - (a) Line A was previously read by CPU because L1D is a read-allocate cache,
  - (b) Line A is dirty because its value was modified by CPU, and
  - (c) Line B is read by CPU
2. Both Line A and Line B are associated with L2 RAM, and
3. While the original L1D victim write-back from condition (1) is in progress, the SDMA performs both:
  - (a) a read or write operation to Line A in L2 RAM and
  - (b) a write operation to Line B in L2 RAM.

If all of the above conditions are met, the L2 RAM data associated with the Line A victim writeback will become corrupt. Additionally, the Line B data originating from the SDMA write will also become corrupt in L1D cache. Figure 4 shows an example scenario of L1D cache and L2 RAM corruption.

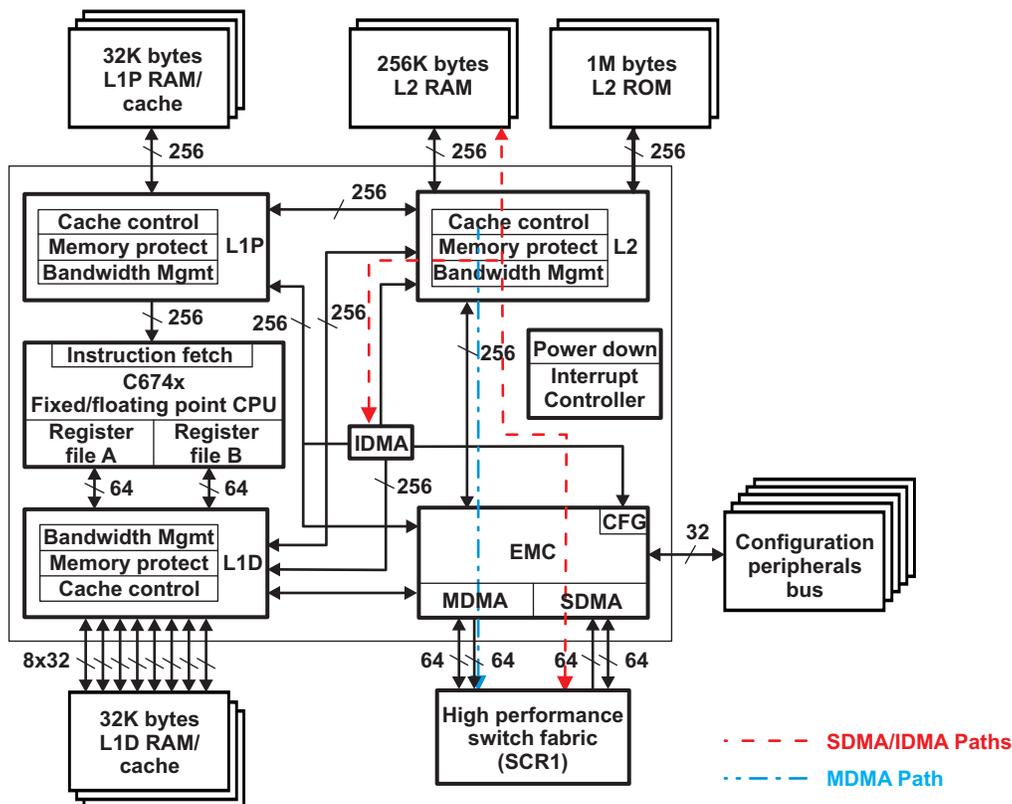
Figure 5. C674x Megamodule

Ideally, the MDMA (dashed-dotted line in [Figure 5](#)) and SDMA/IDMA paths (dashed lines in [Figure 5](#)) operate independently with minimal interference. Normally MDMA accesses may stall for extended periods of time due to expected system level delays (for example, bandwidth limitations). However, when using L2 as RAM, SDMA and IDMA accesses to L2/L1 may experience unexpected stalling in addition to the normal stalls seen by the MDMA interface. For latency-sensitive traffic, the SDMA stall can result in missing real-time deadlines. In a more severe case, the SDMA stall can produce a deadlock condition in the device. An IDMA stall cannot produce a deadlock condition.

Figure 5 is provided for illustrative purposes and is incomplete because of simplification. The IDMA/SDMA (dashed-lines) path could also go to L1D/L1P memories, and IDMA can go to DSP CFG peripherals. MDMA transactions can originate also from L1P or L1D through the L2 controller or directly from DSP.

1. Configure the entire L2 RAM as 100% cache (for example, move all data buffers from L2 to L1D or other memory). Note: Some throughput degradation is expected when the buffers are moved out to external memo
2. Eliminate all IDMA/SDMA access to L2 RAM when IDMA/SDMA stalling would have an impact by performing one of the following:
  - (a) Constrain each DMA master group to perform writes to either DSP memory space or external memory space, but not to both, or
