## Toshiba V8700

## Ferguson 3V23/JVC HR7700

## Toshiba V9600

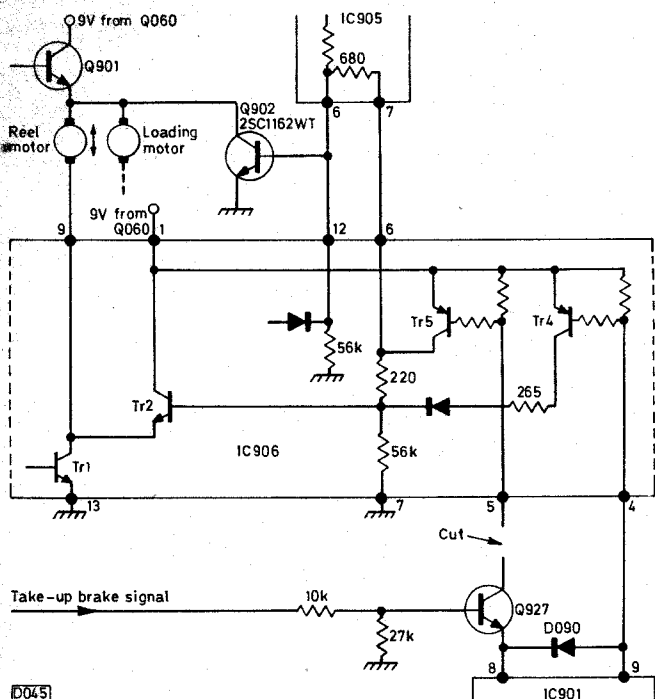
Little did I know when my friend Geoff sent me an Hitachi VT8500 that wouldn't eject what trouble and expense it would cause. The machine wouldn't unlace and it was found that Q902 in the loading motor drive circuit (see Fig. 1) was open-circuit. The curious thing was that it turned out to be a BD131. Other transistors had been removed and replaced as well – legs were sticking out at all angles. I hate to see this sort of thing. Why can't some people be bothered to tidy up? Three i.c.s had also been soldered and may or may not have been removed. The 9V supply for this part of the circuit comes from the series regulator transistor Q060: R081 (2.2 $\Omega$ ) which is in series with this transistor was open-circuit. I replaced it with a resistor, a standard modification, but this didn't have any bearing on the main fault.

After replacing the defective components I left the machine in fast forward. After a while Q902 got very hot. So did IC906. This was strange as Q902 should be off for fast forward. I left the machine to cool down then put it into fast forward in order to make a few measurements. Result: there was 600mV that shouldn't be there at the base of Q902. It took some time to find the source of this voltage. Tracing back I found that it came via pins 6 and 7 of IC905 from pin 6 of IC906. Within IC906 the current was flowing via Tr4, a 265 $\Omega$  resistor, a diode and a 220 $\Omega$  resistor. Q901 and Tr1 are

**Fig 1: Reel motor drive circuit, Hitachi VT8500. Q901/Tr1 drive the motor for fast forward; Tr2/Q902 drive the motor for rewind. Q901 and Q902 are also part of the loading motor drive circuit.**

IC906 was replaced but the rogue 650mV persisted. Pin 4 of IC906 was disconnected and it went away. The microcomputer system-control i.c. (IC901) was next suspected and changed but we were still no nearer a solution. It was then realised that the modification had left the base-emitter junction of Q927 in circuit. Now the reverse breakdown voltage of such a junction is only 2-3V, so a leakage current path was present via D090, Q927 and the base circuit resistance. It was enough to turn Tr4 on.

When Q902 was changed to a sturdier TIP31 the threading problem was cured. So the machine went back to Geoff with the comment that it had already received attention. Geoff phoned the following day to complain that it wouldn't wind fast forward and enquired whether I'd checked this? Well yes, play, record, rewind – but perhaps not fast forward. He also said his customer was adamant that apart from head cleaning the machine had received no servicing attention during the three years he'd had it. This time one of the transistors in IC906 (TA4193) was open-circuit. So the i.c. was replaced and Geoff took the machine back to check it for himself as a final quality control. The remote control unit didn't work due to corroded batteries and he had some difficulty in setting it for timer recordings, but apparently the customer wasn't too concerned about the timer.

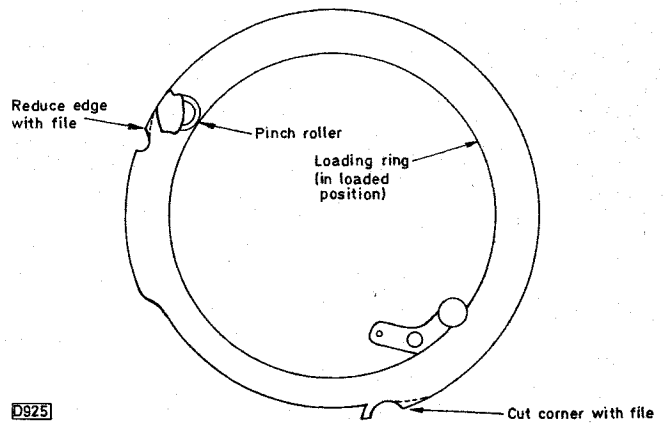
Fig. 1: Loading ring modification for the VTC5300/5400.

**(11) Loss of servo lock in the record mode:** This can happen when there's a sudden change of picture content. Make the following modifications. Add a 1,000pF capacitor between pins 2 and 28 of IC1002 on board VD1 and a 56kΩ resistor between pins 13 and 14 of IC4001 on board SV1. Where very bad interference is experienced fit a noise-masking sub-board on servo PCB SV1 - it fits on the print side, behind IC4001. When this is done add a

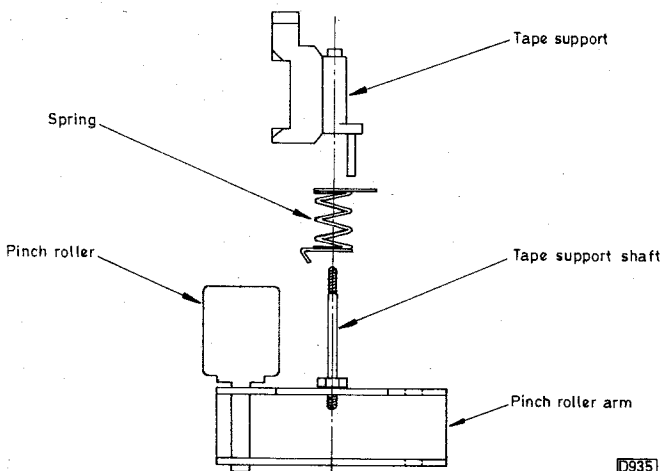
Fig. 1: The pinch wheel tape support assembly used in the Amstrad Model VCR4600.

We've found that a more certain modification can be carried out by fitting, in addition to the previously mentioned items, the pinch-wheel tape support as used in the VCR4600. The only problem here is that the nylon nut doesn't have a part number and is thus presumably not available. A steel nut can be used provided the thread is varnished after setting up. Replacing the pinch-roller arm doesn't appear to be necessary since in all the machines we've come across the arm has been drilled ready to accommodate this part. The relevant part numbers are as

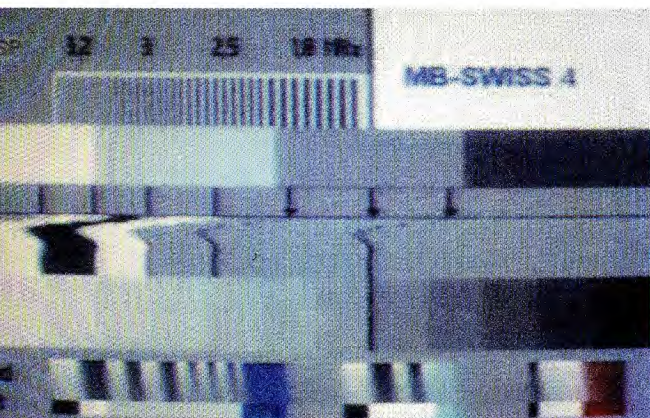
has insufficient torque to overcome the tape friction around the drum wrap while the capstan continues to feed tape to the 'sticky' drum. In such a case cleaning and polishing the lower drum can be tried, but probably won't help. The cure, a new lower drum assembly, is expensive.
