# Technical Service Bulletin

NOISE FROM REAR BRAKES DUE TO BRAKE DRAGGING

Bulletin No.: 04-005/17

Last Issued: 07/21/2017

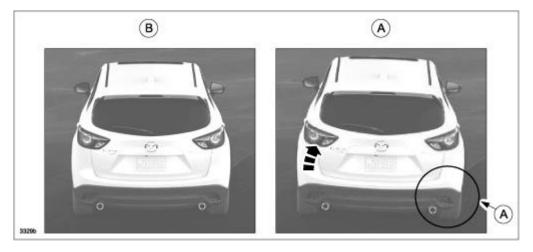
- If the vehicle rolls momentarily to one side, the rear caliper of that side is defective. Go to Step 7.

**NOTE:** In the example below, vehicle (B) rolls straight; both rear wheels release at the same time. Vehicle (A) does not release both rear wheels at the same time and the vehicle rolls to one side (A). The EPB released late / incorrectly

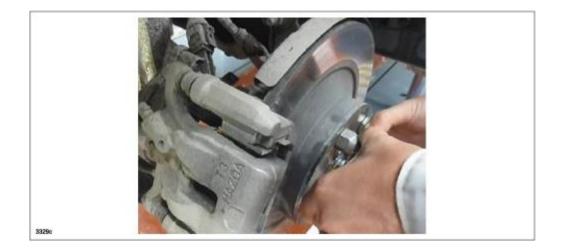
- 4. With the EPB OFF, verify that the rear disc plates rotate smoothly by hand.
- a. Lift the vehicle on a hoist and remove the rear wheels.
- b. Depress the brake pedal firmly and turn the EPB ON with the switch.
- c. Depress the brake pedal and turn the EPB OFF.
- d. Verify that that rear disc plates can be easily rotated by hand (as shown below).

- If the rear disc plate does not rotate (or is difficult to rotate) by hand, that side caliper is defective. Go to Step 7.

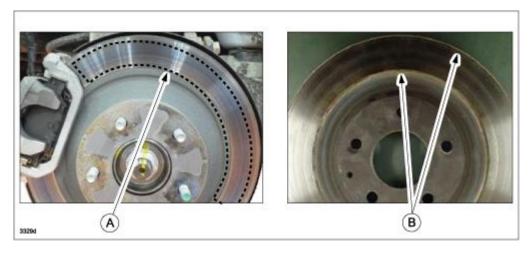
## DISC PLATE INSPECTION

5. Inspect the disc plates for bluish black discoloration (A) or whitened damage (B) due to brake dragging.

- If one or more of conditions specified below is found, it indicates a brake dragging concern and the affected side caliper is defective. Go to Step 7.

7. If the caliper(s) has been found to be defective by the diagnosis procedure, replace the affected side caliper(s) with a modified one(s) according to the instructions on MGSS online "REAR BRAKE (DISC) REMOVAL/INSTALLATION" and "ELECTRIC PARKING BRAKE MOTOR GEAR UNIT REMOVAL/INSTALLATION".

**NOTE:** If the disc plate(s) / brake pads are damaged, inspect and replace the affected side(s) as necessary according to the instructions on MGSS online "REAR BRAKE (DISC) REMOVAL/INSTALLATION" and "DISC PAD (REAR) REPLACEMENT".

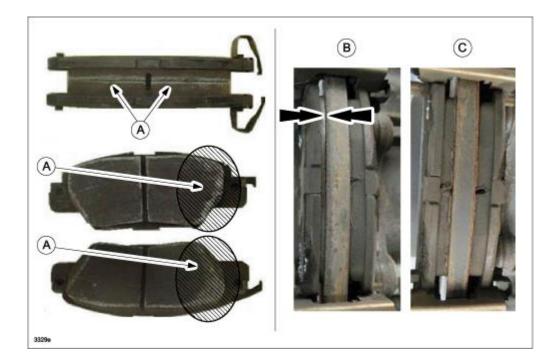
**BRAKE PAD INSPECTION**

6.Inspect the brake pads for whitened by heat (A) or abnormal wear on only the outer pad (B) due to brake dragging.

- If one or more of conditions specified is found, it indicates a brake dragging concern and the affected side caliper is defective. Go to Step 7.

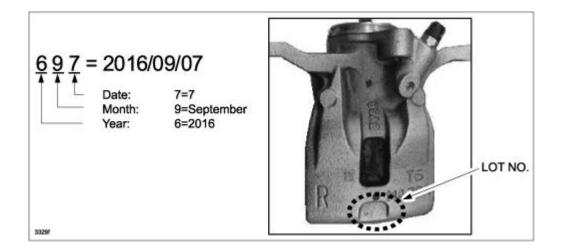
**NOTE:** Part numbers of caliper have not been changed by this modification. Distinguish the modified one from old one using the 3-digit lot number (Production Date) stamped on the caliper. Calipers with the lot number (production date) of **697 (2016/09/07)** and higher are modified.
