Date: 10/07/16
To: Studio Trailer Owners
From: Multiquip Product Department
Subject: Studio Trailer A-Frame Hairline Cracks — **Immediate Action Required**

Service Bulletin

Studio Trailers TRLR1400AE/AH

Product Group: Studio Trailers	Date Issued: 10/07/16	Service Bulletin No. TL20160921
Bulletin Type <input checked="" type="checkbox"/> Immediate Action Required <input type="checkbox"/> Information Only <input type="checkbox"/> Recommended Change		Models/Series Affected: TRLR1400AE/TRLR1400AH SEE ATTACHED LIST FOR VIN/SERIAL NUMBER Bulletin Expiration Date: N/A

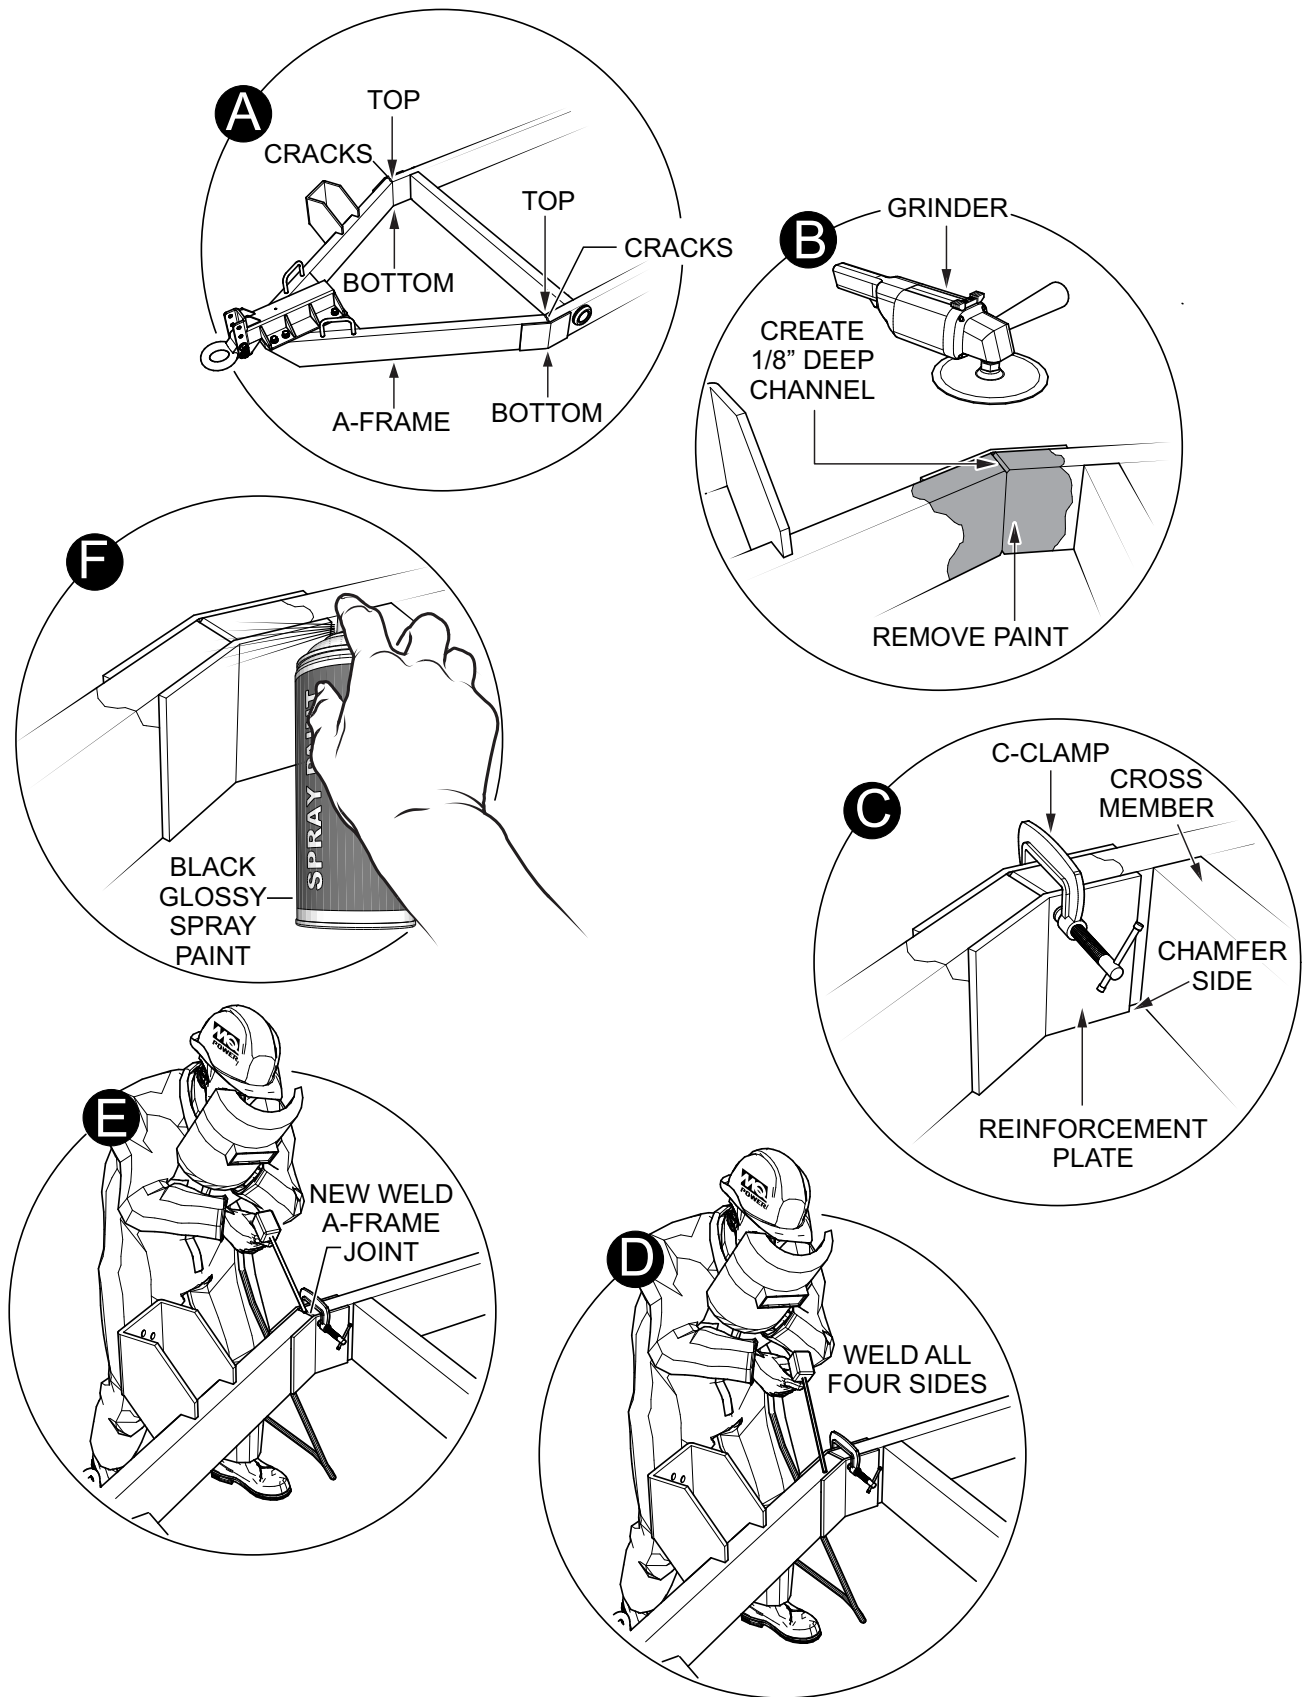
Figure 2. Inner Reinforcement Plate Installation

Details Problem: a. A production run of studio generator trailer frames may experience hairline cracks at the TOP and BOTTOM of the A-frame joint. Solution: a. Immediately inspect the trailer A-frame joint for hairline cracks as referenced in Figure 2A

1. Using a grinder, ***remove paint*** from area to be heated during welding (Figure 2B).

2. Grind off existing welds 1/8" deep (Figure 2B) at the **TOP** and **BOTTOM** of the A-frame joint.
3. Place inner reinforcement plate (EE59670) onto trailer frame as shown in Figure 2C. Secure reinforcement plate with C-clamps.

Make sure the chamfer side of the inner reinforcement plate is placed adjacent to the trailer cross-member.

4. Weld inner reinforcement plate (Figure 2D) onto trailer A-frame. Weld ***all four sides*** of inner reinforcement plate.
5. Apply new welds (channel) to the **TOP** and **BOTTOM** of the A- frame joint(Figure 2E).
6. At the completion of the welding process, remove any flux, burrs or rough edges from the welding area.
7. Clean the top and bottom areas on the A-frame with a wire brush, then paint area with ***black glossy spray paint*** (Figure 2F). Let welded area cool before painting.
