Technical Information Bulletin

A002

PACCAR 40K Forward Rear Axle Pinion Side Gear Incorrectly Heat Treated

12/19/2019

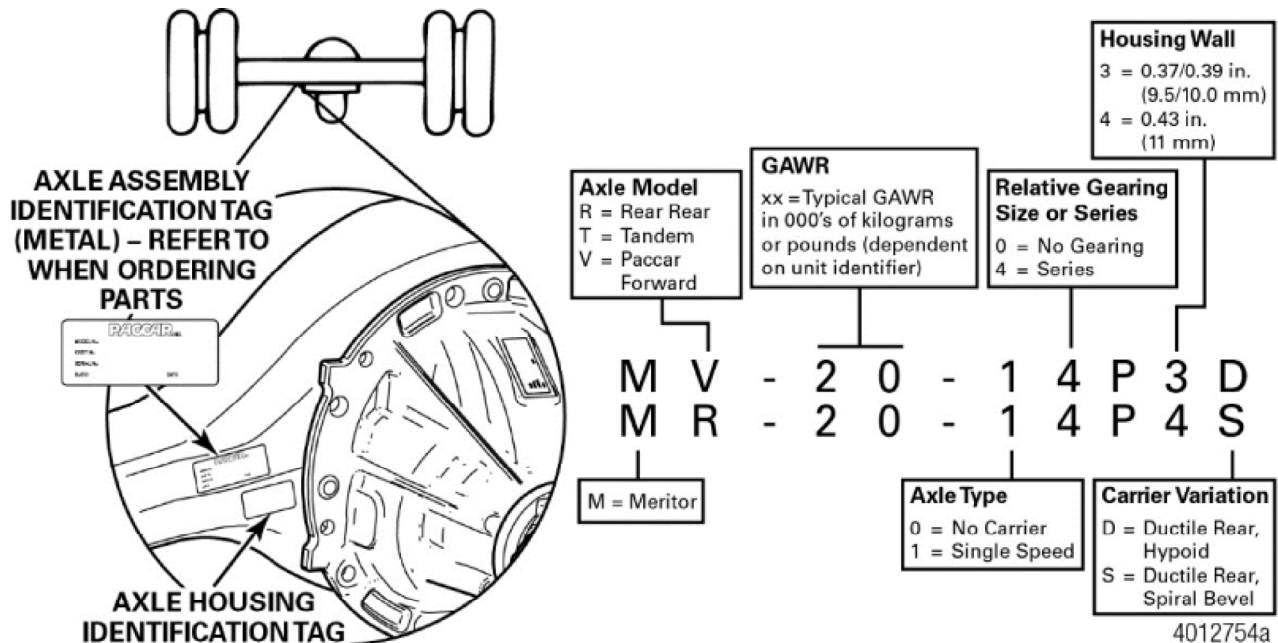
- Contact the PACCAR Parts line at 1-800-944-0251 and when prompted, select option 4, and you will be routed to a Meritor representative. Provide the Meritor representative with the VIN number, axle serial number, and mileage to confirm that the unit requires inspection. The call center will provide a case number for tracking purposes.
 - If the mileage exceeds 120,000 miles (193,121 km) and there are no complaints of vibration or a knocking noise, no further inspection is required. Report the above information to the Meritor representative and file for Quick Claim A002.
 - The axle assembly serial number can be found on a metal tag on the leg of the housing adjacent to the carrier.

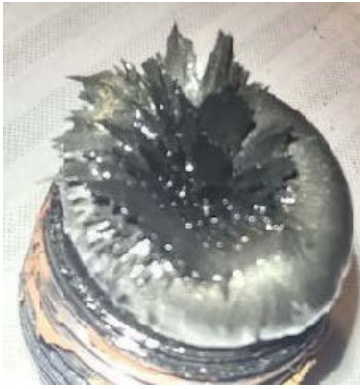
- If it has debris as shown below, the carrier and the hub bearings need to be replaced. Follow procedures in the appropriate service manuals.
- If there is very little debris on the fill plug, then reinstall the fill plug.

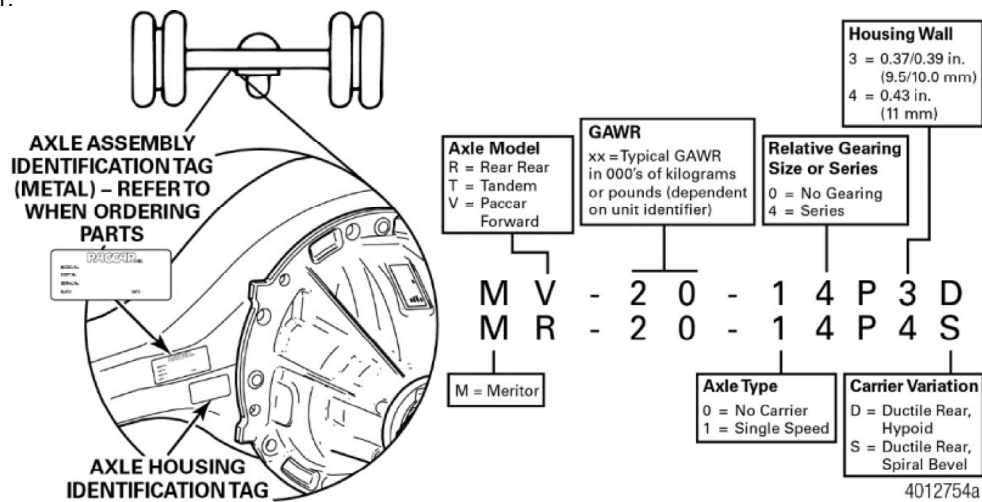
1. Contact the PACCAR Parts line at 1-800-944-0251 and select option 4 when prompted, and you will be routed to a Meritor representative. Provide the Meritor representative with the VIN number, axle serial number, and mileage to confirm that the unit requires inspection. The call center will provide a case number for tracking purposes.
 - If the mileage exceeds 120,000 miles (193,121 km) and there are no complaints of vibration or a knocking noise, no further inspection is required. Report the above information to the Meritor representative and file for Quick Claim A002.
 - The axle assembly serial number can be found on a metal tag on the leg of the housing adjacent to the carrier.

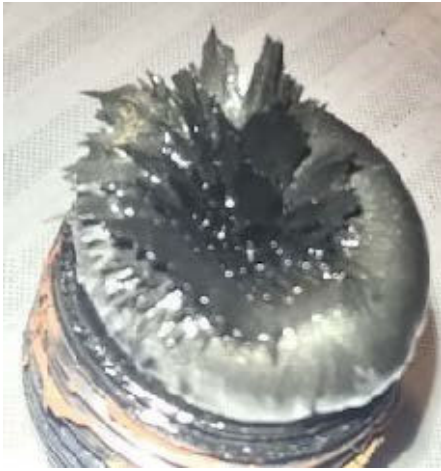
- If it has debris as shown below, the carrier and the hub bearings need to be replaced. Follow procedures in the appropriate service manuals.
- If there is very little debris on the fill plug, reinstall the fill plug.
