Coal Combustion Residual Landfill Annual Inspection Report

Boardman Generating Facility

Prepared by: Mathew Quigley, P.E.

January 2016

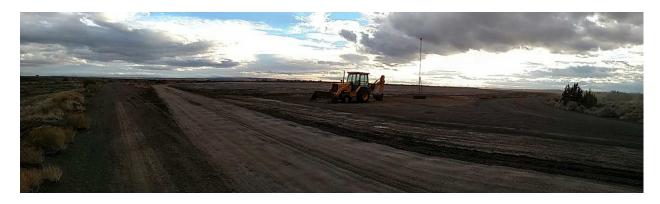
- Where vehicles access the landfill site at its northeast and southwest corners, there is no ability
 to capture and convey stormwater into perimeter ditches leading to the stormwater retention
 area. Instead flows can exit the landfill site.
- Some erosion of bottom ash piles has created irregular ditch profiles along the southern edge of the landfill.
- Brush has built up in some ditches.
- Some recessions in the landfill appear to exist which may allow ponding of stormwater.

CCR landfill at northeast corner, viewing southwest. Entrance to northeast side of landfill.

- Grading at entrances to the landfill at the northeast and southwest corners of the landfill should be adjusted to create embankments which can be traversed by site traffic while preventing egress of stormwater from the site. Ditches leading to these locations will need to be directed to culverts under the embankments.
- Ditches along the southern edge of the landfill should be reestablished to correct irregularities
 caused by bottom ash washing into the ditches. Bottom ash pile slopes should be grades to
 mitigate further erosion into ditches.
- Brush within ditches around the landfill site should be removed.
- Ash disposal should be concentrated at observed recessions in the landfill to prevent ponding of stormwater.

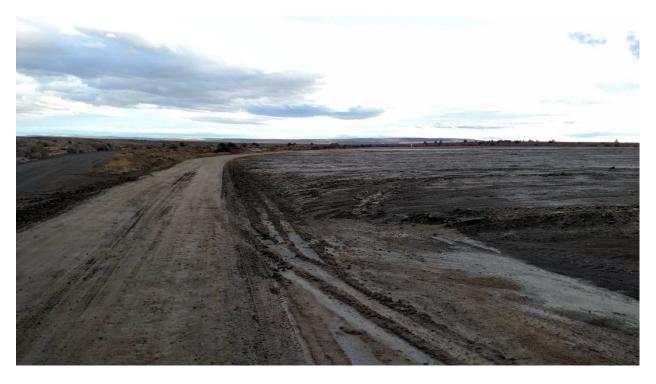
CCR landfill at northeast cornering, viewing south. Entrance to northeast side of landfill.

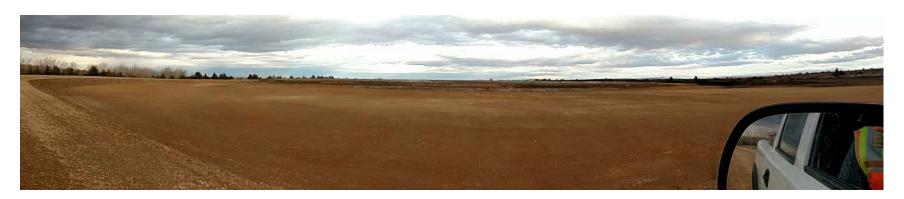
CCR landfill at west side, viewing east. Stormwater retention area.

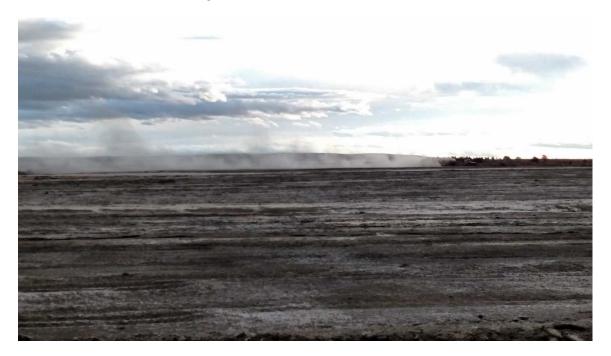
CCR landfill at north side, viewing south. Ash truck depositing fly or economizer ash.

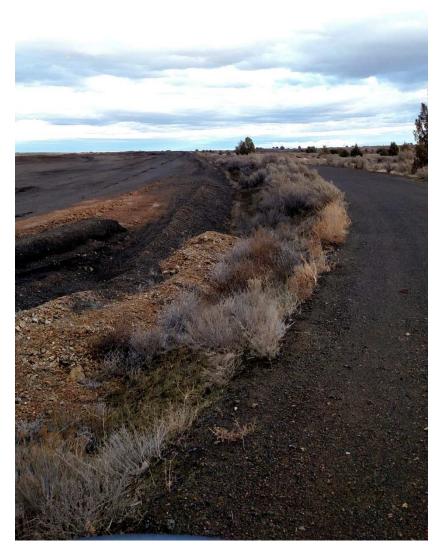
CCR landfill at southwest corner, viewing east. South perimeter ditch.

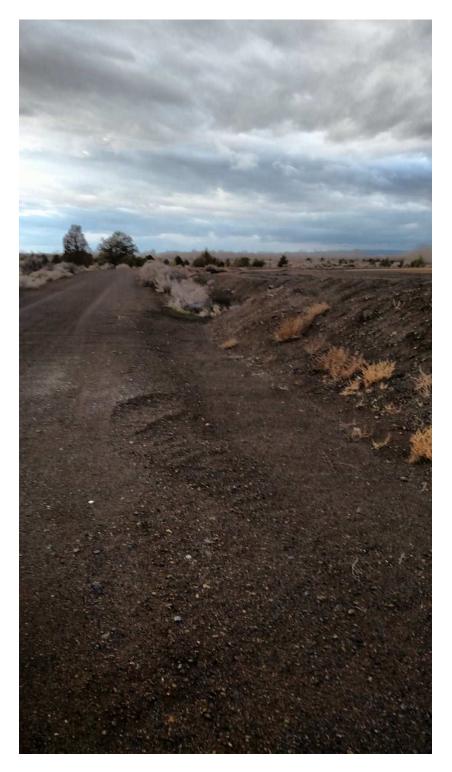
CCR landfill at south side, viewing west. South perimeter ditch.

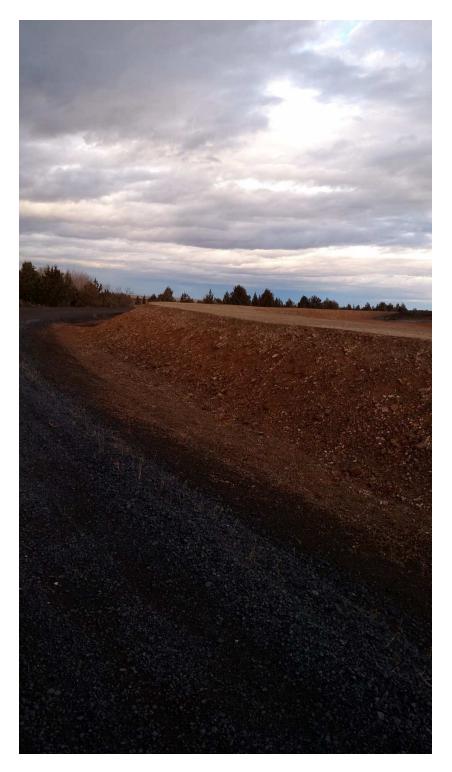
CCR landfill at west side, viewing northeast. Stormwater retention area impoundment.

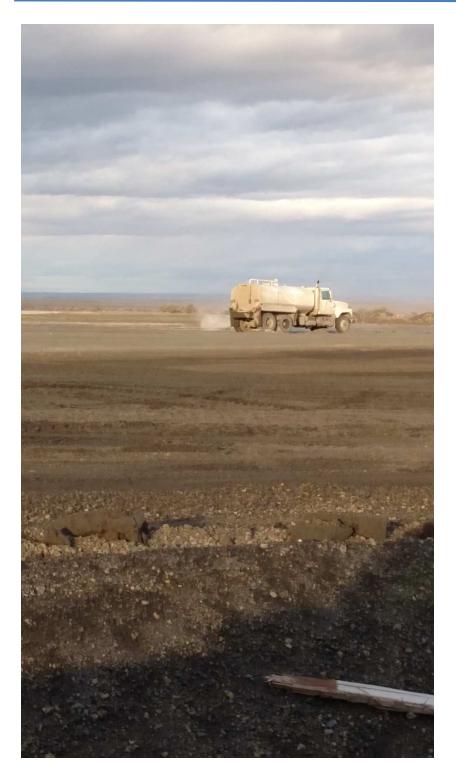
CCR landfill south side, viewing north. Water truck conditioning deposited fly or economizer ash.

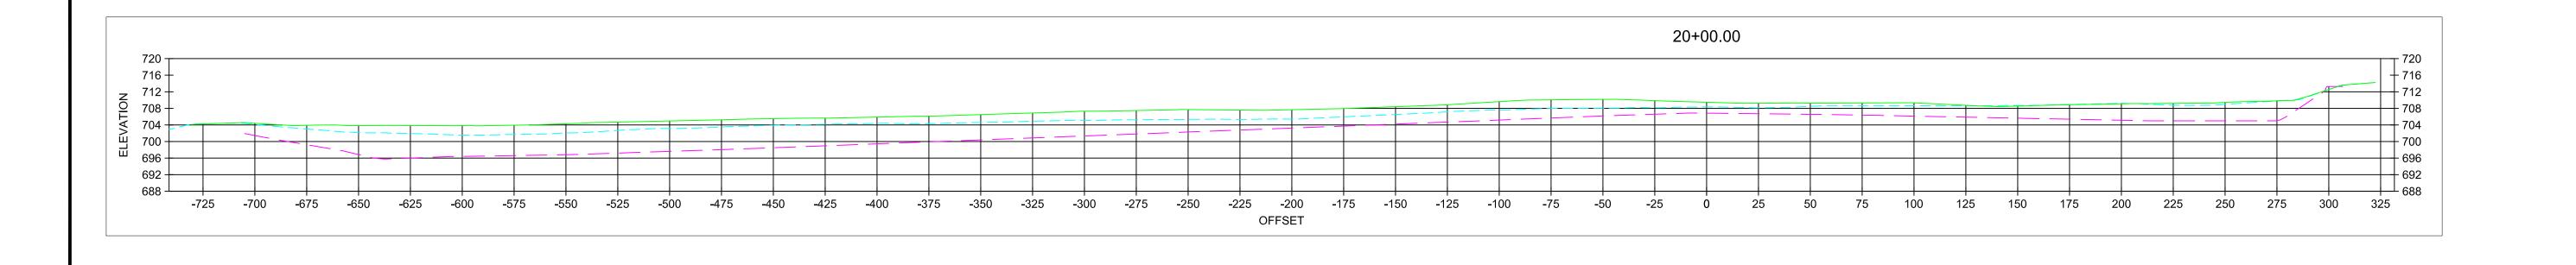
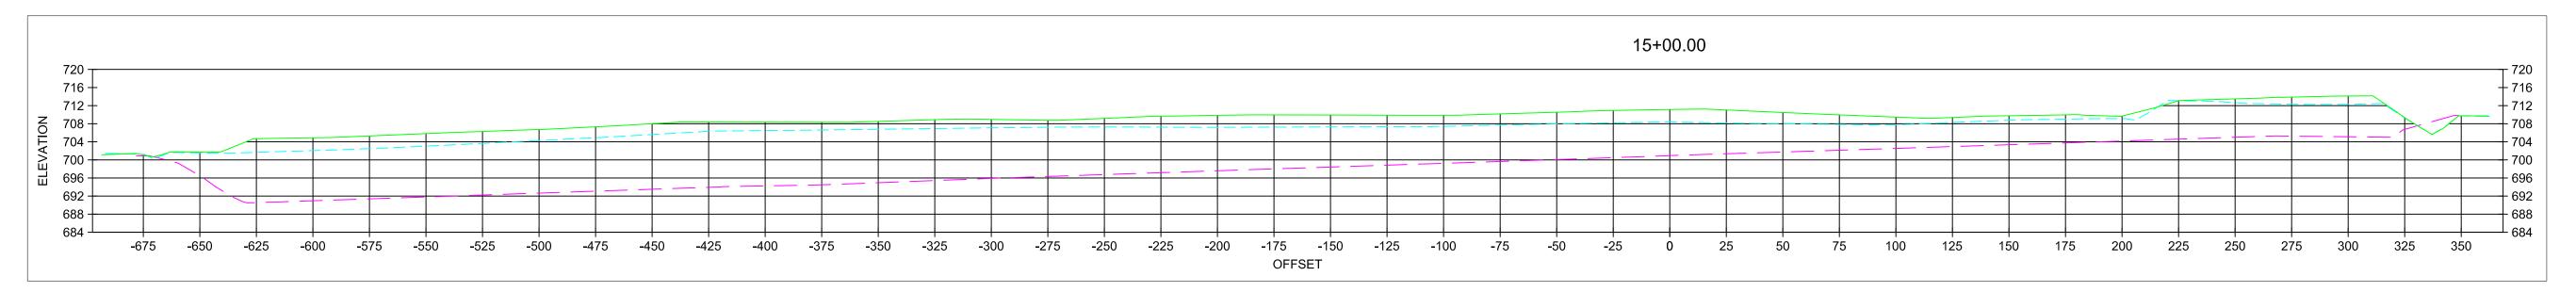
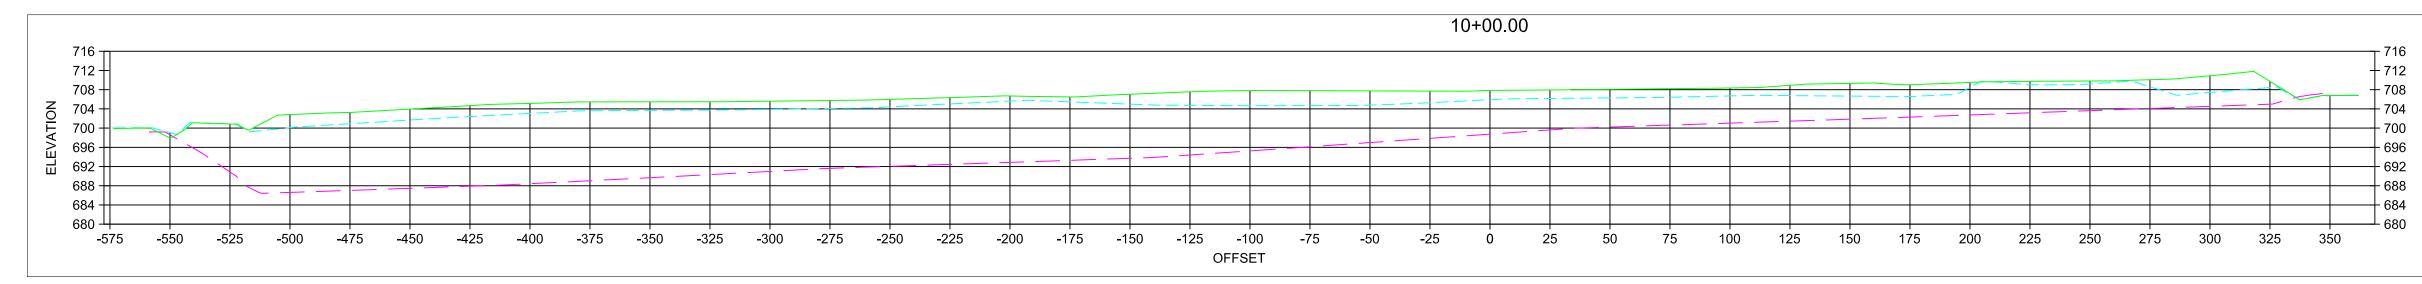
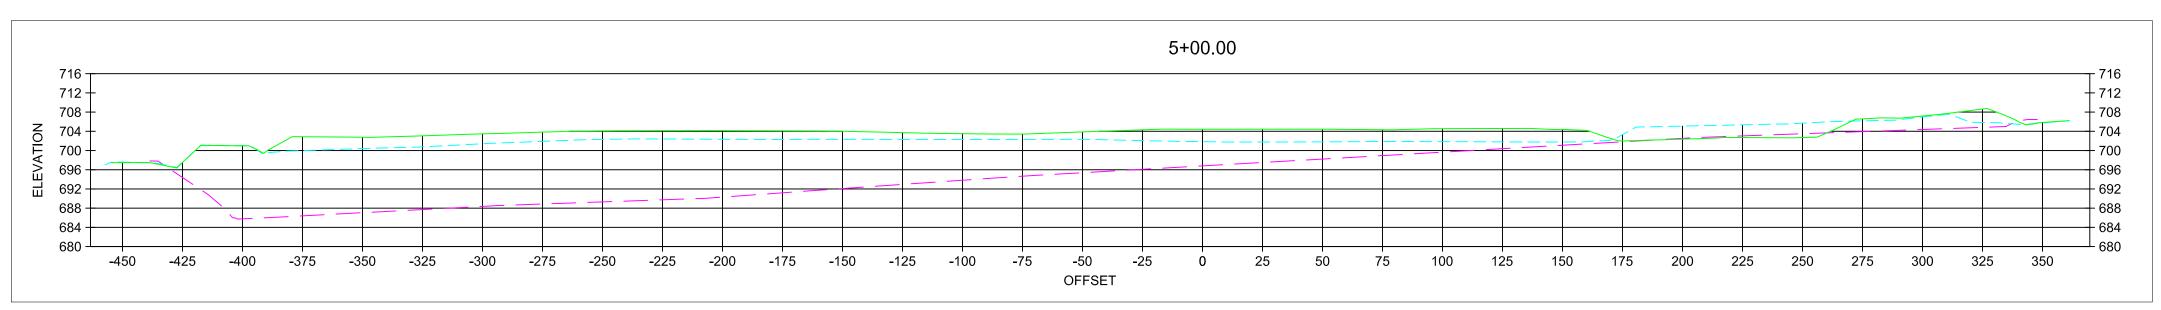
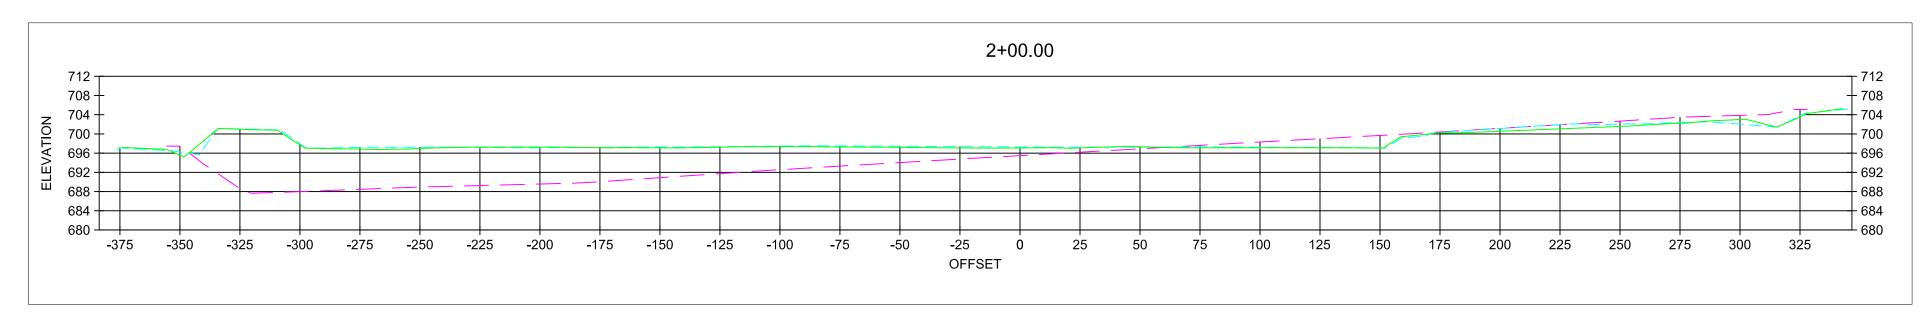
OCTOBER 2015 ASH PILE TOPOGRAPHIC SURVEY QUNTITY COMPARISON TO 2013 CDOCC CECTIONIC

Appendix B contains figures of the CCR landfill depicting the previous and current topography of the landfill as recorded on October 8th, 2015. The previous survey of the landfill topography was completed in May of 2013. From May 2013 to October 2015, approximately 104,176 cubic yards of material have been deposited on the landfill. Original landfill site topography data from 1980 is incomplete but has been approximated to estimate that around 582,000 cubic yards of deposited material are present within the landfill. The aerial extents of the landfill have not increased. Ash disposition has generally increased the surface elevation of the landfill in the southeast quarter and in a few locations along the southern side.
