Dell Data Security

Encryption Personal Technical Advisories v8.17.1

Encryption Personal Technical Advisories

Rev. A03

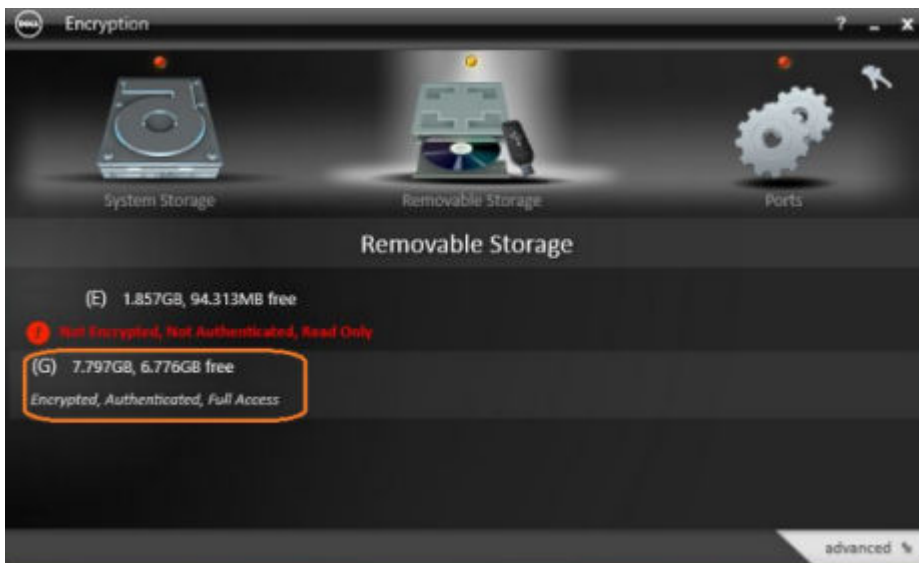
- The Secure Hibernation policy is not supported with Legacy BIOS on Windows 7. [DDPC-2279]
- Encryption status displayed in the Dell Data Security application for a fixed or removable drive may differ from the actual status of the drive, which is correctly displayed in the Local Management Console.

[DDPC-5521, DDPC-5670]

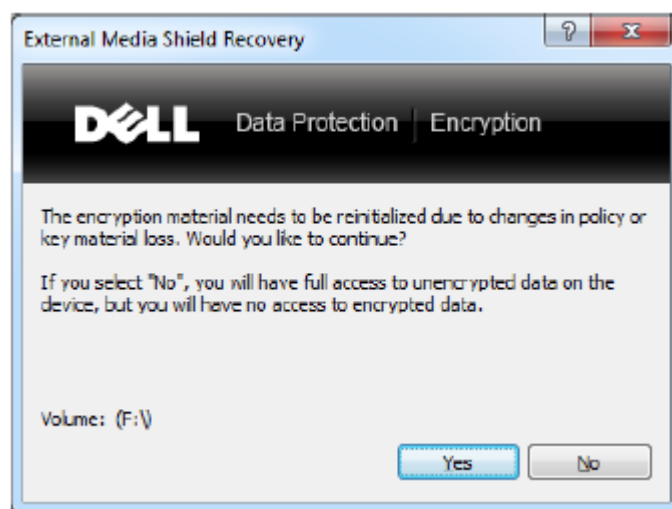
This condition occurs when external media provisioned by Dell Data Protection | Encryption for Mac is accessed on Windows computers running Dell Data Protection | Encryption for Windows. To recover from this condition, follow the instructions below. [29055]

- c Manually delete the `Access Encrypted Files (Mac).dmg`, `AccessEncryptedFiles.exe`, and `autorun.inf` files from the root of the device.
- d Login to a computer running Dell Data Protection | Encryption with the same user account that originally encrypted the external media. Older versions of Dell Data Protection | Encryption will also require both the same user **and** same computer that originally encrypted the external media.

- e Insert the EMS-encrypted external media.
- f You are prompted to perform a recovery. Click **Yes**.

- g Enter a new password to restore access to encrypted files.
- PCIe SSDs are not supported on Precision T-series computers.
