Dell Data Security

Encryption Enterprise Technical Advisories v8.17.1

Encryption Enterprise Technical Advisories

Rev. A03

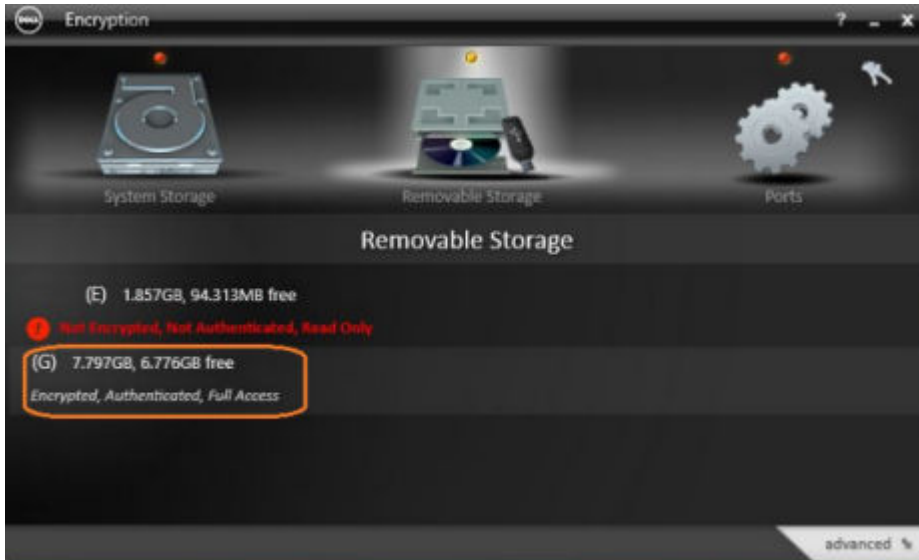
- The Secure Hibernation policy is not supported with Legacy BIOS on Windows 7. [DDPC-2279]
- Encryption status displayed in the Dell Data Security application for a fixed or removable drive may differ from the actual status of the drive, which is correctly displayed in the Local Management Console.

[DDPC-5521, DDPC-5670]
