TECH REPORT

CAM20-MT Choke Valve Withstands Erosive Fracturing Flowback with No Damage or Wear, Eagle Ford Shale

External floating sleeve trim remains unaffected by high flow rates and pressures as well as abrasive solids in the fluid flow

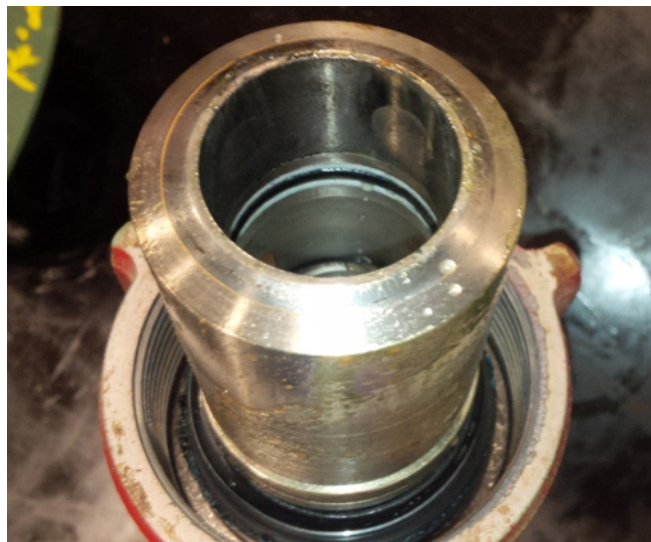
The test lasted 72 hours with no shut-ins. The choke opening was gradually increased from $\frac{9}{64}$ in to $\frac{19}{64}$ in. During this time, the choke withstood pressures ranging from 3,950 psi to 2,875 psi. After the test, the choke valve was removed and subsequently disassembled and thoroughly inspected in the workshop. There were no signs of erosion, corrosion, damage, or wear, even in the lowest part of the seat, which is exposed to the most severe conditions due to high fluid velocities and large debris; the seat and FS trim were in as-new condition. The seals were replaced and the choke valve swiftly returned to service so that production could continue through the flowback tree, a common practice in the Eagle Ford.
