## TS 940 Mods

### Expanded xmit for Kenwood TS-940S

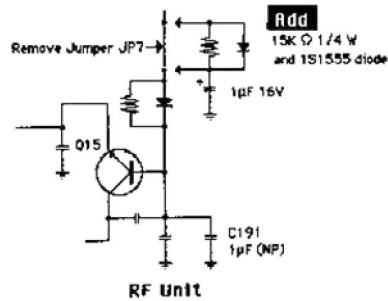
The following changes will improve the adjacent rejection of the TS-940S when a relatively strong nearby signal is present (s-4 or above).

1. Remove jumper wire JP7 and replace it with the parallel combination of the 15 Kohm resistor and the 1S1555 diode. Pay close attention to polarity.
2. Add the 1 µF capacitor as shown in the diagram.

Change capacitor C75 from a 1 µF 50V capacitor to a .047 µF 50V capacitor.

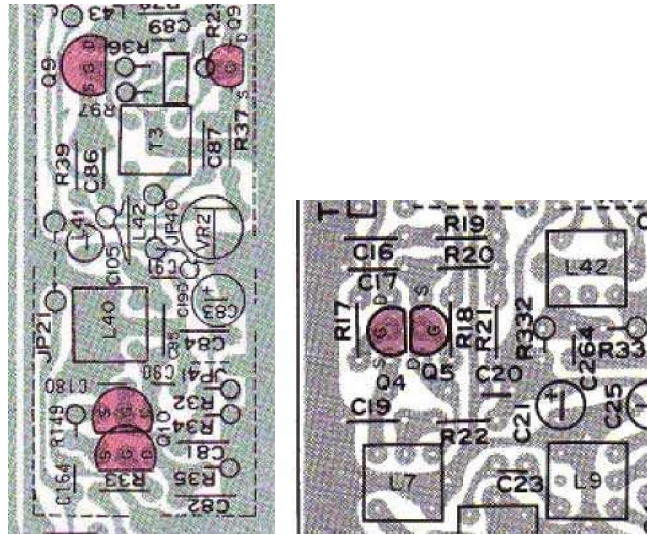
See the FETs Q10 (RF Preamp Preamp 2SK125, N-FET, 25V, 0.1A, 0.3W) and Q4 Q5 (2nd balanced mixer, also 2SK125).  
The picture above was scanned from the TS-940S Service Manual, Revised Edition.  
In these pictures the FETs are in the wrong position.

I can assume that thousands of other TS-940S are also waiting to be corrected and perform Rx even better (mistakes "hidden" for almost 20 years!)

Check yourself with instruments, it can be probably more than 10 dB of gain and a better AGC performance.

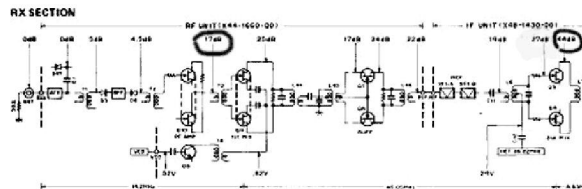
See the Level Diagram in the Service Manual. With the FETs on the right position, we would have 12.5 dB (17 - 4.5) gain in the RF Preamp, and 17 dB (44 - 27) in the 2nd balanced mixer at the indicated points in the picture above.  
It would be interesting to measure these gains before the correction.  
With this measurement we would have an idea about the sensitivity losses due to the two errors.

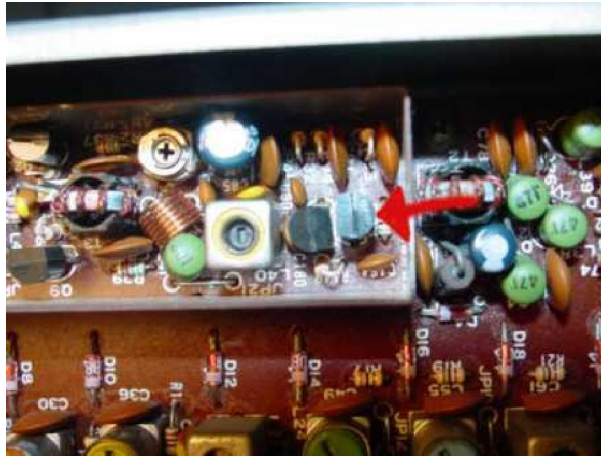
My radio was working apparently well. This is the 1st TS-940S that I could observe and analyze in detail its circuits. First I found the RF Preamp FET in a odd position, but only few days after I could focus and see that the cascode circuit was correct in the schematic diagram and wrong in the PC board. It was also wrong in the PC board view pictures in the Service Manual.

I also noticed that a FET was hotter than the other. It was as simple as disordered and turn the FET 180° and resolder it all over again.

*This picture shows the FET in the correct position.*

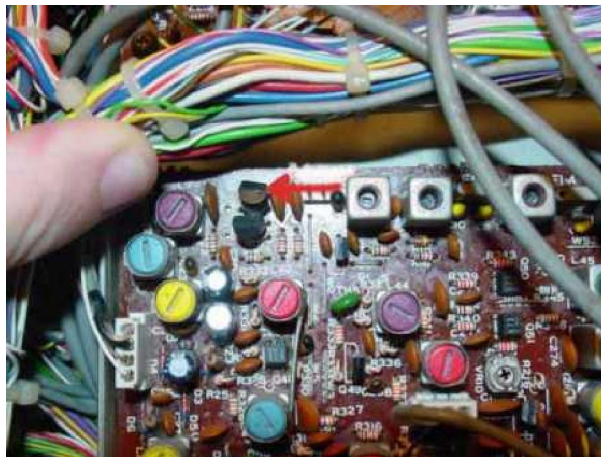
I got back to the Service Manual, and following the circuit diagram, checking the PC boards, I found a second mistake: in the 2nd balanced mixer, in the IF unit, another inverted FET (Q4), harming the mixing/conversion, the gain, and the AGC performance.

*This picture shows the FET in the correct position.*

By eliminating these "losses", my famous TS-940S "won" 10 dB more! Because of that, I had to make S-Meter adjustments.

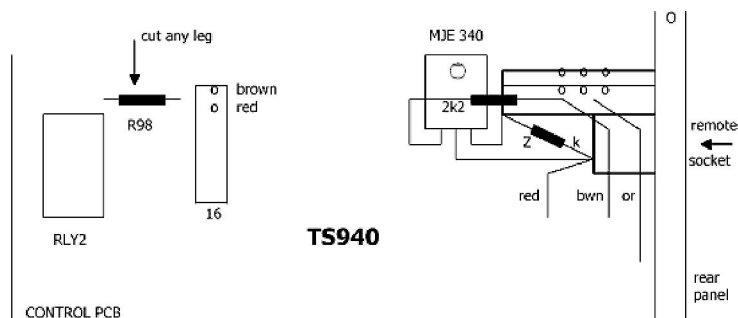
After many years of service the relay RL2 that activates the PTT to a linear amplifier can become unserviceable and its replacement is an elaborate process involving the complete removal of the Control PCB. All this can be avoided by substituting the relay with a transistor that can be mounted physically on the Remote Socket and only one resistor leg needs to be cut on the Control PCB:

For use with a TL922 amplifier it is necessary to use a high-voltage transistor such as the MJE340 and a zener diode of 150V as it has a 100V DC relay coil that must be grounded for TX operation. This modification will work on any amplifier requiring pull-down for TX. If the pull-down is only for 12V, the zener diode voltage can be lowered to 15V or eliminated all together if there is no relay.

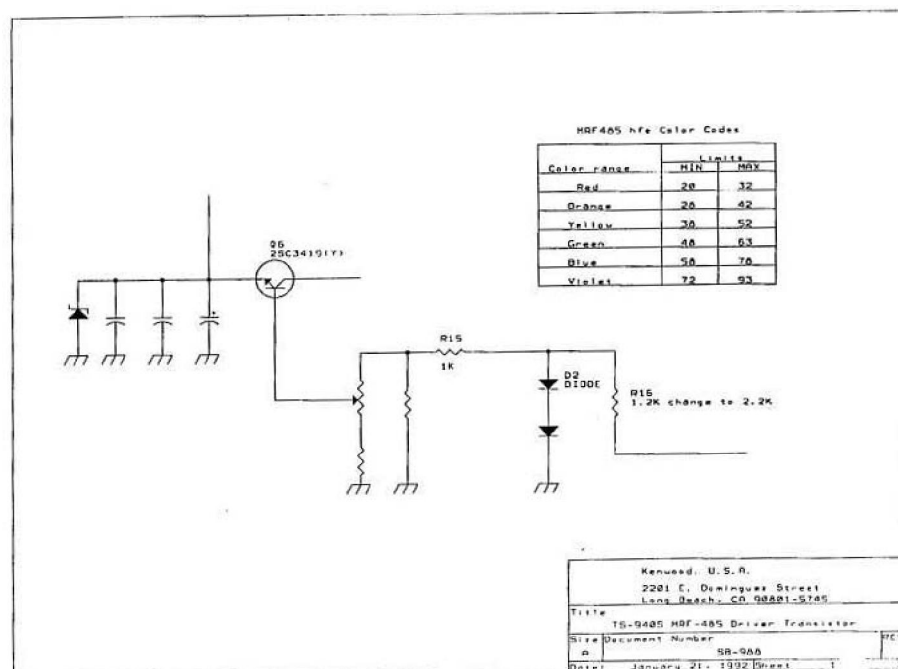
Some MRF-485 transistors are being supplied by Motorola with a Green or Blue color ranking. If these transistors are installed without modifying the driver bias circuit there is a strong possibility that they will fail within a very short time frame.

These high gain transistors cause the circuit to become unstable which can cause the circuit to break into self oscillation, and therefore self-destruct.

Use of Red, Orange, or Yellow hfe color rankings is recommend. These lower gain transistors work just fine and do not suffer from the circuit instability problem. If you are only able to obtain the high gain transistors you will need to modify the varistor/temperature compensation circuit on the final unit (X45-1400-00) by changing R16 from 1.2 Kohm to 2.2 Kohm.

During its production the TS-940S used two different varistor values. The original part was an STV3H(O). It was changed in mid-production to an SV03YS. R15 was changed from an 820 ohm resistor to a 1 Kohm resistor at the same time. Therefore the countermeasure differs depending upon the serial number of the radio.

**Caution:** If using a Green or higher hfe rank one of the above countermeasure must be taken depending upon the serial number of the set. After replacing the drivers check the bias current. We recommend transmitting for 1 hour in SBB mode with no modulation into a dummy load. After this time frame check the bias current. It must not exceed 300 mA on the original radio. If the current changes you must change R16 from 1.2 Kohm to 2.2 Kohm.

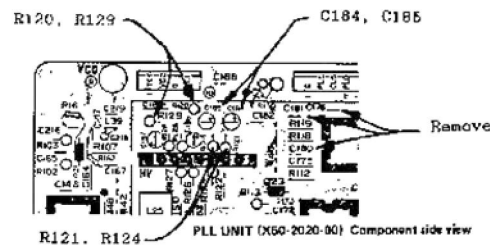
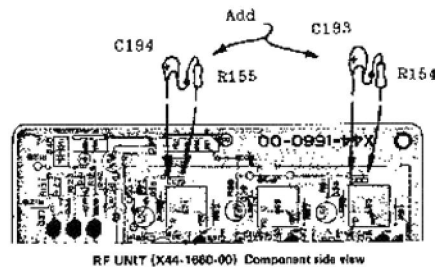
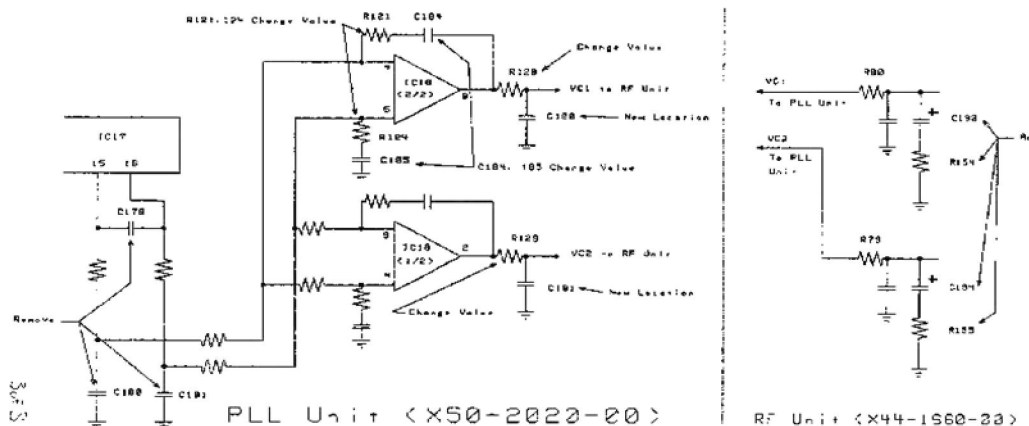
### PLL UNIT

The Carrier to Noise ratio of the TS-940S may be improved by the following changes. This bulletin supersedes bulletin number 911 dated September 15, 1986.

On the PLL unit (X50-2020-00) remove capacitor C176, C180, and C181. Change resistor R120 and R129 from 470 ohms to 3.3 Kohm. Change resistor R121 and R124 from 1 Kohm to 680 ohms. Change capacitors C184 and C185 from .22  $\mu$ F to .33  $\mu$ F 35V tantalum capacitors. Install C180 and C181 in the positions shown in the accompanying diagrams. The use of new capacitors is recommended to improve reliability, don't try to reuse the old capacitors! Capacitors C181 and C180 should be attached to the foil side of the PLL unit.

On the RF unit (X44-1660-00) install the series RC circuit composed of R154 and C193, and R155 and C194, as shown in the accompanying diagrams. As the diagrams illustrate it is easiest to move C132 and C193 to the foil side of the board and install the series RC circuit on the component side.

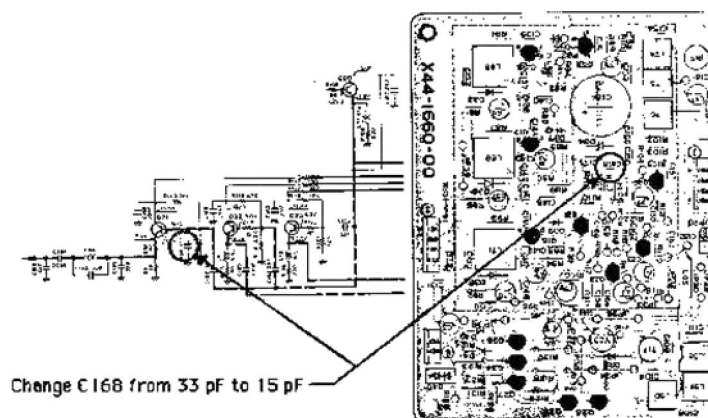
Reports of a PLL lock on the lower frequencies may be due to low VCO levels. The following change will increase the VCO level and should prevent recurrence of this symptom.

This change is applicable to units prior to serial number 606xxxx.

1. On the RF unit (X44-1660-00) change C168 from a 33 pF capacitor to a 15 pF 50V capacitor.
2. Readjust the VCO BPF (RF unit L74-76) according to the instructions contained in the TS-940 Service manual.

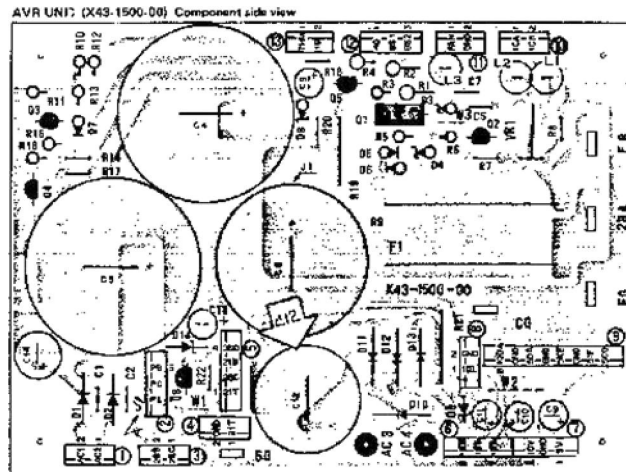
In those areas of the country that are subject to large power line voltage fluctuations, excessive voltage may be applied to capacitor C12 on the AVR unit (X43-1500-00). These voltage fluctuations might exceed the capacitor breakdown voltage. Replacing capacitor C12 with a capacitor having a higher breakdown voltage will help prevent this potential problem.

This change is applicable to serial numbers prior to 701xxxx.

On the AVR unit (X43-1500-00) change C12 from a 6800  $\mu$ F capacitor to a 5600  $\mu$ F 25 V capacitor (C90-2037-05)
