U150 2-3 Upshift Complaints & Solutions

Transmission Report

Volume 9, No. 3

November 2018

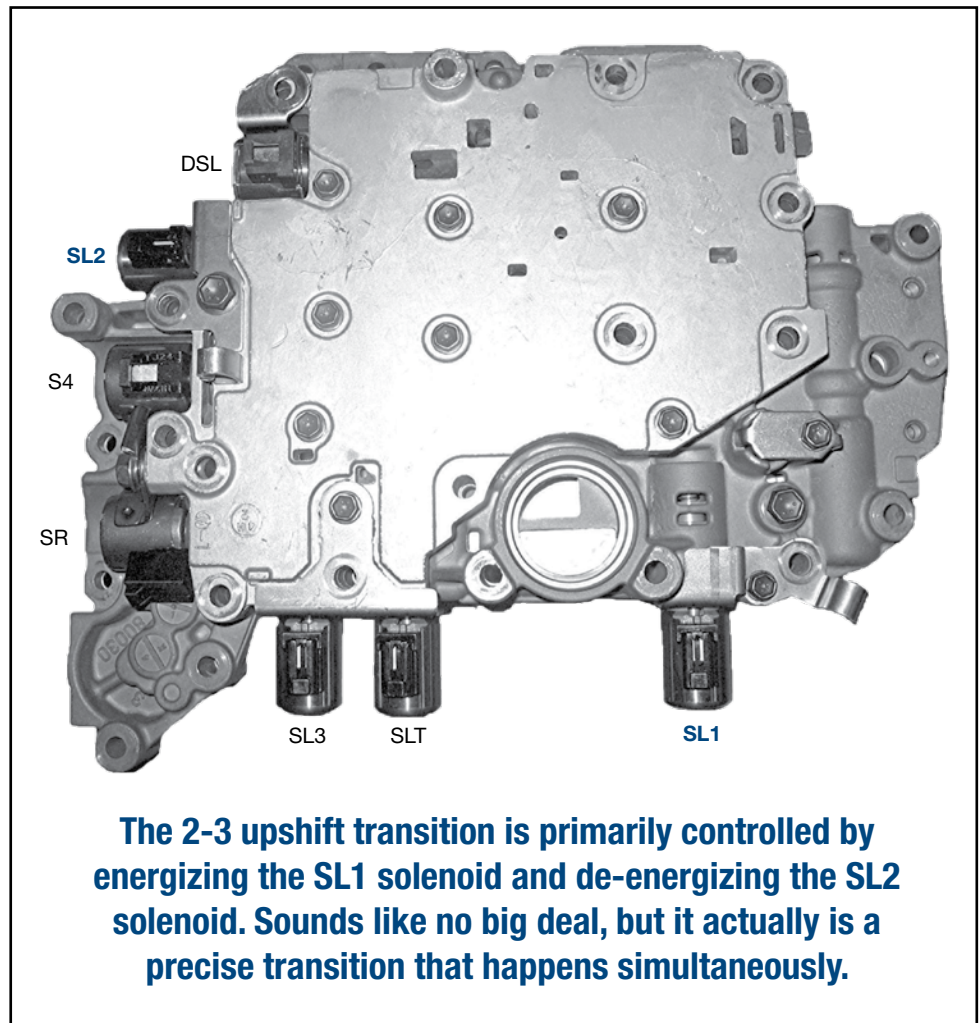
Figure 1 – U150 Solenoid Locations

The 2-3 upshift transition is primarily controlled by energizing the SL1 solenoid and de-energizing the SL2 solenoid (locations on the valve body in **Figure 1**). Sounds like no big deal, but it actually is a precise transition that happens simultaneously.

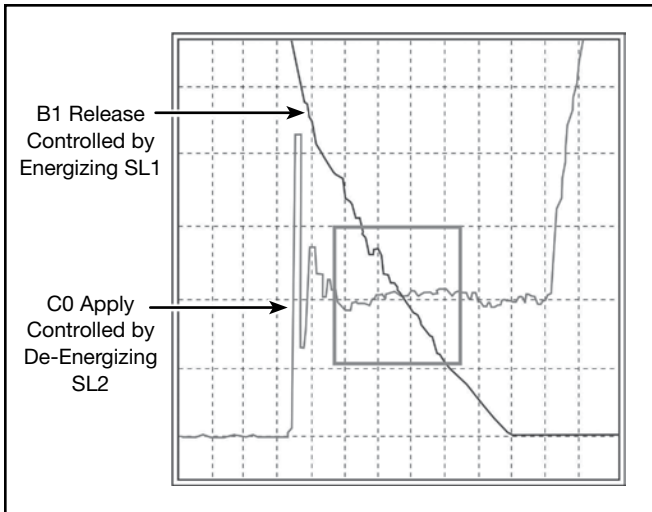
Figure 2 — Good Shift Quality
(A sequential shift from 2nd to 3rd Gear.)

Figure 2 shows a graph of the B1 brake pressure releasing and C0 clutch pressure increasing during the 2-3 upshift. Note that, as B1 pressure is released, C0 Clutch comes on at low pressure at the beginning of the transition to bridge the gap, then goes to full pressure when the transition is complete. This is an example of a good-quality shift with the correct amount of overlap on the 2-3 upshift.

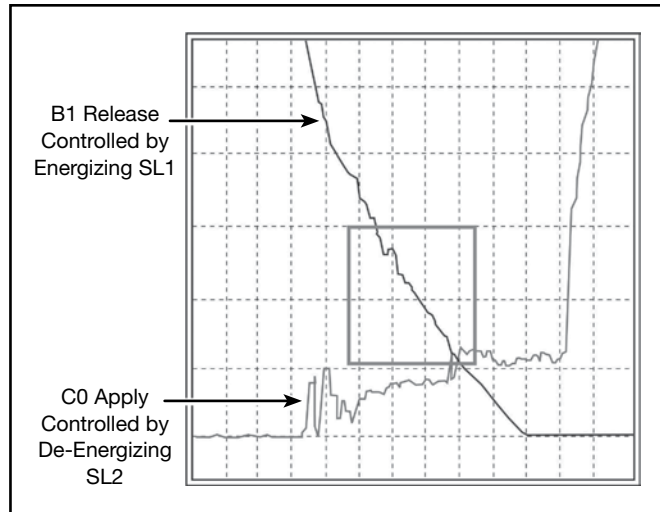
Figure 3 — Poor Shift Quality
(A flared upshift from 2nd to 3rd Gear.)

There are other complaints related to the 2-3 upshift that can also be related to solenoid malfunction, including a flare during the 2-3. **Figure 3** shows a graph of the SL2 as the root cause of this complaint. The C0 clutch pressure is slow to increase, which allows a flare or engine RPM rise during the upshift.

The PCM will try to adjust for these type of solenoid timing issues, but it can only do so much. Flares and slide bumps typically show up when transmission fluid is cold or high temp., so it is important to road test first thing in the morning after the vehicle was sitting overnight as well as after a long drive.

It is safe to say that if malfunctioning solenoids get out the door, the third time the vehicle comes back, it may be on the back of a wrecker. Swapping out SL1 and SL2 solenoids when you run into 2-3 upshift problems can help head off a bad day for you and your customers. ◀

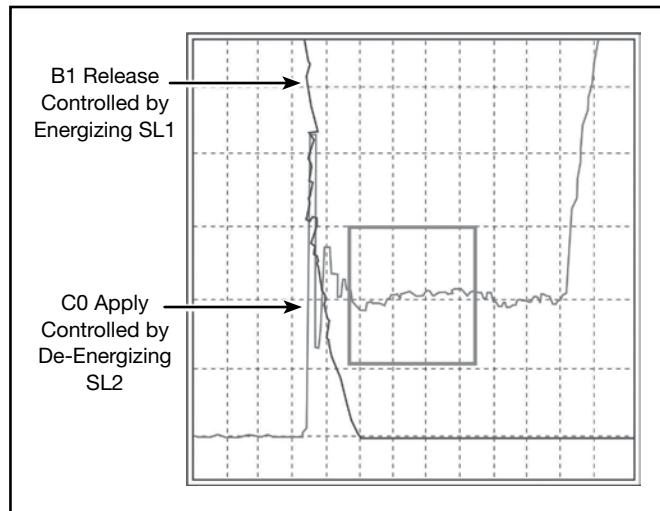
Figure 4 — Poor Shift Quality
(A slide bump shift from 2nd to 3rd Gear.)

A 2-3 slide bump is another common complaint. **Figure 4** shows a graph that points to SL1 as being the root cause. B1 pressure drops too quickly, which triggers a quick slide; the bump comes from the C0 clutch engaging at the end of the slide.

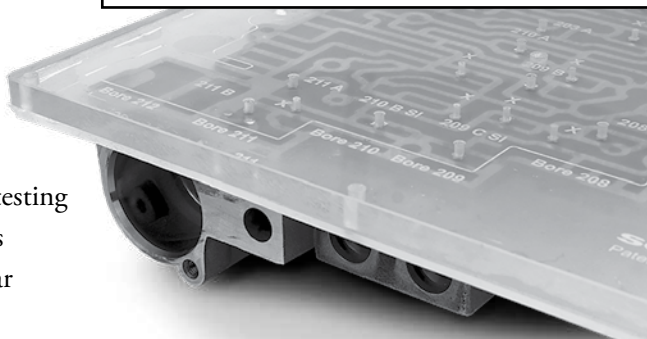
F-77964-TL14 reams this bore. **77964-RM2** does NOT ream this bore.

If low vacuum test results here, use **77964-14K**. If acceptable vacuum test results here, use either **77964-14K** or **77964-04K**
