# PHILCO TV

## SCHEMATIC DIAGRAMS

MODEL 48-700 THRU 53T2750

# 1947-1953

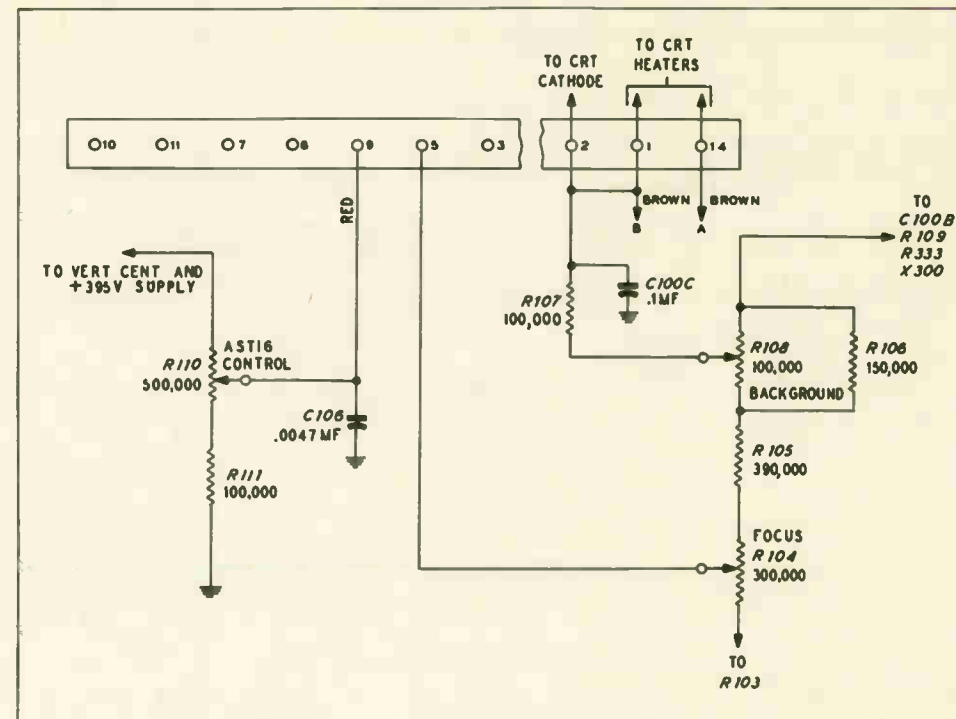
Figure 11. Addition of Astigmatic Control, Run 6

In sets prior to Run 6, the background control, R108, may fail because of transients or surges under certain operating conditions. When replacing this control, it is suggested that the circuit be rewired as shown in figure 11. This change was incorporated in production in Run 6.

The astigmatic control, which was added in Run 6, is used to adjust the second-anode voltage of the picture tube. Whenever this tube is replaced, the control should be adjusted as directed below.

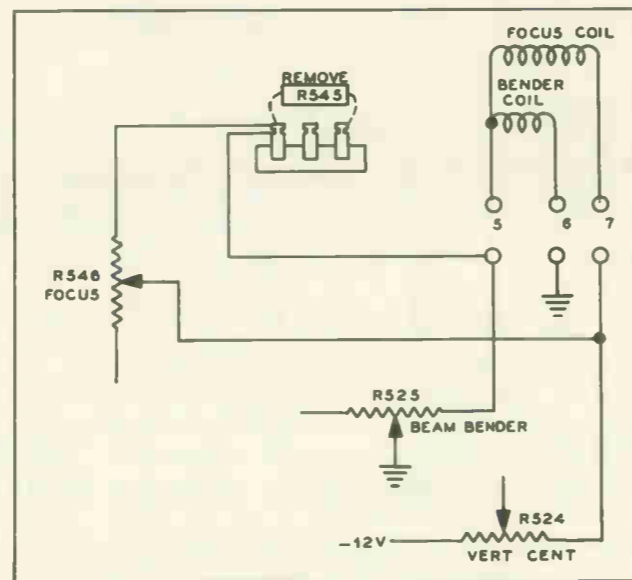
Figure 17. Focus-Coil Replacement

The focus coil for the Model 48-1000, Code 121, is no longer stocked by the Accessory Division. The high-resistance focus coil used in this model and code may be replaced if all the components are replaced (focus coil, focus control) with the corresponding low-resistance focus components, i. e., focus-coil assembly Part No. 76-2622-2 and focus control Part No. 33-5547-2.

- connect the leads to the outside terminals of the terminal panel on the cradle.
3. Remove resistor R545 and the old focus control, R546.
4. Connect a wire from the terminal connection that formerly held R545 and the wire from R546 to pin 5 of J500.
5. Install the new-type focus control, Part No. 33-5547-2, and reconnect the wires as before.
6. Remove the wire connection between R524 and R525 at the R525 end. Reconnect this wire to pin 7 of J500.

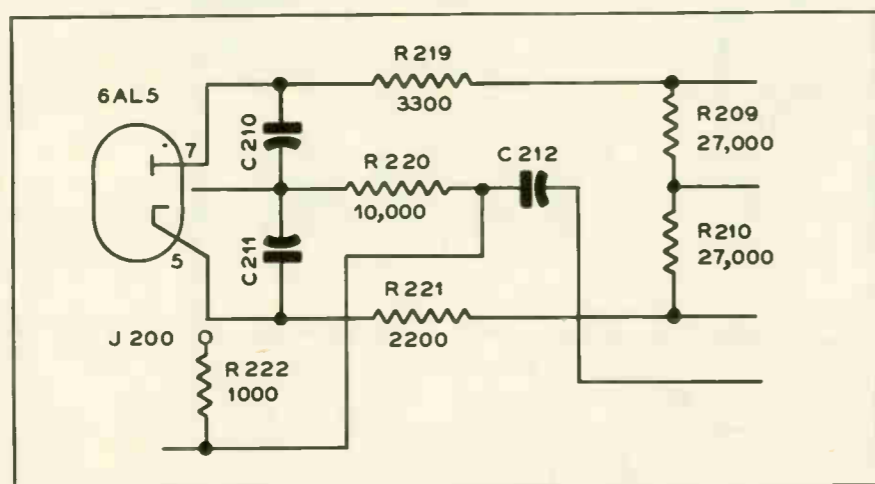
Figure 12. Discriminator Circuit Changes in Runs 4 and 5

Beat patterns may appear in the picture when operating on Channel 7; less frequently on Channels 4 and 11. This condition may be corrected by adding compensating and filter resistors to the FM discriminator

It is recommended that the following changes be made when the chassis are serviced, or when Channels 4, 7, or 11 are adjusted for reception.

- Remove the following parts carefully, as they are to be reinstalled.
  - C218, connected between pin 5 of the discriminator tube (6AL5) and ground.
  - C219, connected between pin 7 of the discriminator and ground.
  - R215, connected between pin 5 of the discriminator and ground.
  - R216, connected between pin 7 of the discriminator and terminal 3 of terminal board TB6.
  - Length of wire, connected between terminal 1 of terminal board TB3 and socket J200.

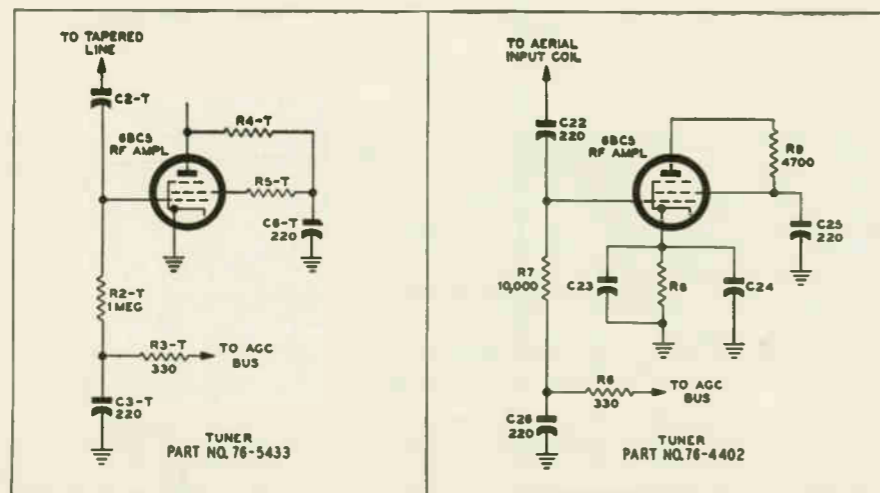
Figure 7. A-G-C Circuit Details of Philco Tuners Part No. 76-5433 and 76-4402.

An improvement in signal-to-noise ratio, which has more apparent effect in the semi-fringe, rather than the extreme fringe area, can be made by removing the a-g-c voltage that is applied to the r-f-amplifier grid, and returning the grid-leak resistor directly to ground. The r-f-amplifier circuits used in Philco Tuners Part No. 76-5433 and 76-4402 are shown in figure 7. The removal of a-g-c voltage allows the r-f amplifier to operate at maximum gain, thus increasing the r-f signal voltage to the mixer. In the extreme fringe areas, where little or no a-g-c voltage is developed, because of the relatively weak signal, this modification will not cause too much improvement in signal-to-noise ratio. If the TB-2 Booster is used in conjunction with this modification, improved reception will result, even in an extreme fringe area. Ordinarily, when a booster is used in the extreme fringe area, the additional preamplification of the signal results in a proportionate increase in a-g-c voltage. This added bias reduces the gain of the r-f stage, causing a proportionate decrease in signal-to-noise ratio. When the a-g-c voltage is removed from the r-f amplifier, the added preamplification of the booster, plus the full gain of the r-f stage, combine to permit the best "snow-free" reception. If a booster with a poor noise figure is used, the modification will result in a stronger signal, but there will be no appreciable reduction in snow.

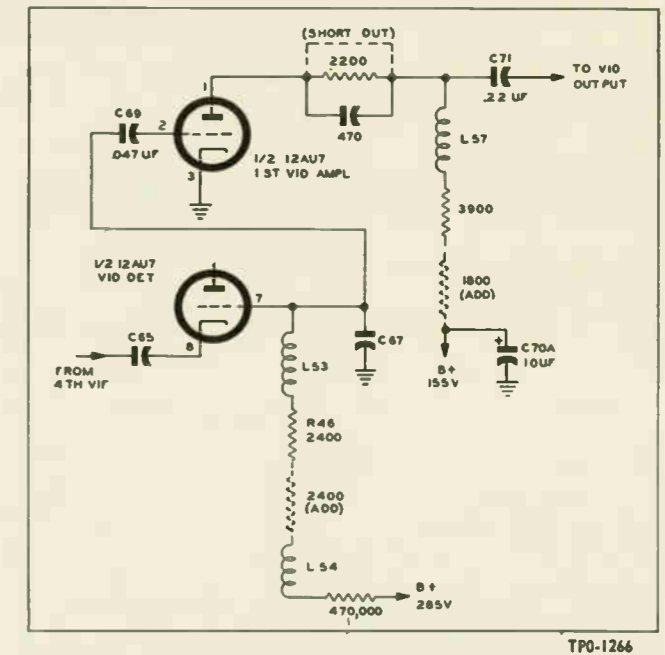
Figure 9. Modification of Video Detector and First Video Amplifier

Greater video gain may be obtained in fringe areas by modifying the output loads of the video detector and video amplifier. As shown in figure 9, a 2400-ohm resistor may be added in series with R46, to increase the value of the detector load to 4800 ohms. This change provides a greater level of signal for the first video amplifier. In the 50-T1400 series, Code 125, Run 6, the 2200-ohm video amplifier plate load resistor and 470- $\mu$ f. shunt condenser may be shorted out. The 3900-ohm plate resistor, in series with the peaking coil, may be increased to 5700 ohms by adding a series 1800-ohm resistor (figure 9). The video output plate load resistor

Another change which can be made is the removal of the "gamma-control" resistor, 22,000 ohms, from screen to ground of the video-output tube. This change gives a considerable amount of extra drive to the picture-tube grid, and consequently, a much blacker picture. In 50-T1400-series receivers of a code and run earlier than Code 125, Run 6, where the sync take-off is from a tapped portion of the plate load of the video-output tube, removing the gamma-control resistor and increasing the value of the plate load may produce sync clipping, and thus deteriorate the general sync performance. This change makes the sync performance extremely dependent upon the position of the contrast control. If, in conjunction with the gamma change and video

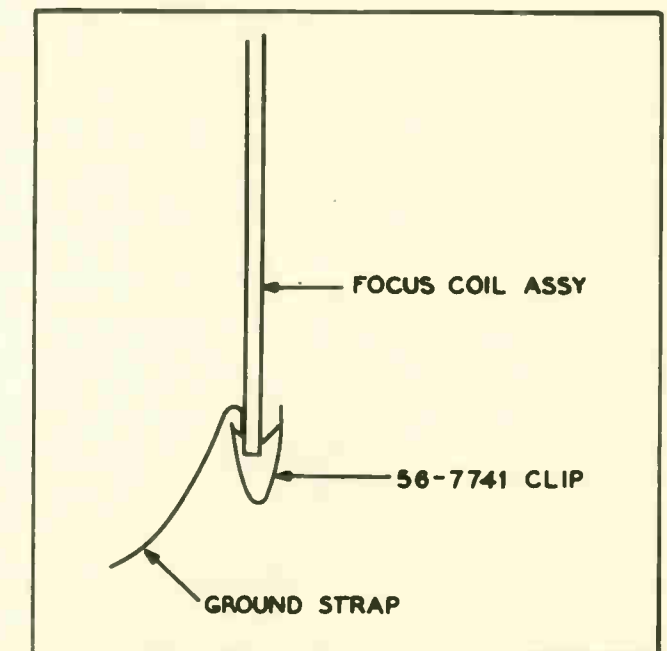
Figure 10. Simple Ground-Strap Repair

In case this strap is broken, it may be repaired by the use of a clip, Philco Part No. 56-7741, as shown below.

Length of Strap	Part No.
3 3/4 inches	76-5472
6 inches	76-5472-1
