Troubleshooting Guide

imagePRESS 1135/1125/1110 Series

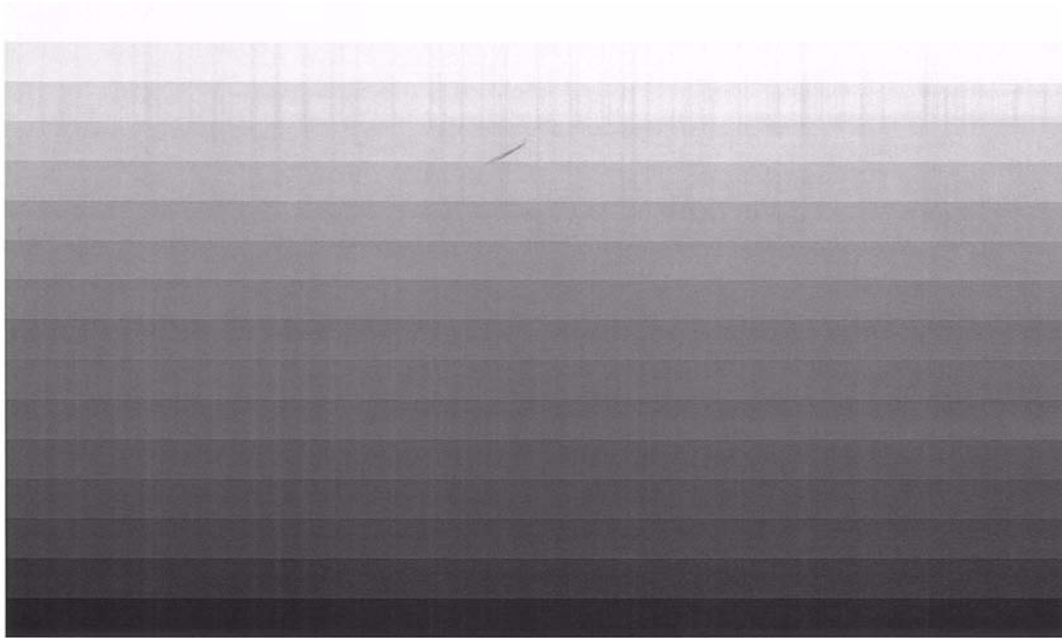
Streaks image in sub scanning direction is occurred.

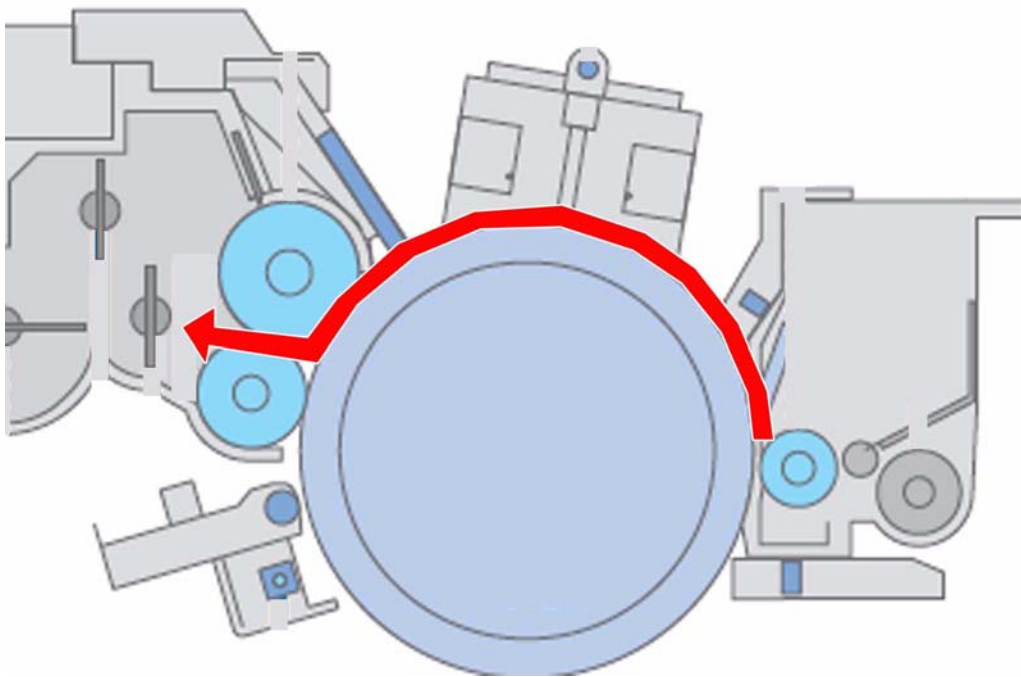
As the Drum cleaning blade was wrongly faced and installed, the Toner slipped beneath and got into the Developing assembly to damage the Developing sleeve.

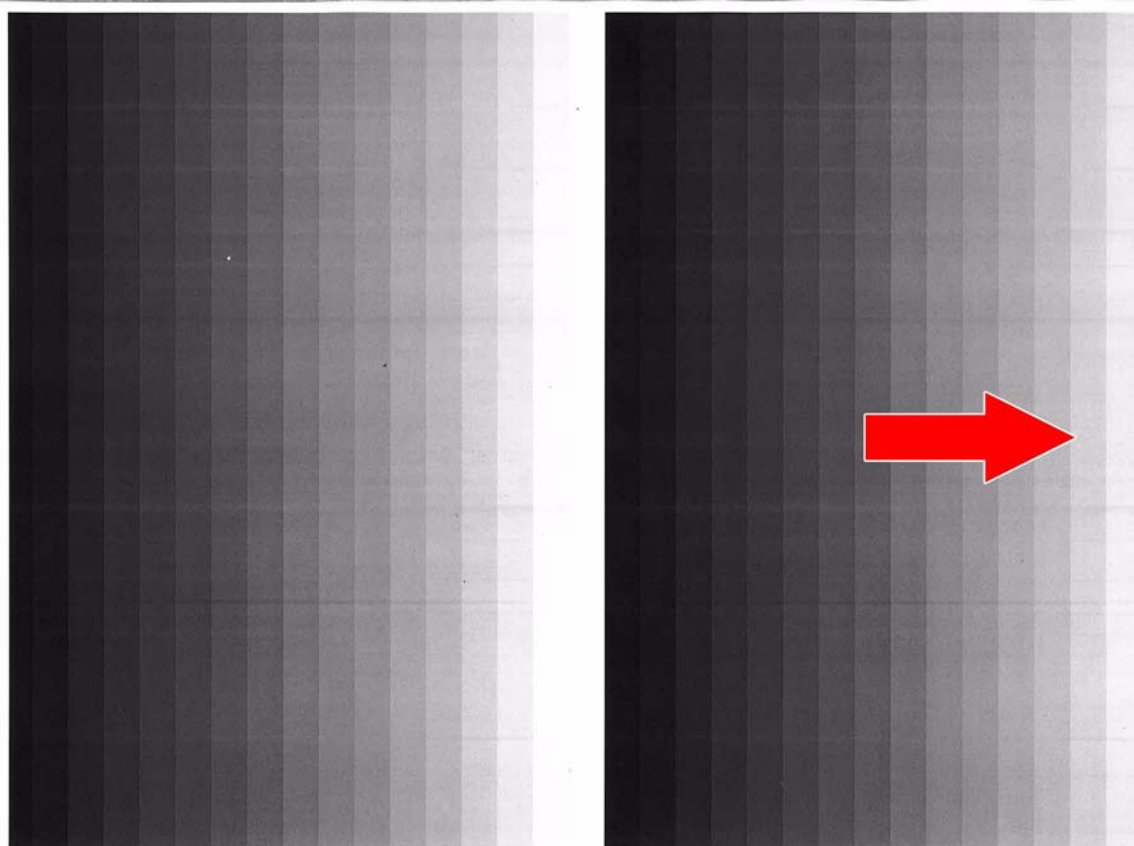
A white line appeared in an image.

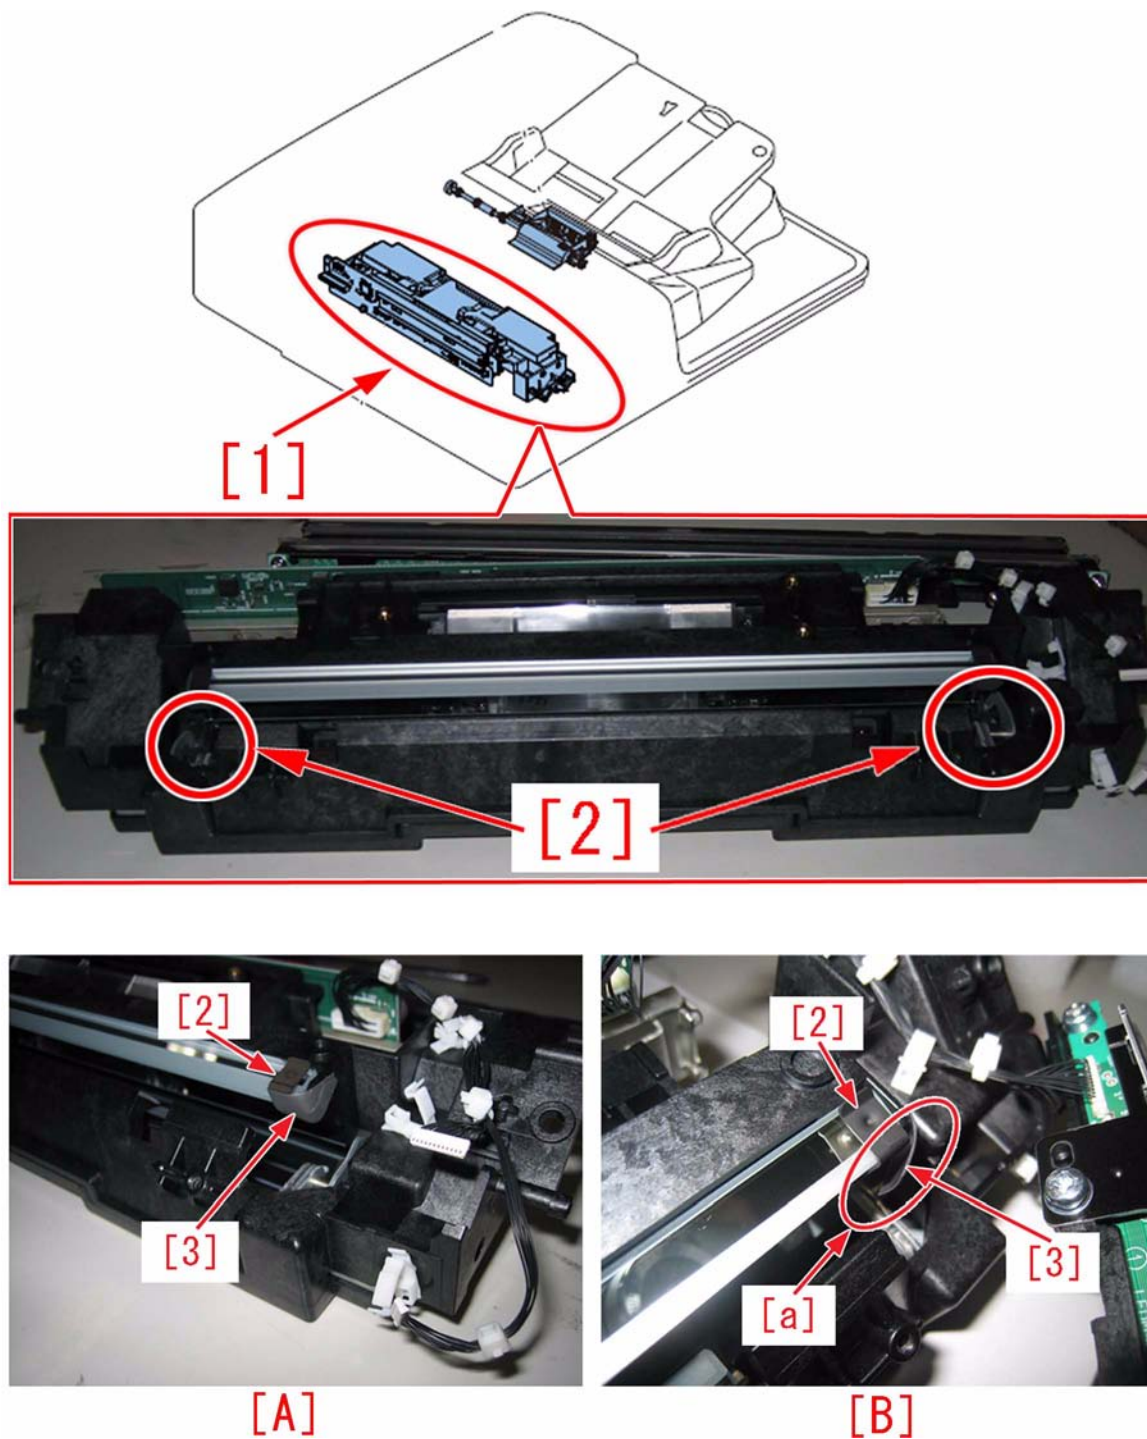
On the scanner unit [1] inside of the DADF, the light-blocking sheet [3] attached on the mirror spring [2] comes off and floats [a], causing to block the light path. [A] shows the light-blocking sheet is attached securely, and [B] shows the light-blocking sheet coming off.

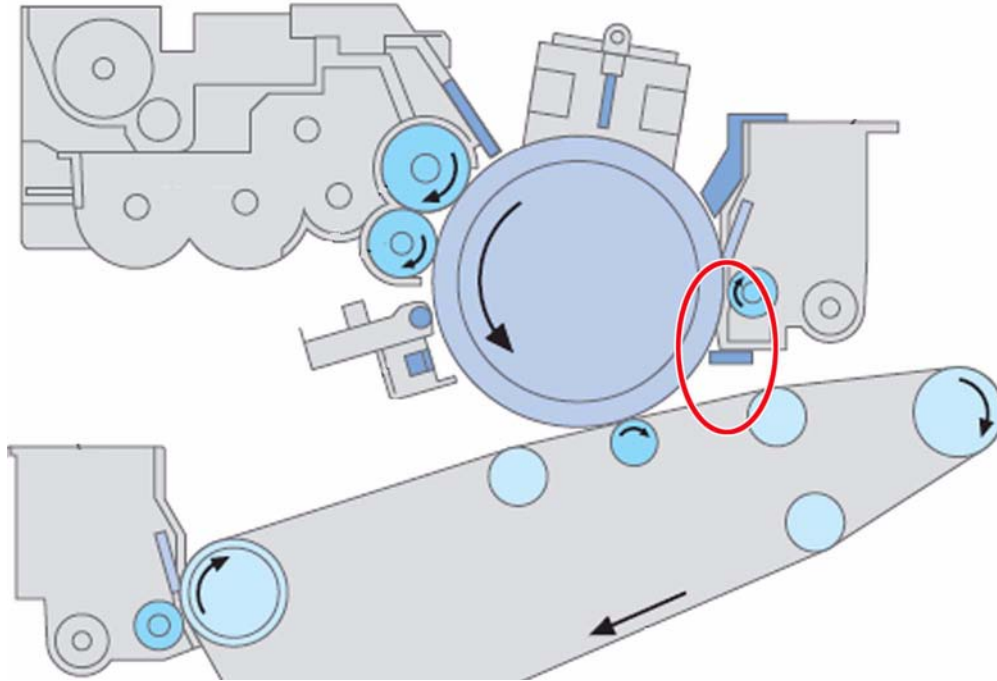
Stained image occurred due to toner dropping on ITB caused by poor document feed in the drum cleaning unit.

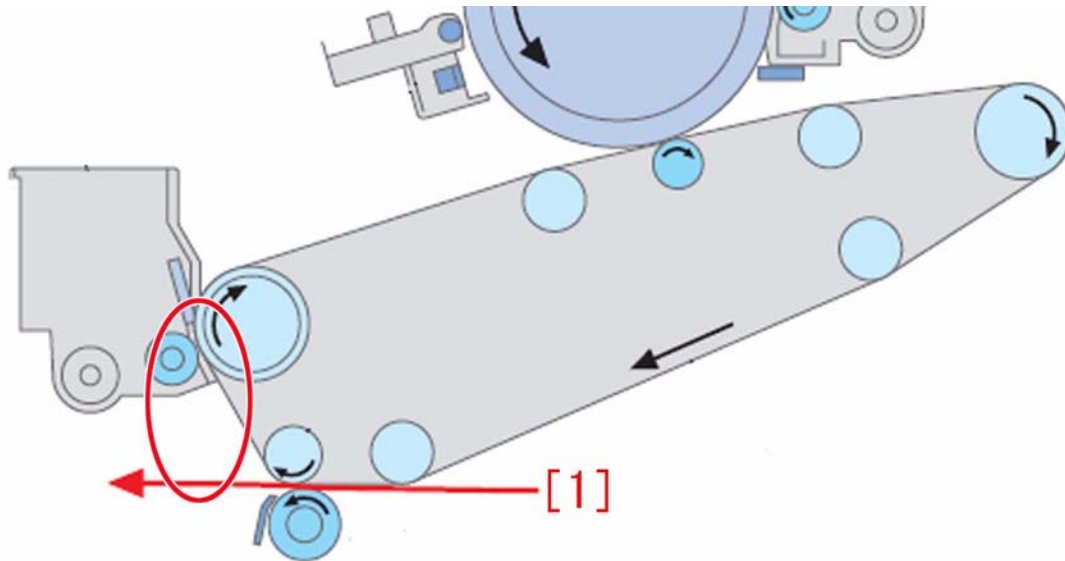
Toner feedability of ITB Cleaning unit was lowered, and toner dropped onto paper[1] to occur stained image.

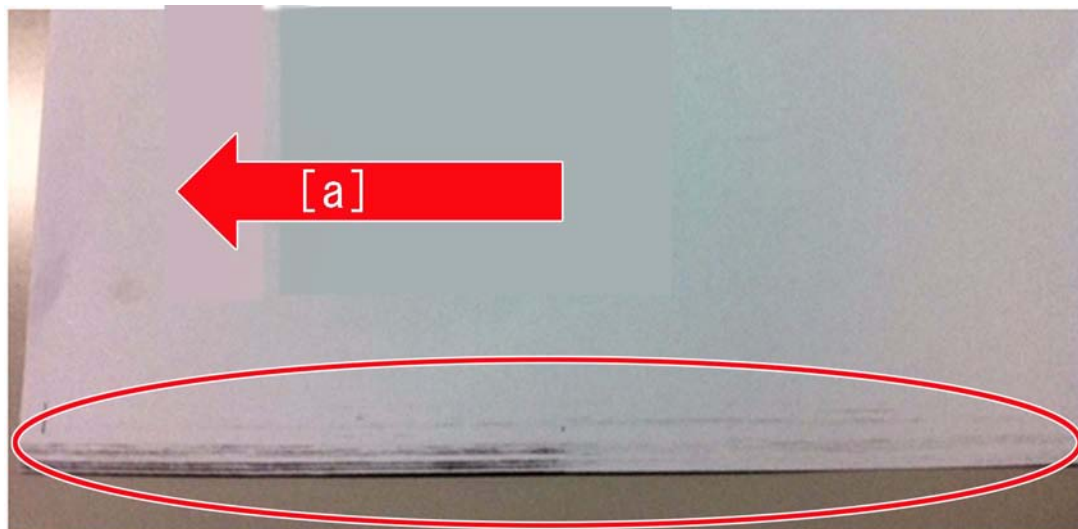
Streak stain appeared in the sub scanning direction [a].

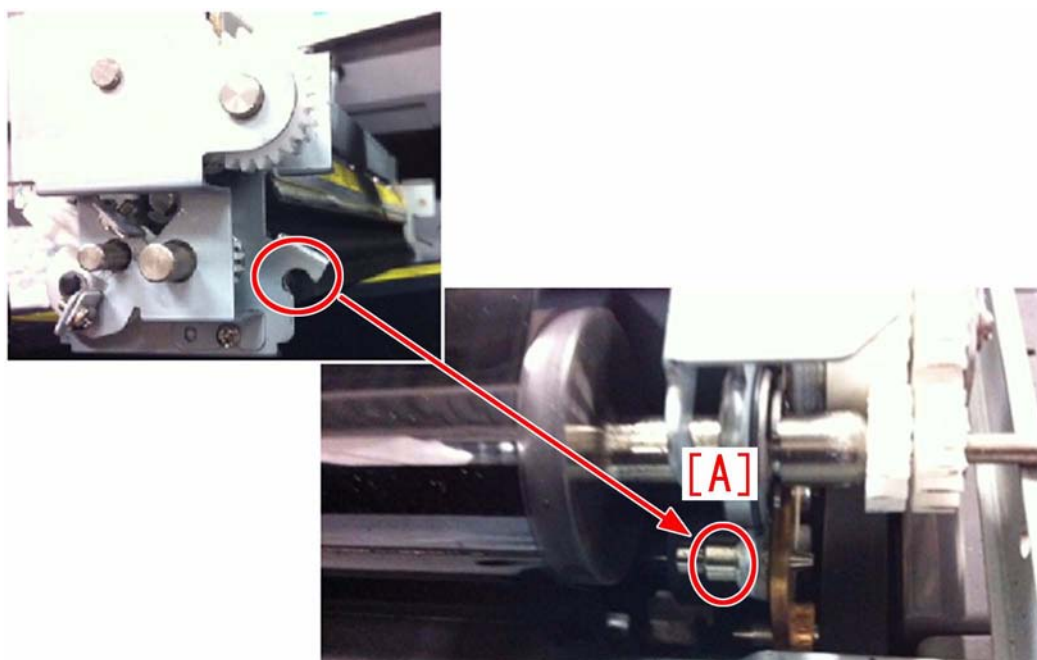
Faulty ITB cleaning occurred due to the state [A] wherein the ITB cleaning unit was poorly mounted. In addition, overflow of waste toner occurred due to the state [B] wherein drive was not transmitted to the magnet roller's drive gear.

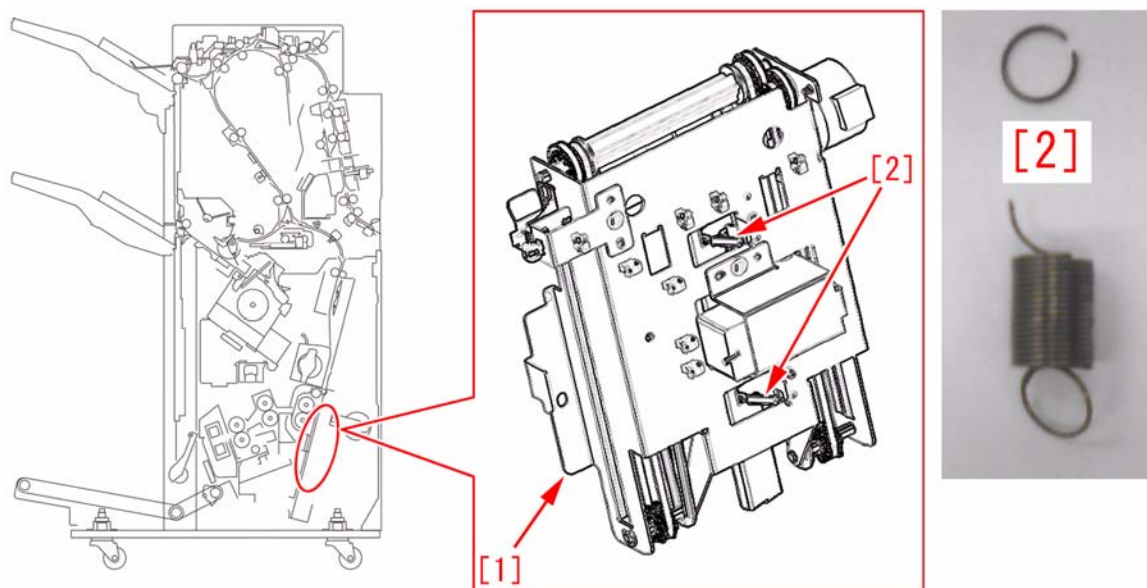
As the tension spring[2] of the edge stopper unit[1] is broken, the balance between upper/lower stopper is lost, and then paper does not stop at the proper position. The photo shown below is the broken tension spring[2].

15) Install in the reverse order from the step of 12).
[Replacement part]
FU8-2270 SPRING, TENSION

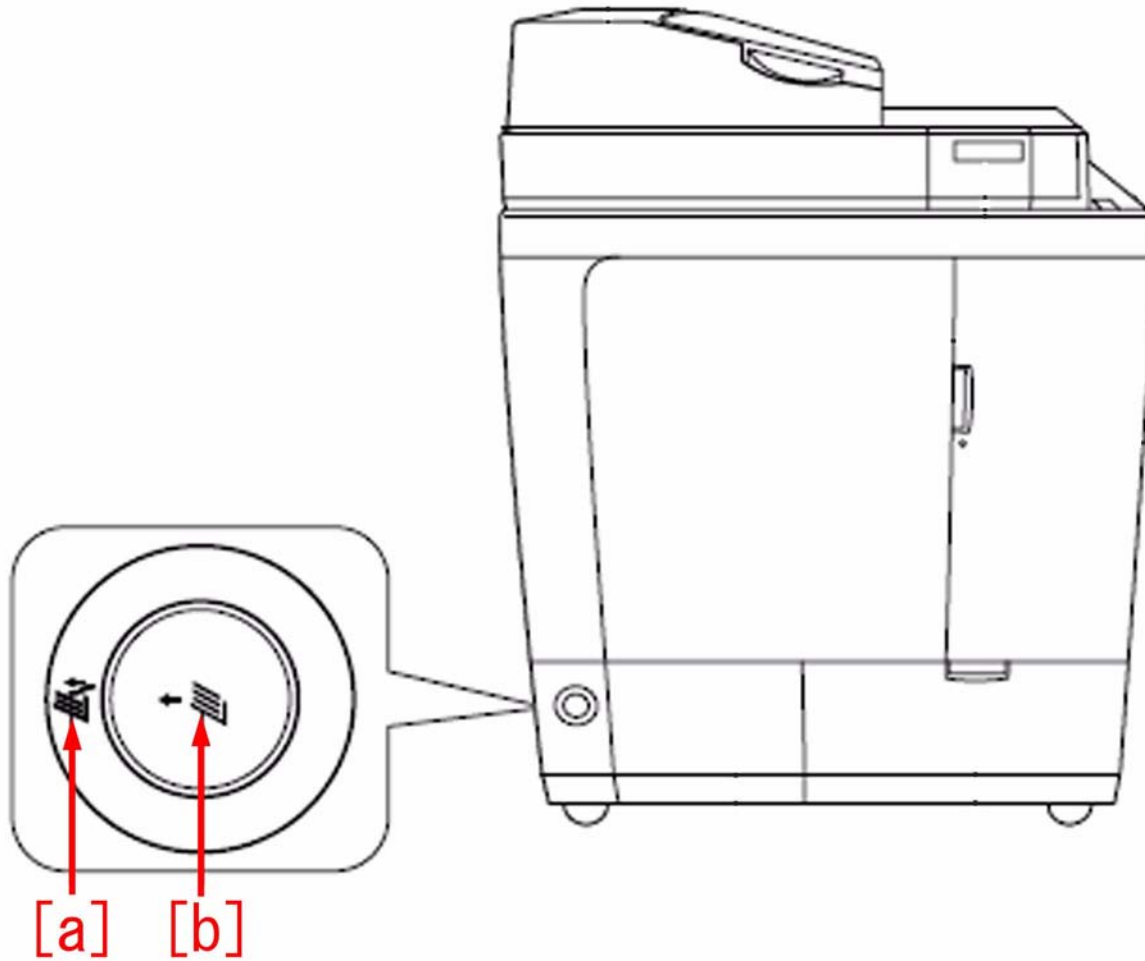
In the system software BND-TRIM Ver.2.01 or later for the Perfect Binder-C1, the loading status indicator [a] lit even though the stacker was not full. [b] is the stacker open button LED.

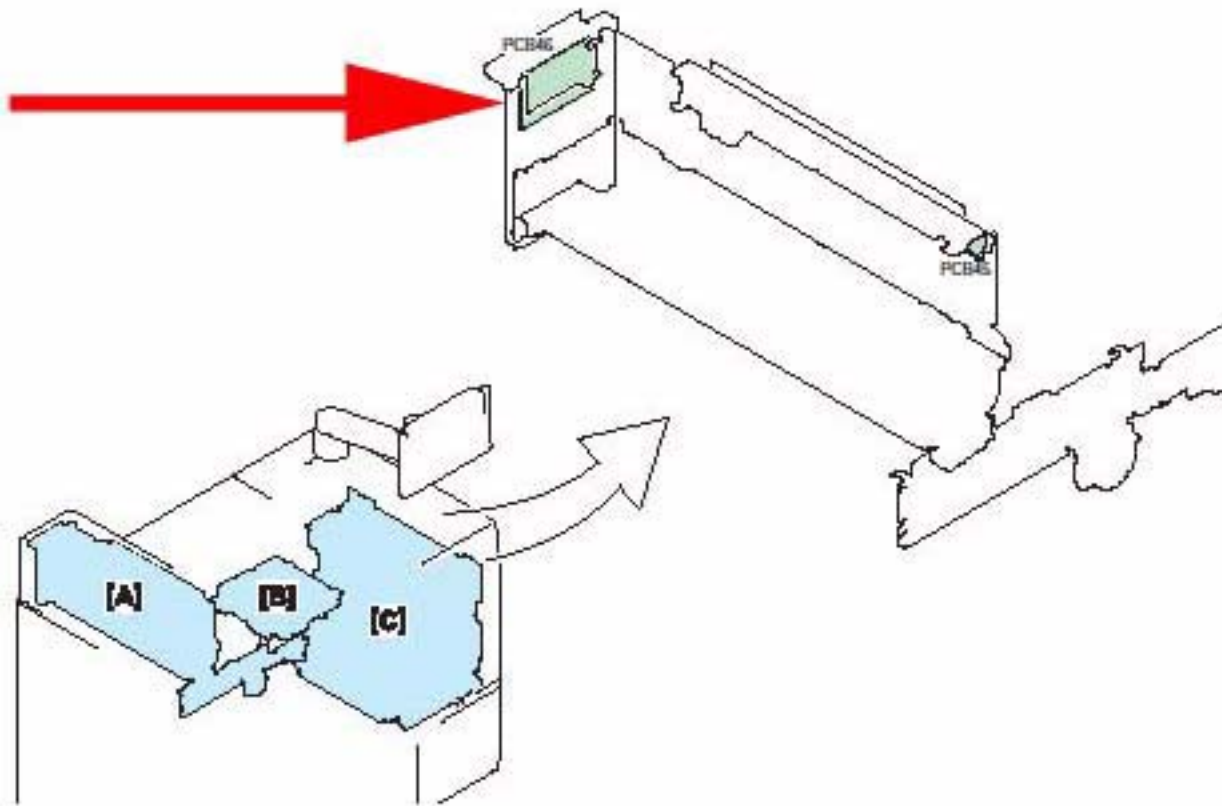
The solution was to replace both the Hopper Driver PCB (FM3-5243) and Hopper Motor M3 (FK3-0824). The following image shows the location of the Hopper Driver PCB.

FM3-5243 HOPPER DRIVER PCB ASSEMBLY
FK3-0824 MOTOR, DC

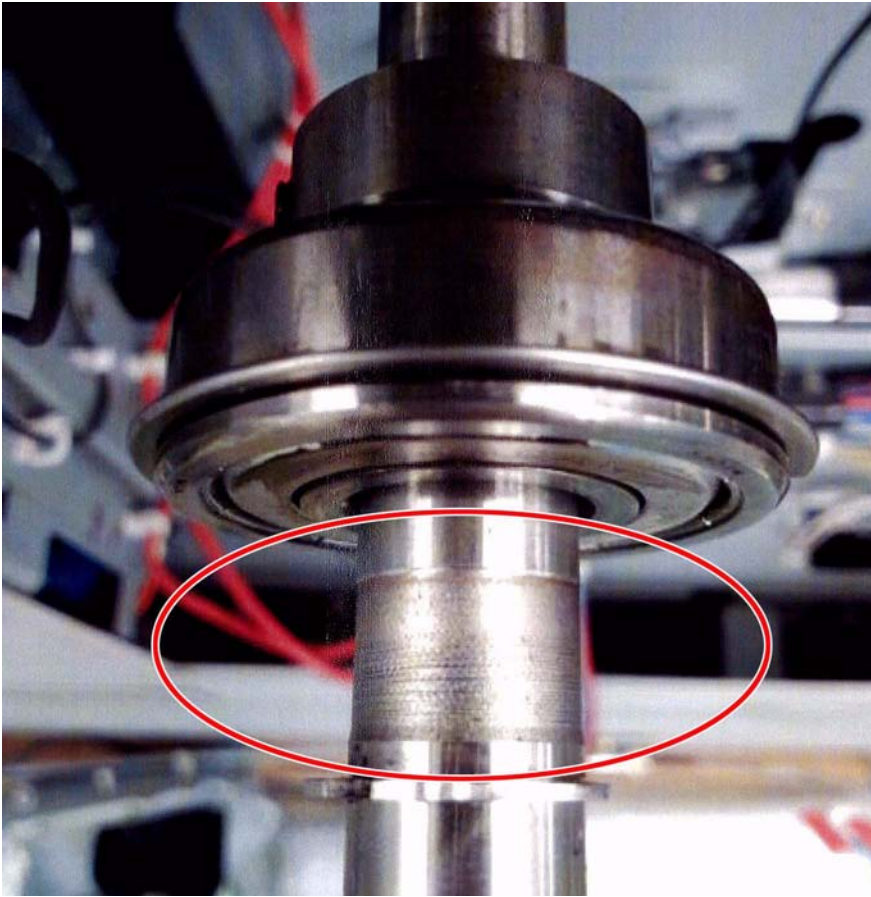
A field issue of drum shaft shaving occurred in a unit installed with the new type drum shaft assembly.

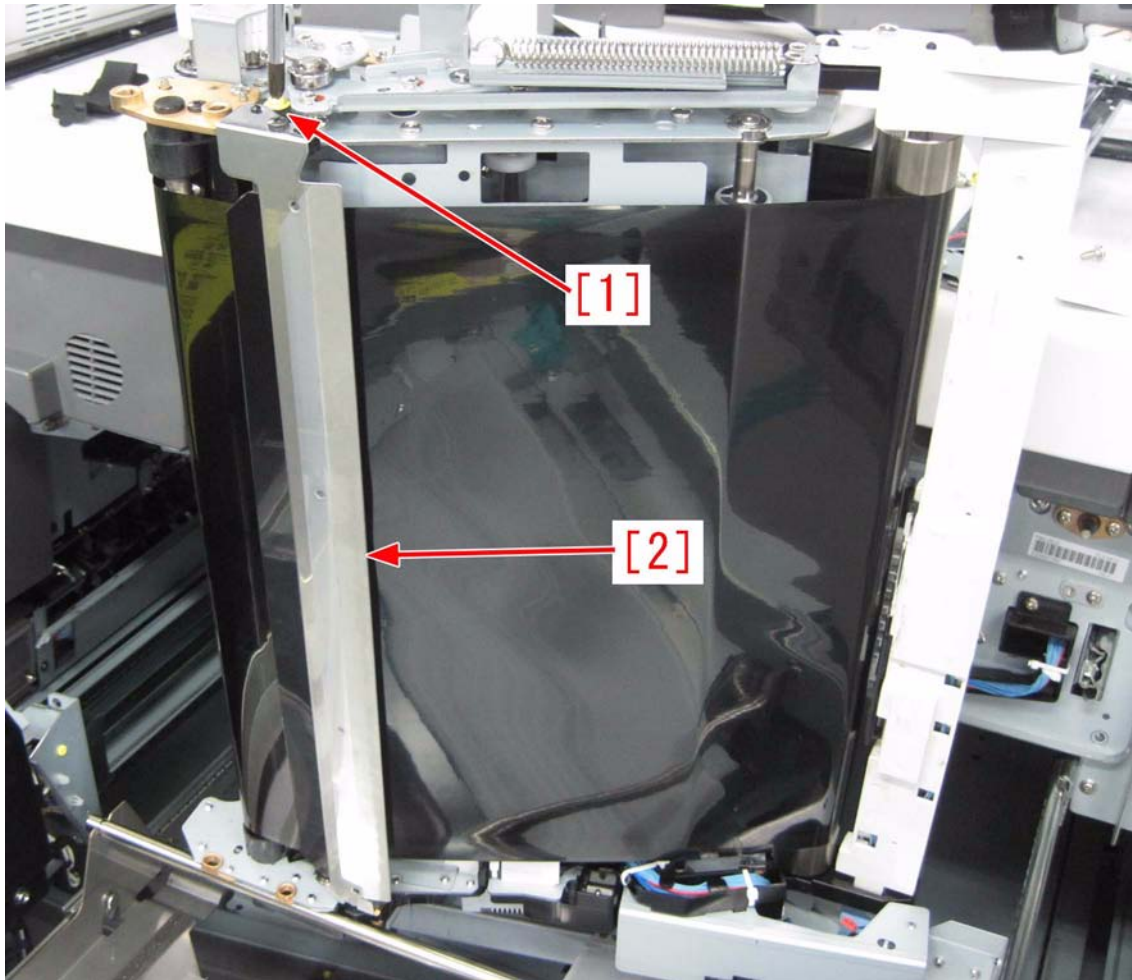
As a result of breakage of the entrance upper holder (front) [1], the secondary transfer inlet upper guide [2] interfered with paper passage, thereby causing jam.

[Replacement Part]
FC7-9252 HOLDER, ENTRANCE UPPER, FRONT

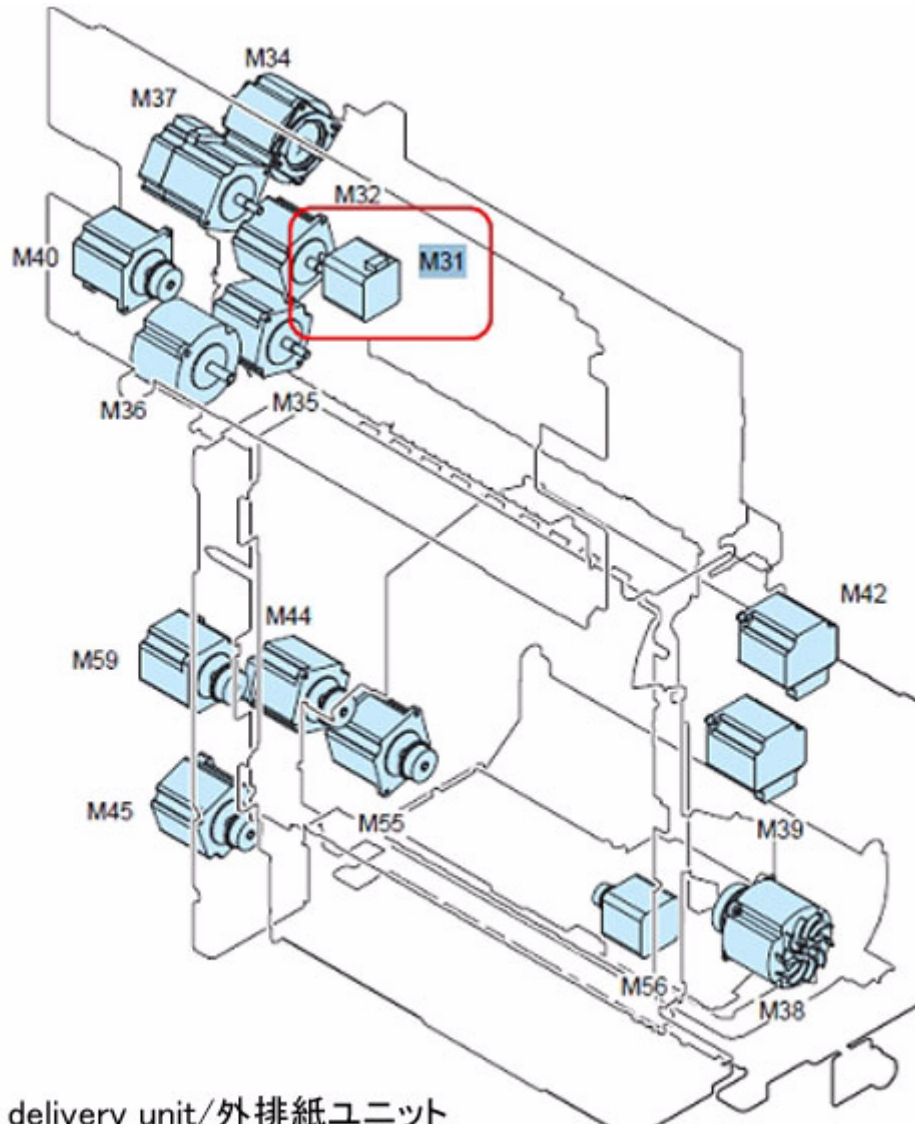
Found loose connection on M31 Delivery Switch Motor. This motor controls the deflector for face up & face down output.

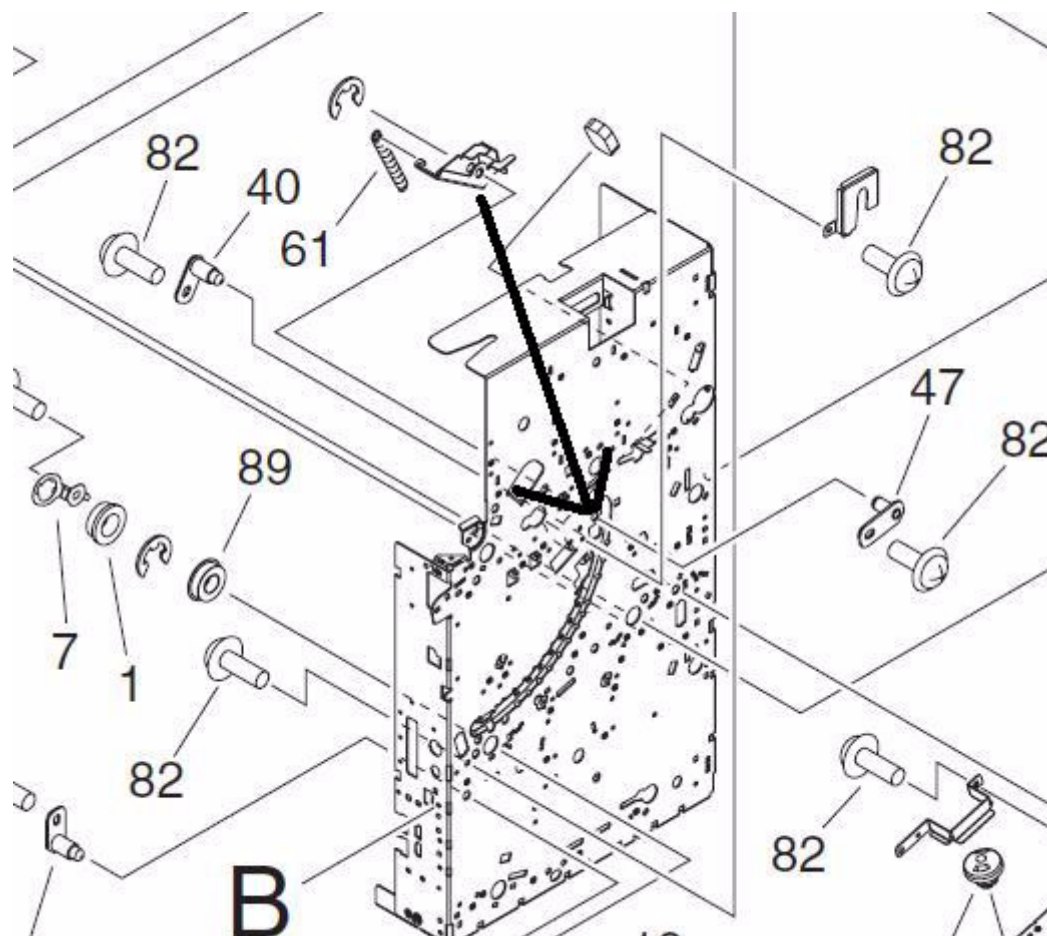
The cause of this jam code can be due to a bent Cam Plate located on the rear frame of the pre registration feed assembly. The bent guide will not allow the C-B4 inlet guide to lift fully and engage the feed rollers with the idle rollers. Due to the lack of drive the paper will slow at PS27 and not pass within the timing window resulting in the jam code of 0206.

FC7-8797 PLATE, CAM

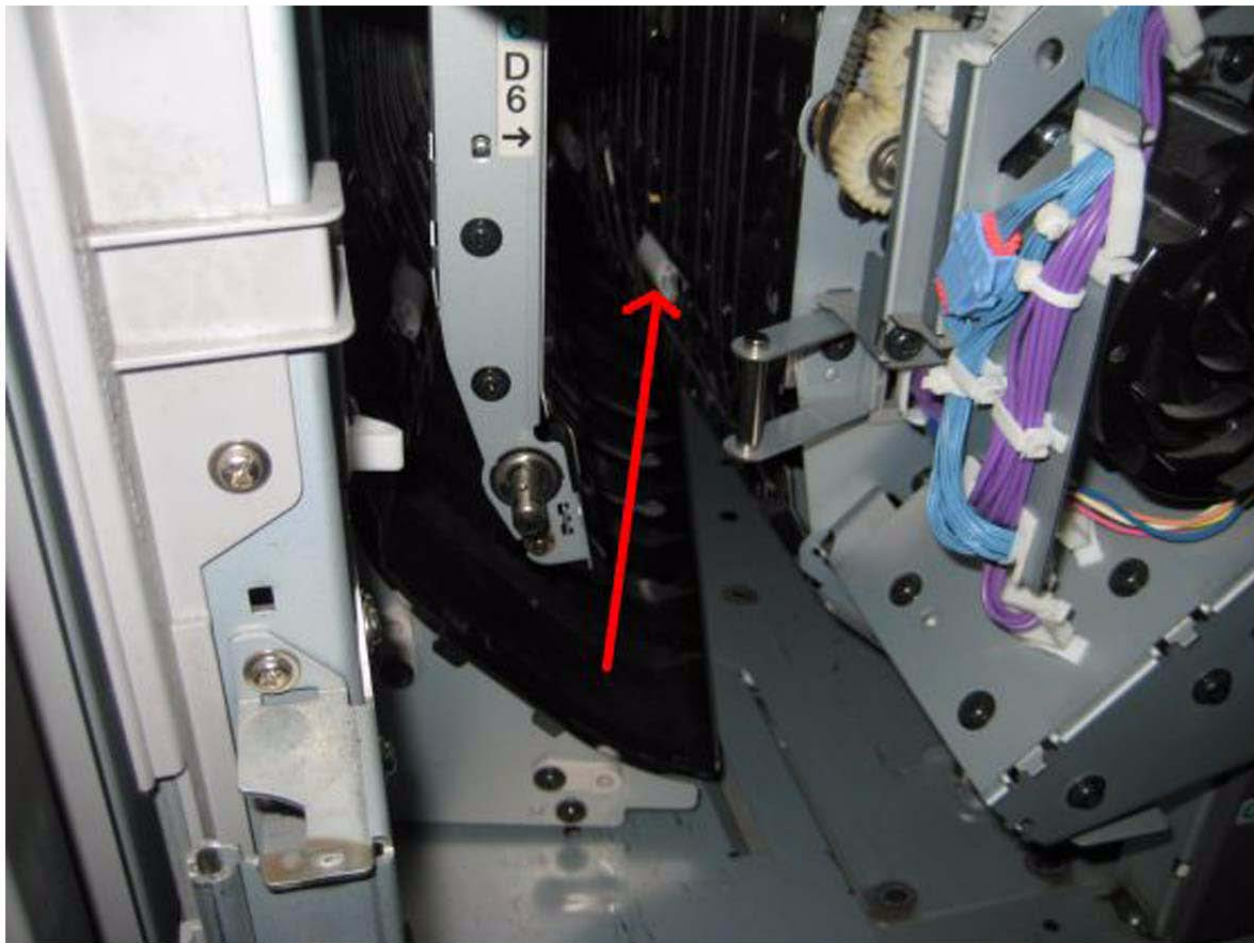
The lower tension roller located in the front delivery buffer unit can seize and cause the leading edge of the copy paper to stall and jam. Remove and clean the tension roller and the tension roller bushings. The tension roller can be viewed at Figure 357 item #21. View the attachment for a photo of the tension roller.

FC8-6557 ROLLER, DRIVEN
FC9-4832 BUSHING

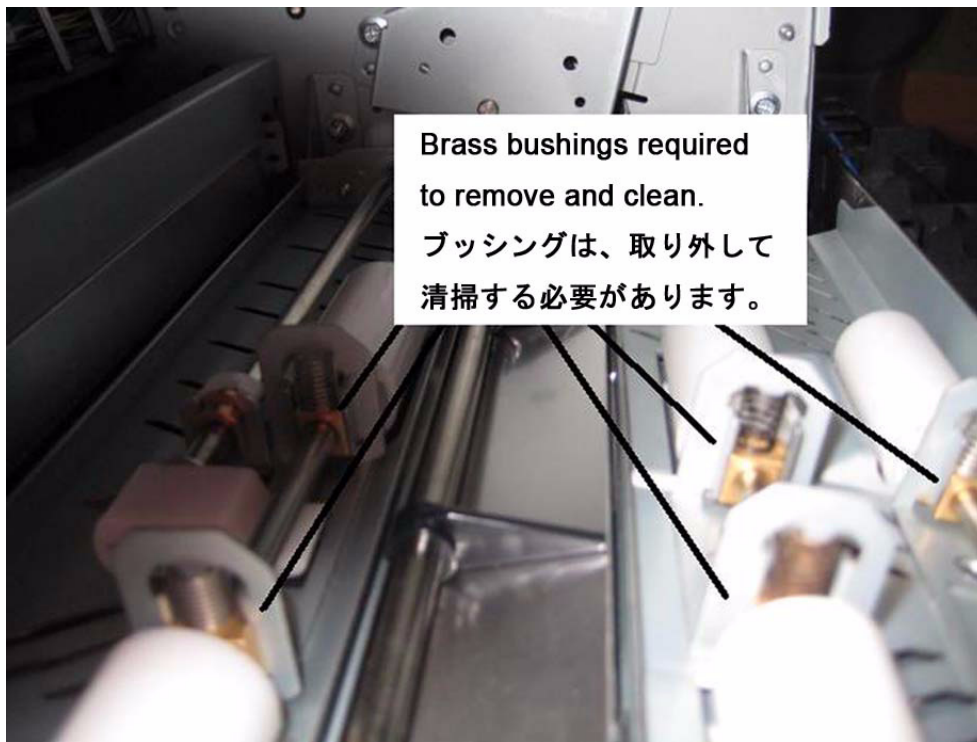
The cause of the jam is due to the white idle rollers not rotating properly and causing the paper to slow down in the paper path. A build up of paper dust and dirt will form in the brass bushings that hold the shafts of the idle rollers and can slow down or completely bind the idle rollers. To resolve the issue remove the bushings and shafts and clean the internal surfaces of the brass bushing to remove the build up.

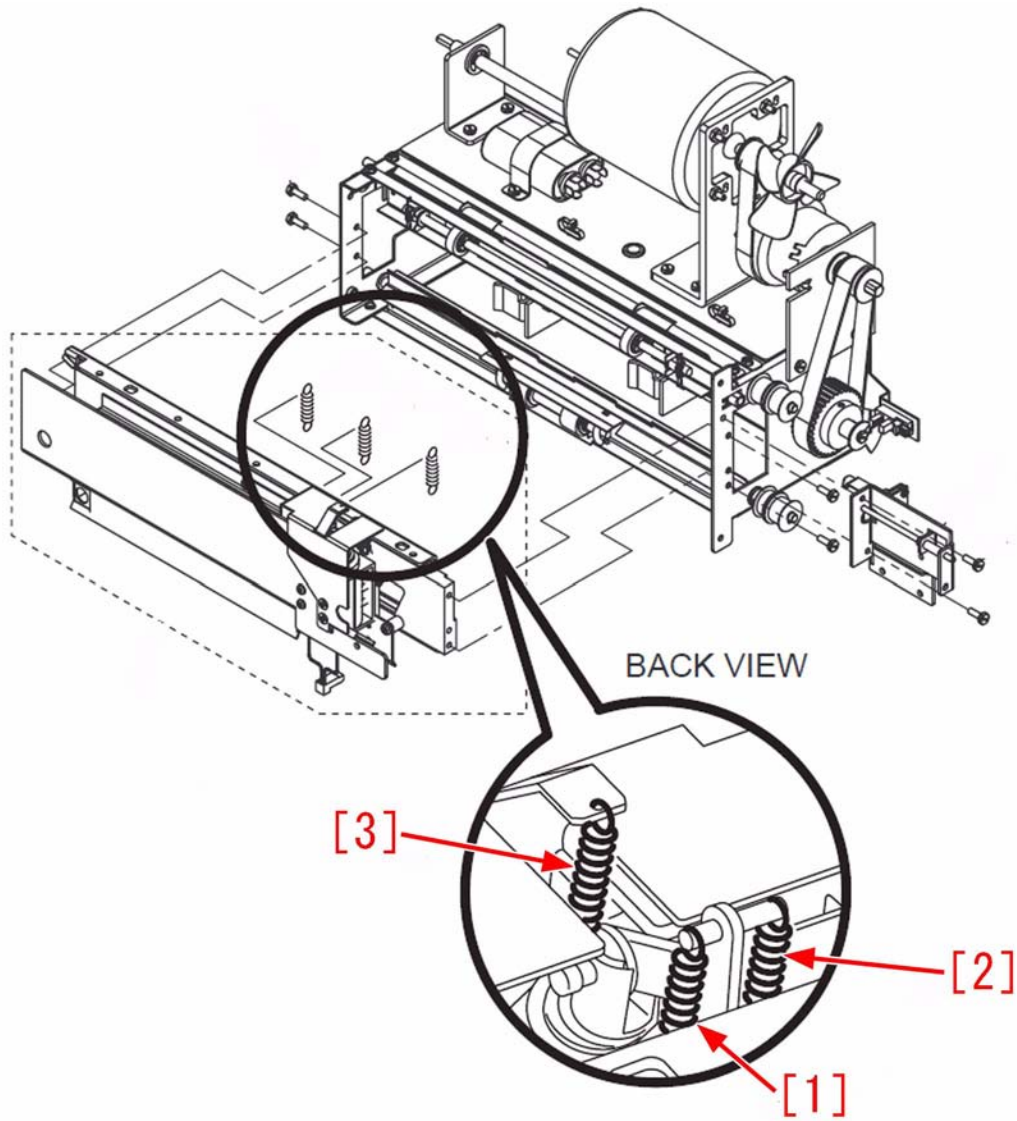
The jam occurred due to operational defect of the back gage caused by breakage and detachment of the brown spring [1] attached to the back gage unit. [Reference] The same symptom occurs when the red spring [2] or the blue spring [3] is detached.

[Replaced Part]
 FC3-6713 BLOWN TENSION SPRING
 [Added Part]
 FY9-6005 GREASE, SUPER LUBE

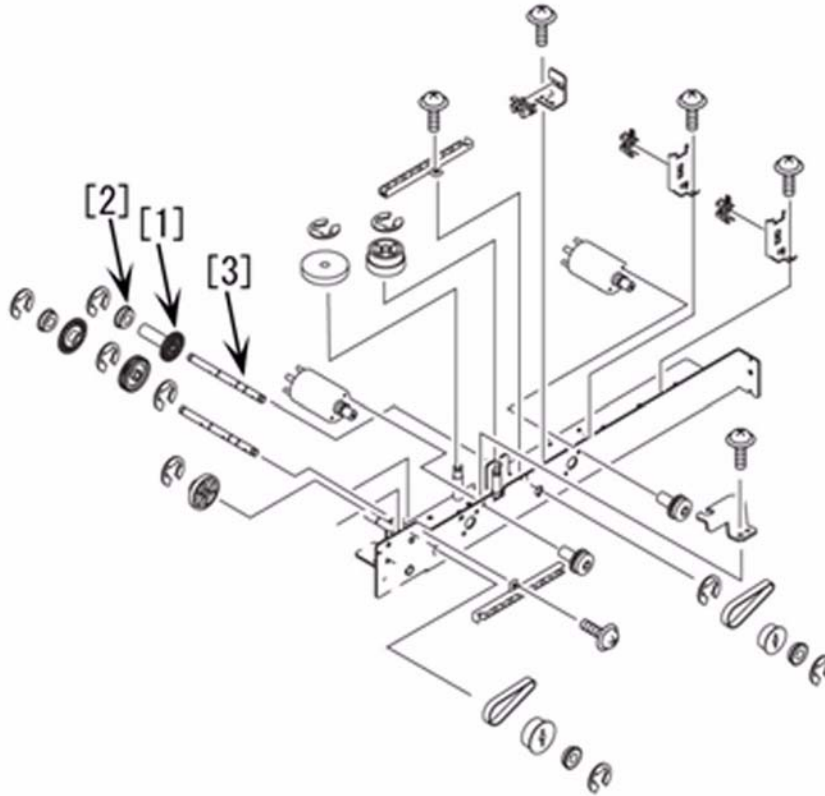
F-1-33

This caused falling out of the Bushing [2]
