YASHICA FIXES FIXES REPAIR MANUAL

YASHICA CO., LTD., TOKYO

ASSEMBLING CHART

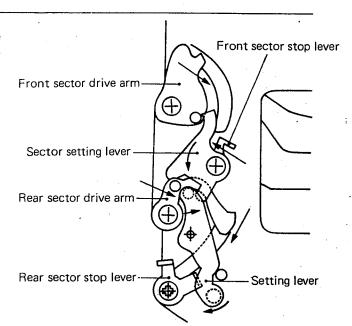
Sector Setting

Faults that may occur Setting failure.

The stop levers do not plunge into the arms. (Due to short setting, or moving failure of the stop levers.) In this event, viewing from the film side, the rear sector returns (ascends) when the winding lever returns.

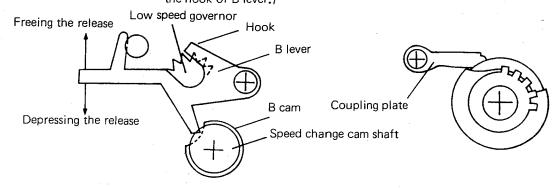
Operation of Bulb

The shutter fails to close. Bulb skipping

Because of the flatness of B lever being dissatisfactory, it does not return.

(Change the release-position by SR lever (3) below the body. Change the bending angle of the hook of B lever.)

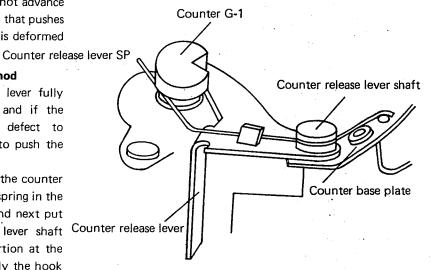
Operation of Counter

The film counter does not advance when making the winding lever operate, and the latter half of the film counter slips. (It will advance while pressing the back cover.)

Although the counter G-1 engages the counter gear, yet the former slips and does not advance because the counter release SP is soft that pushes the counter G-1. (In case the spring is deformed during installation.)

- Check whether the counter release lever fully operates toward the counter G-1, and if the former is deformed, repair the defect to strengthen the force of the spring to push the counter G-1.
- First put the part of spring to press the counter G-1 against the latter, and place the spring in the catch of the counter release lever and next put the spring in the counter release lever shaft Counter release lever making a little free the wound portion at the central part of the spring, then apply the hook on the opposite side to the film counter base.

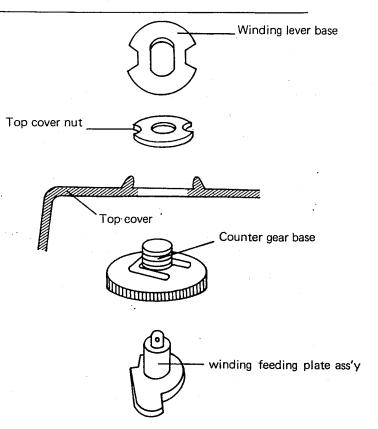
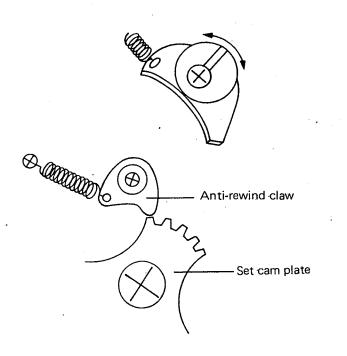
Faults that may occur

When operating the winding lever all the way, it comes to be out of order, so that it does not return by use of spring tension.

Because the check anti-rewind claw fails to free from the set cam plate when operating the winding lever for winding.

Remove the bottom cover, a little loosen the check anti-rewind claw caller SS, make the eccentric check anti-rewind claw caller rotate, and tighten the check anti-rewind claw caller SS while fixing the slotting part. The above operation should be repeated until a perfect operation is obtained.

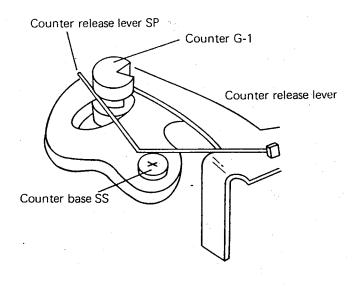
When the counter counts 36 frames or less and then the back cover is opened, the counter is not reset.

- When forcibly tightening the counter G-1 before it completely enters the hole in case the counter base is installed, burrs are produced, so that malfunction of the counter G-1 is caused.
- The counter release SP is clamped by the counter base SS with the result that malfunction of SP is caused.
- Any blistering part of the sticked counter name plate touches the top cover with the result that the adhesives are pressed out and touches the counter SP hook.

- 1. When the movement of the counter G-1 is not smooth, replace it.
- 2. After tightening the counter base, hook SP.
- 3. If the name plate is blistering, peel off the name plate, remove the adhesives completely, and then re-stick the name plate.
