## A FLIGHT TEST EVALUATION OF THE LET L-33 SOLO SAILPLANE

By Richard H. Johnson, Published in *Soaring Magazine*, July 1995

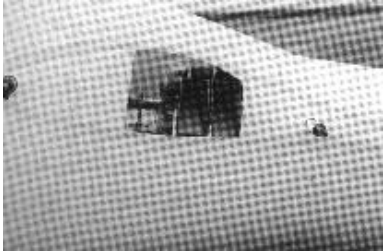
*Photo 2: Fuselage wing attachment area, showing wing spar opening, forward and aft shear pins, and aileron and airbrake automatic control connection sockets.*

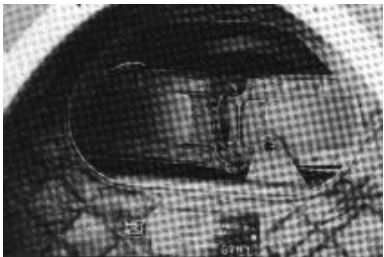
*Photo 3: Aluminum wing spars joined at the fuselage centerline behind pilot by 2 longitudinal steel shear pins. Bracket forward of left wing spar retains that wing during assembly/disassembly operations.*

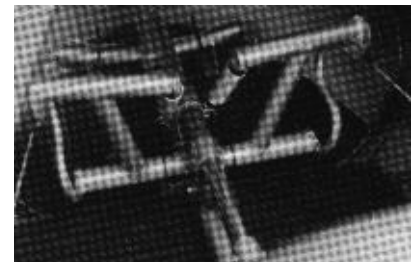
*Photo 5: Inflight adjustable rudder pedals, ahead of instrument pedestal.*

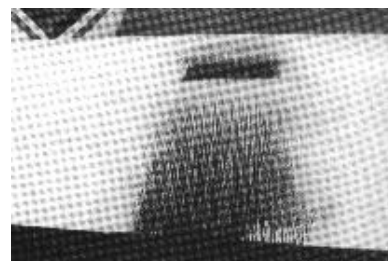
Photo 8: Oil flow on top surface of right wing near fuselage. Dark oil band behind main wing spar indicates a separation bubble, followed by high shear turbulent flow to trailing edge.

After that, oil flow studies were performed on the wing. Dirty 10W-40 motor oil was sprayed on the left wing upper and lower wing surfaces at 4 spanwise stations, starting near its root and ending near the tip. The L-33 was then flown by Steve for about 24 minutes at airspeeds between 50 to 60 kts. The oil flow patterns formed well during that flight, and they indicated that low drag laminar flow was being achieved on both the top and bottom surfaces, from the leading edge aft to about half of the wing chord. Laminar flow was also indicated in the sanded down paint ridge areas. Normal laminar-to-turbulent airflow transitions were shown near the 50% chord locations, and no significant separation bubbles were indicated, except on the bottom surfaces ahead of the ailerons. If turbulator strips were installed slightly ahead of the bubble leading edge, a further improvement of the L-33's performance is possible. Unsuitable weather prevented that testing for the present time.
