**MARKING TESTS TO CERTIFY PART
IDENTIFICATION MARKING PROCESSES FOR USE IN
LOW EARTH ORBIT (LEO)**

OCTOBER 11, 2005

Donald L. Roxby

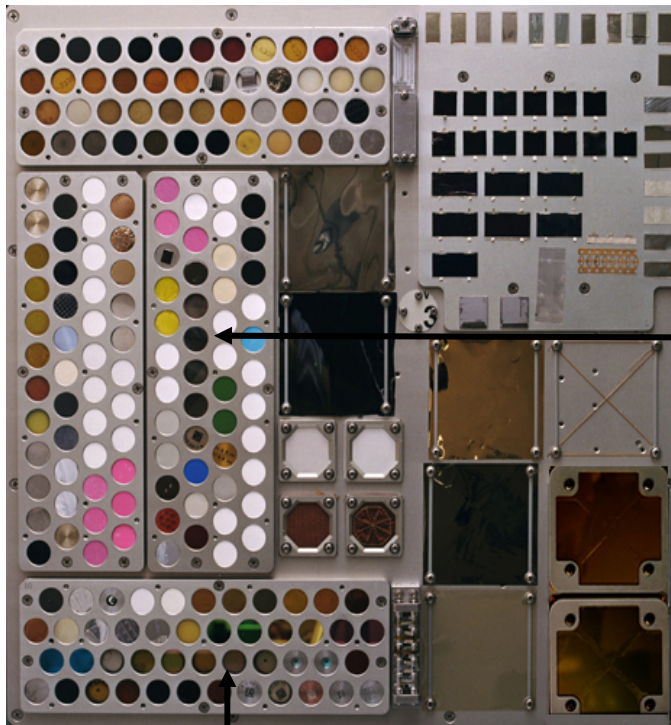
MISSE 1, Tray 1, Top

The marked disks selected for flight were installed onto Experiment Holders EOIM 3 and EOIM 4 on the top side of the Atomic Oxygen (AO) and Solar Tray 1, MISSE 1, PEC 1 and onto Experiment Holders EOIM 10 and D2 on the top side of the Ultra Violet (UV) Tray 2, MISSE 2, PEC 2.

EOIM 3 Holder

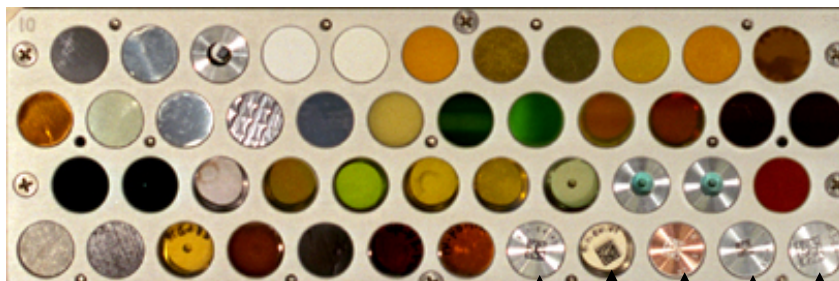
EOIM 4 Holder

E4-42
E4-43
E4-44
E4-45
E4-46

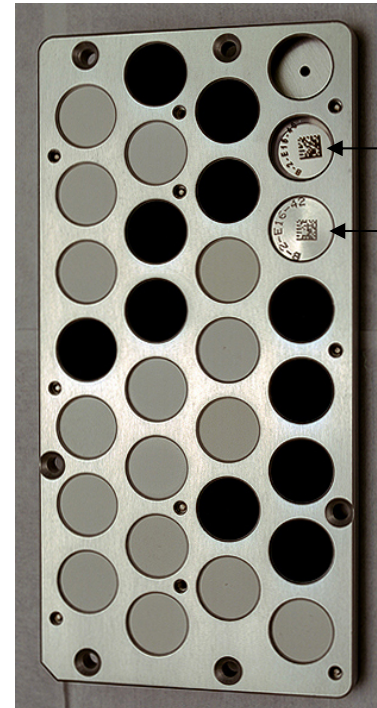
MISSE 2, Tray 2, Top

D2 Holder

E16-42

E16-43

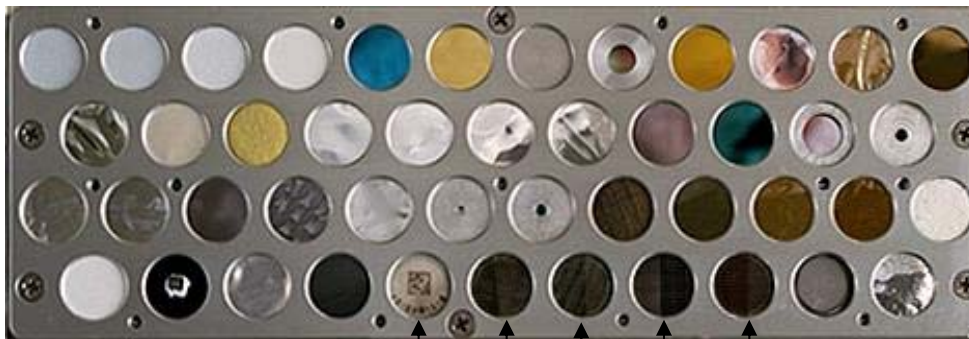
EOIM 10 Holder (Flipped Horizontally)

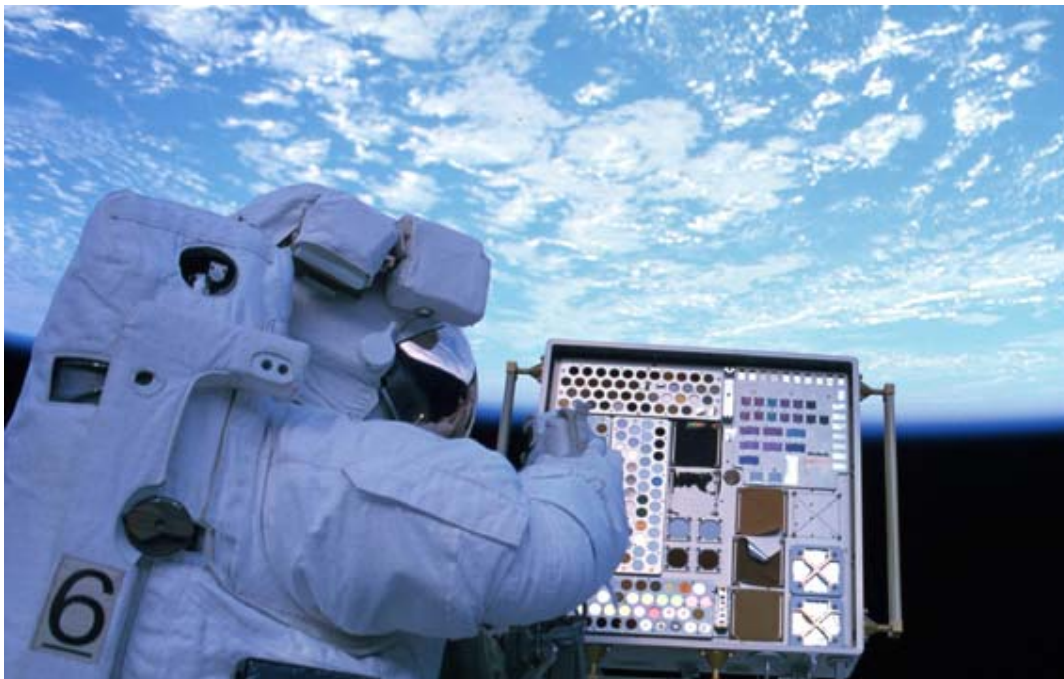
Shuttle Astronauts visited the MISSE experiments to make observations and to take photographs while MISSE 1 and 2 were in orbit. These Extra Vehicular Activities (EVA's) were made to the experiments in September, October and December of 2001; February, April and October 2002; and March, April and August of 2003. The part identification markings included in the MISSE experiments were clearly visible in many of the photographs and appeared to be readable.

Data Matrix Symbols Still Clearly Visible

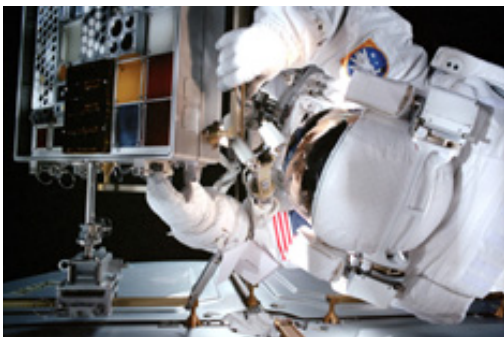
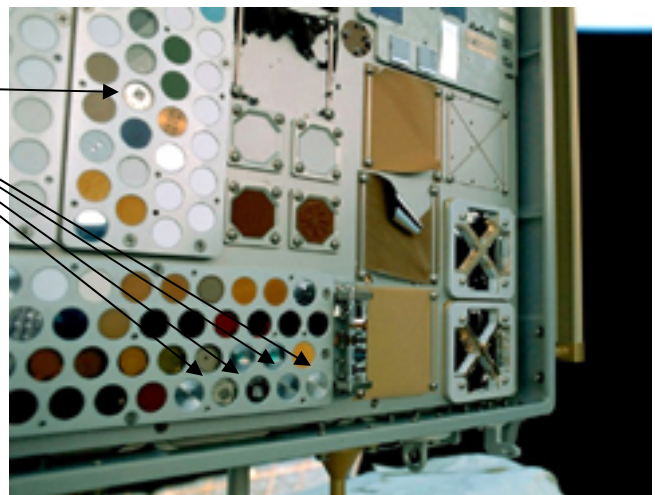
August 2003 EVA Photograph

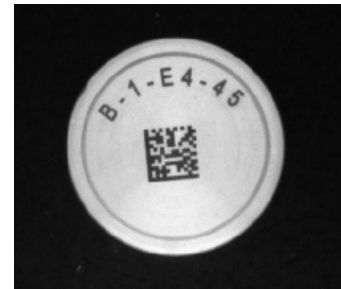
**GALE
B-1-E4-45**

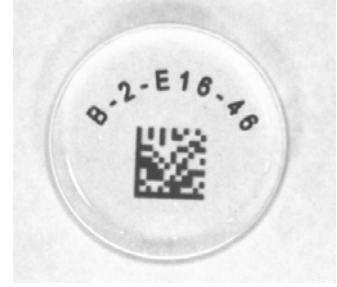
LIVD - Tin
B-2-E16-46

3. Require that markings applied to glass substrates using Laser Inducted Vapor Deposition (LIVD) process be applied to the interior (unexposed) side of the item.

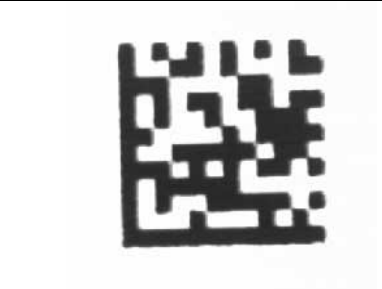
% Contrast A Axial Uniformity A Print Growth A Error Correction A Overall Grade A
B-1-E4-42 Laser Bonding

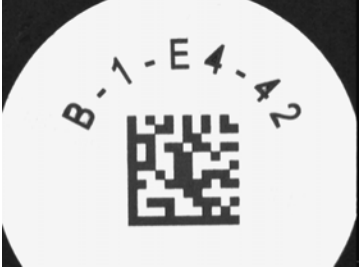
% Contrast A Axial Uniformity A Print Growth A Error Correction A Overall Grade A

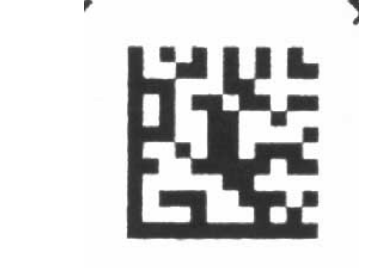
% Contrast A Axial Uniformity A Print Growth A Error Correction A Overall Grade A

Table 3 – Pre-Flight/Post Flight Marking Comparison - MISSE 1 & 2

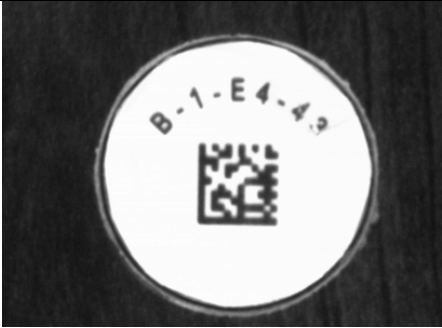
Sample Number	Marking Comparison			
	Pre Flight Mark Photograph	Pre Fight Verification Grade	Post Flight Mark Photograph	Post Fight Verification Grade
B-1-E4-43 Laser Bonding

% Contrast A Axial Uniformity A Print Growth A Error Correction A Overall Grade A

% Contrast B Axial Uniformity A Print Growth A Error Correction A Overall Grade B
B-1-E4-44 Laser Coat & Remove - VAVD

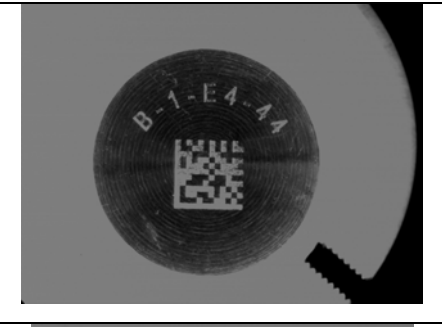
% Contrast A Axial Uniformity A Print Growth A Error Correction A Overall Grade A

% Contrast A Axial Uniformity A Print Growth A Error Correction A Overall Grade A
B-1-E4-45 GALE

The mark quality of specimen number B-1-E4-44 (Laser Coat and Remove – VAVD) improved over the 4 years in orbit. The contrast levels for this specimen increased as the copper colored coating darkened to a dark green as a result of oxidation. This specimen was the only specimen to show signs of micro-partial impact during flight. The impact sites could only be viewed under high magnification and did not have an effect on decoding. This specimen also showed signs of discoloration outside of the marking area, which was attributed to marking process deficiencies caused by contamination in the coating sprayed or on metal at time of coating. This contamination resulted in coating discoloration after exposure to the LEO environment.

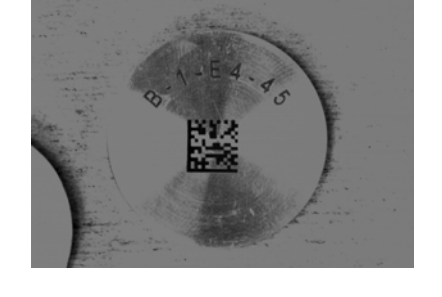
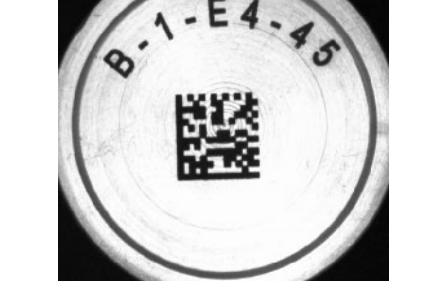
% Contrast A Axial Uniformity A Print Growth A Error Correction A Overall Grade A

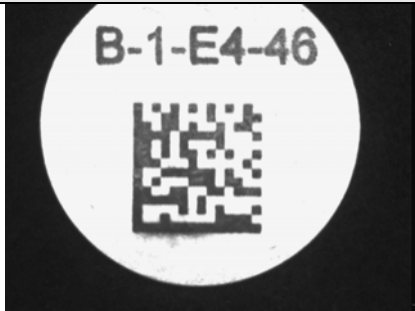
Sample Number	Marking Comparison			
	Pre Flight Mark Photograph	Pre Flight Verification Grade	Post Flight Mark Photograph	Post Flight Verification Grade
B-1-E4-46 Electro-Chemical Coloring

% Contrast A Axial Uniformity A Print Growth A Error Correction A Overall Grade A

% Contrast A Axial Uniformity A Print Growth A Error Correction A Overall Grade A
B-1-E10-03 LIVD - Brass	Line Pattern	Good Contrast – Excellent Line Resolution	Sample being Evaluated by Boeing Phantom Works	N/A
B-1-E10-04 LIVD - Tin	Line Pattern	Good Contrast - Excellent Line Resolution	Sample being Evaluated by Boeing Phantom Works	N/A
B-1-E10-05 Laser Bonding	Line Pattern	Excellent Contrast And Line Resolution	Sample being Evaluated by Boeing Phantom Works	N/A
B-1-E10-06 VAVD - Copper	Line Pattern	Good Contrast – Excellent Line Resolution	Sample being Evaluated by Boeing Phantom Works	N/A

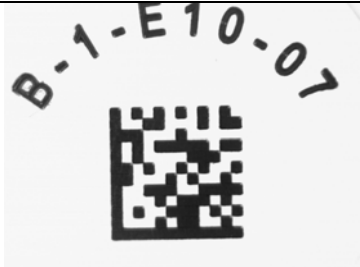
B-1-E10-07 LIVD - Brass

% Contrast A Axial Uniformity A Print Growth B Error Correction A Overall Grade B

All of the Data Matrix symbols flown received passing grades as defined by International Standard Organization (ISO) document ISO-15415 as amended by NASA-STD-6002B. Only one (1) of the flown symbols showed signs of degradation. This was specimen number B-1-E4-43 (Laser Bonding marking process), which showed a slight decrease in contrast, falling from an A grade (≥ 0.50 percent) to a B grade (≥ 0.40 percent). This was attributed to a combination of exposure to strong UV light and atomic oxidation. The B grade is acceptable per the standard, which requires an A or B grade at point of manufacture and remarking in the field after the mark quality verification grade levels fall to a C grade.

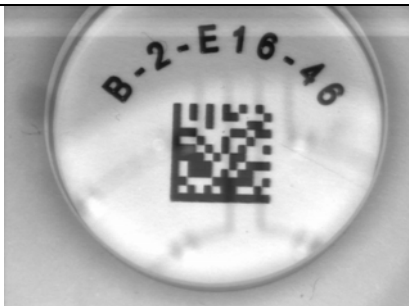
% Contrast A Axial Uniformity A Print Growth A Error Correction A Overall Grade A
B-2-E16-43 LIVD Note: Position reassigned after marking. ID's as B-2-E16-46, flown in position B-2-E16-43

% Contrast A Axial Uniformity A Print Growth A Error Correction A Overall Grade A

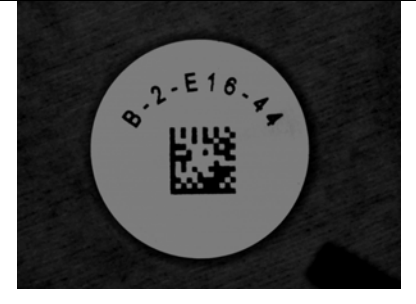
% Contrast A Axial Uniformity A Print Growth A Error Correction A Overall Grade A

Table 4 – Pre-Flight/Post Flight Marking Comparison Continued – MISSE 3 and 4
