EVALUATION OF TIMBER BARRICADES AND PRECAST CONCRETE  
TRAFFIC BARRIERS FOR USE  
IN HIGHWAY CONSTRUCTION AREAS

September 1976  
VHTRC 77-R13

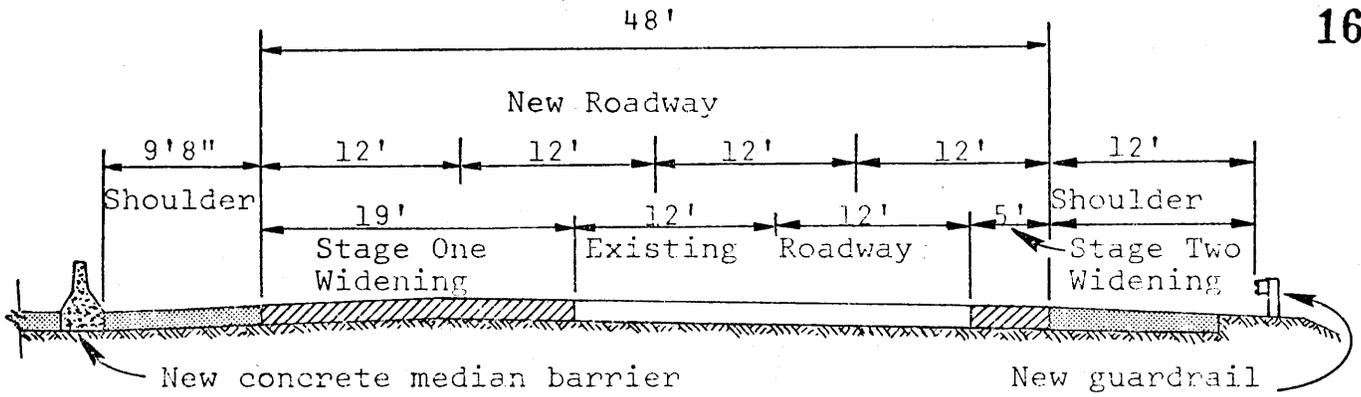
Figure 2. Reconstructed mainline I-495 cross section for one direction of travel.

The widening of the Virginia portion of I-495 to eight lanes is being performed in three construction contracts. Construction contract No. 1 covers the section from the Cabin John Bridge to U. S. Route 50, a distance of 7.64 miles (see Figure 1). The bid price for this contract is \$27,881,216.79, and work commenced in February 1974. Construction contract No. 2 covers the 6.67 miles from U. S. Route 50 to I-95 (see Figure 1). The bid price for the contract is \$22,764,799.20, and work commenced in May 1974. The work required in contract Nos. 1 and 2 consists primarily of adding two lanes in each direction to the existing four-lane roadway and a safety shape concrete median barrier. Figure 2 shows the existing 24' (two 12' lanes) roadway and the 19' widening in the median area and the 5' widening on the right shoulder to achieve the new 48' (four 12' lanes) roadway. Construction contract No. 3 covers I-495 from I-95 to the Woodrow Wilson Memorial Bridge, a distance of 7.79 miles. The bid price for the contract is \$35,748,936.55, and work commenced in November 1974. The work in the third contract consists primarily of adding one lane in each direction to the existing six-lane roadway and a safety shape concrete median barrier.

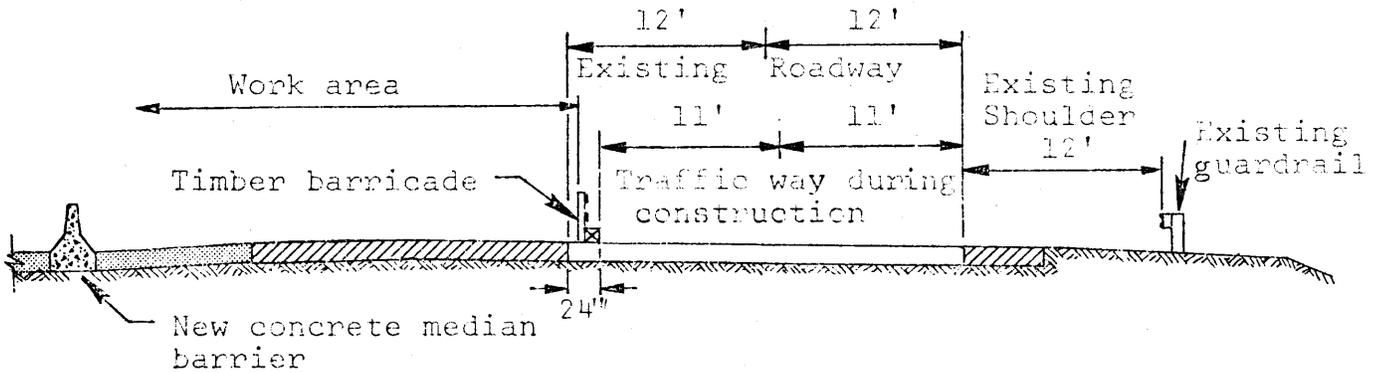
Figure 3. Reconstructed I-495 cross section for one direction of travel during construction stage one.

The widening of I-495 is being accomplished in three stages of construction. Construction stage one consists of widening the roadways within the median area (see Figure 3). Traffic is maintained over the existing roadway and ramps. Construction stage two consists of widening the roadway on the right of the traveled way, and repairing the joints in the existing pavement and overlaying it with a bituminous concrete surface (see Figure 4). During this stage, traffic is maintained on the newly completed paved area within the existing median. Construction stage three consists of accomplishing all tasks that could not be completed in the previous stages.

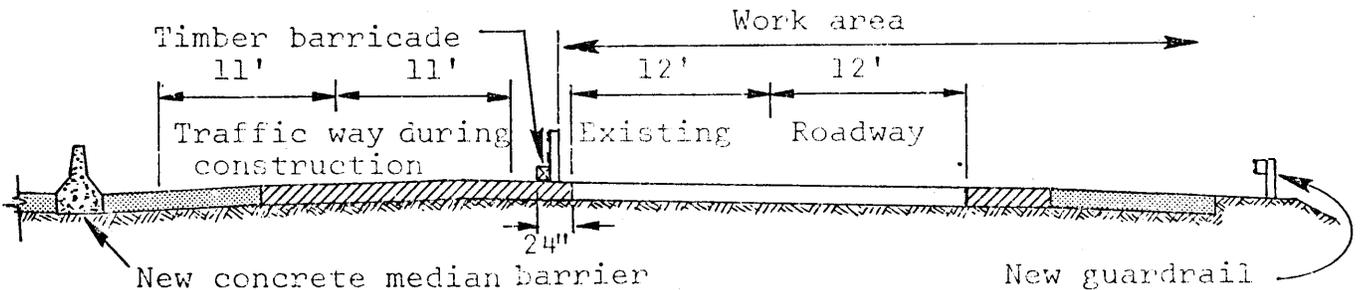
Figure 4. Reconstructed I-495 cross section for one direction of travel during construction stage two.

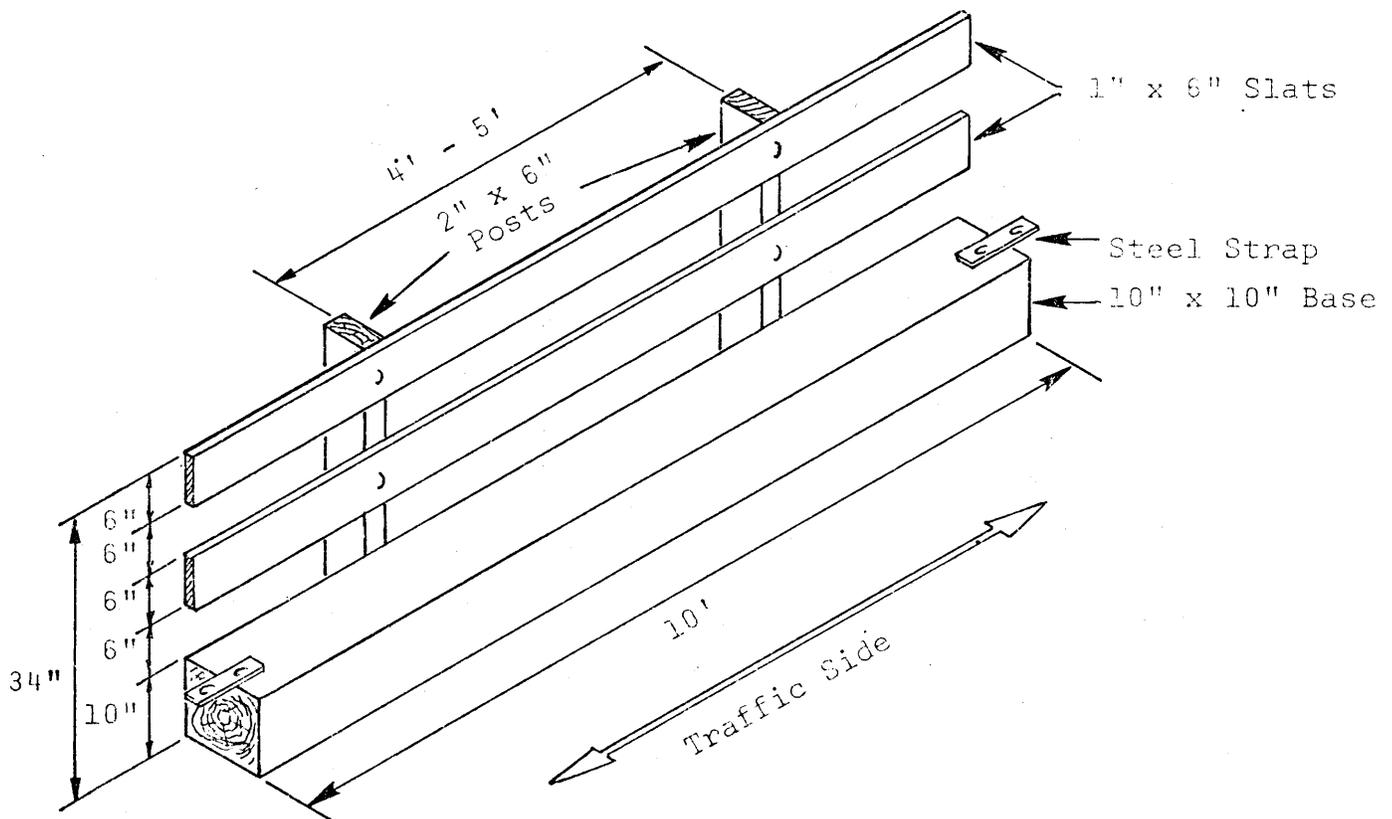
Figure 6. Typical timber barricade used on I-495.

The device chosen to separate traffic and workmen was not new and engineers have generally considered it effective (see Figure 6). For want of a better name it is called a "timber barricade," and it was used for ten years on the widening of the Shirley Highway (I-95 south of Washington, D. C.). In monitoring that use of the barricades, personnel of the Construction Division of the VDH&T had found from field reports of contractors and police, and from personal evaluation, that they seemed to function satisfactorily. Based on the aforementioned consideration of alternative devices and the apparent effectiveness of the timber barricade in the Shirley Highway work, when the VDH&T sent the specifications to the design consultant on July 5, 1972, the timber barricade was designated as the device to use as the delineator and barrier. The design consultants, the engineering firm of Howard, Needles, Tammen and Bergendoff, had employed the timber barricade for widening projects on many high speed, high volume roads, including the Shirley Highway and the New Jersey Turnpike. The firm believed that the timber barricade was an effective device for this type of project and so endorsed its use in the plan submitted to the VDH&T. On April 16, 1973, representatives of this firm, the VDH&T and the FHWA made a field inspection of the first stretch of road to be let for contract. During this inspection it was unanimously agreed that the timber barricade would be employed. (12) The Traffic and Safety Division of the VDH&T checked the final plans and saw no reason for any objection.

The timber barricade was considered to offer good delineation. The 10" x 10" base and horizontal railings at heights of 34" and 22" were painted white, and lights were installed every 75' for delineation during periods when visibility was poor. The obvious mass of the barricade was considered psychologically effective for keeping the traffic stream from traveling close to it. The 16" width of the barricade also made it the thinnest device considered suitable as a positive barrier. Although conceded to be penetrable, it was considered to provide much more protection for drivers and workmen than would cones or other warning devices. To ensure continuity, the barrier units were required to be connected by steel straps nailed into their bases.

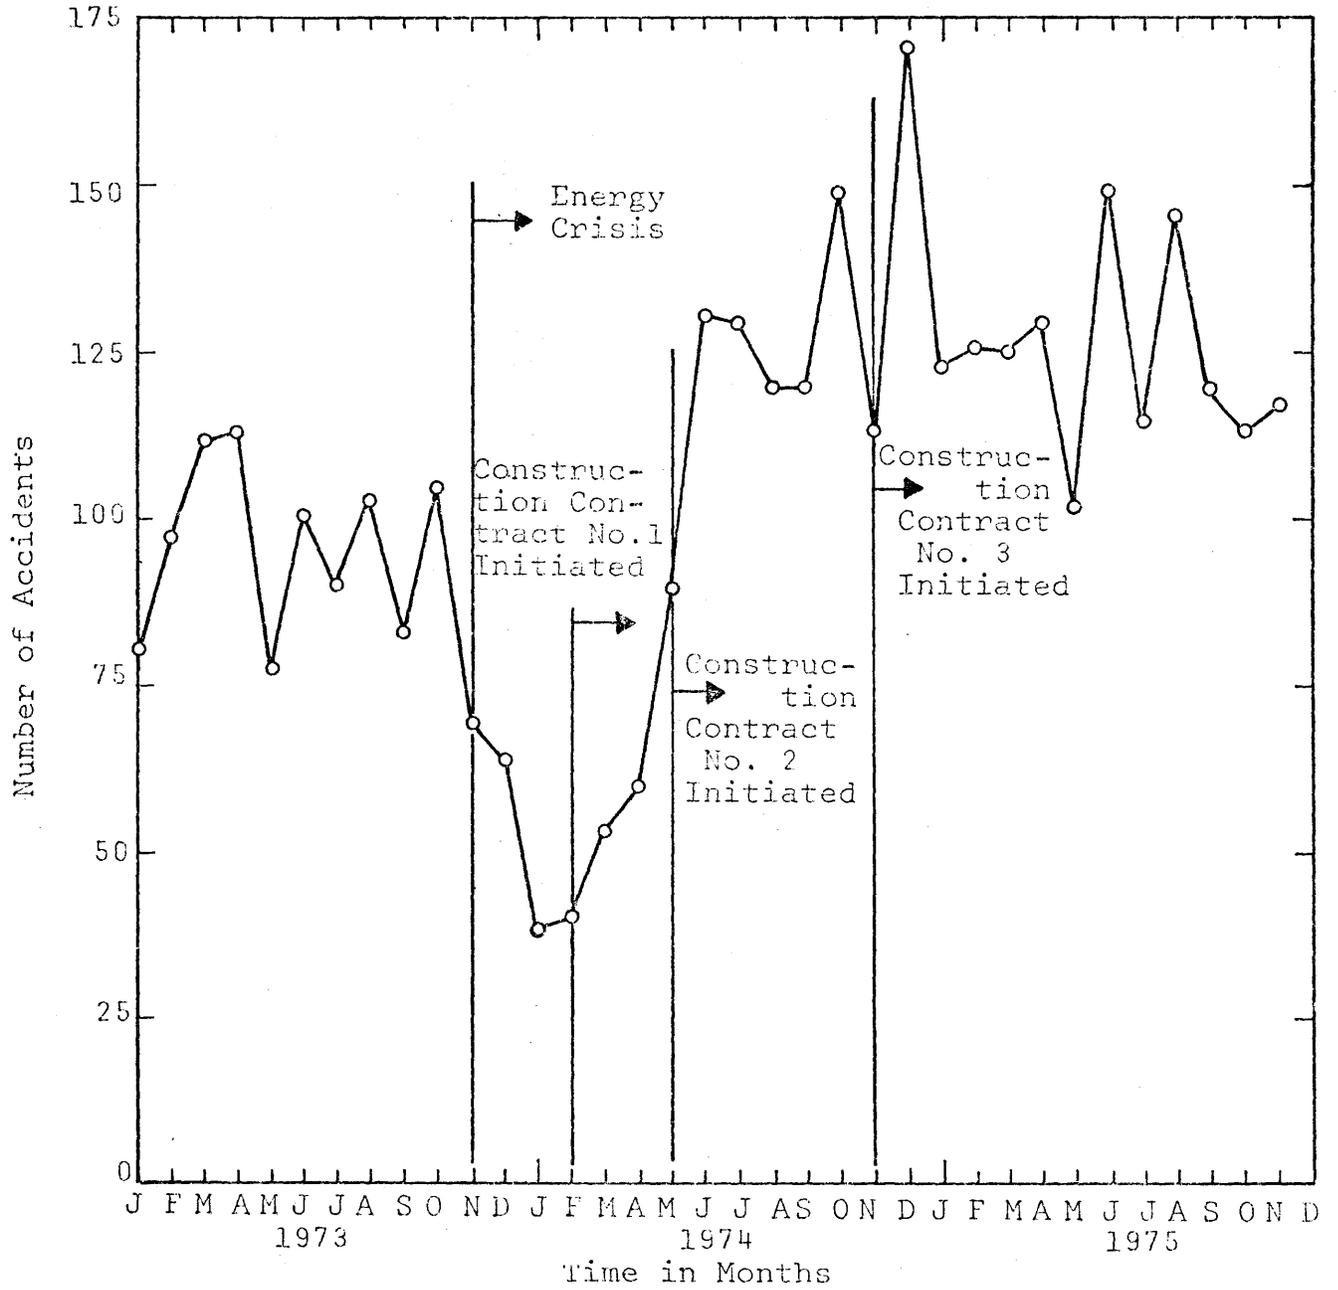
Figure 7. Total number of accidents on I-495 by months.

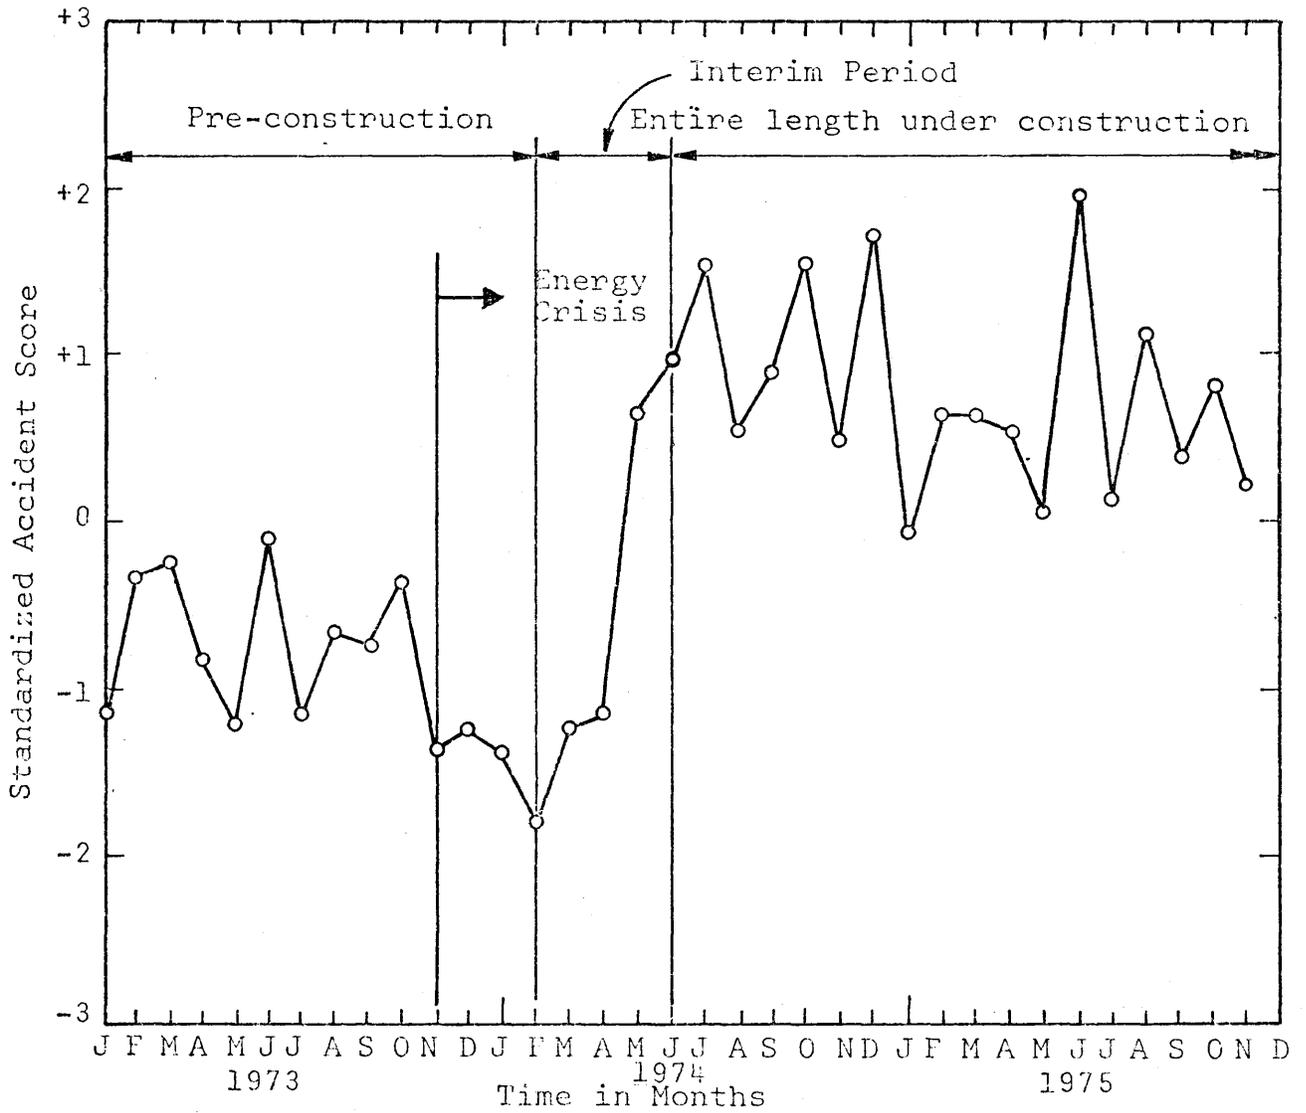
Figure 8. Standardized accident scores for construction contract No. 1.

accidents were converted into standardized accident scores.\* The standardization of numbers of accidents removes the differences in statistical distributions between the three zones, controls for the unique roadway characteristics of each zone, and allows an accurate comparison of the accident trends.

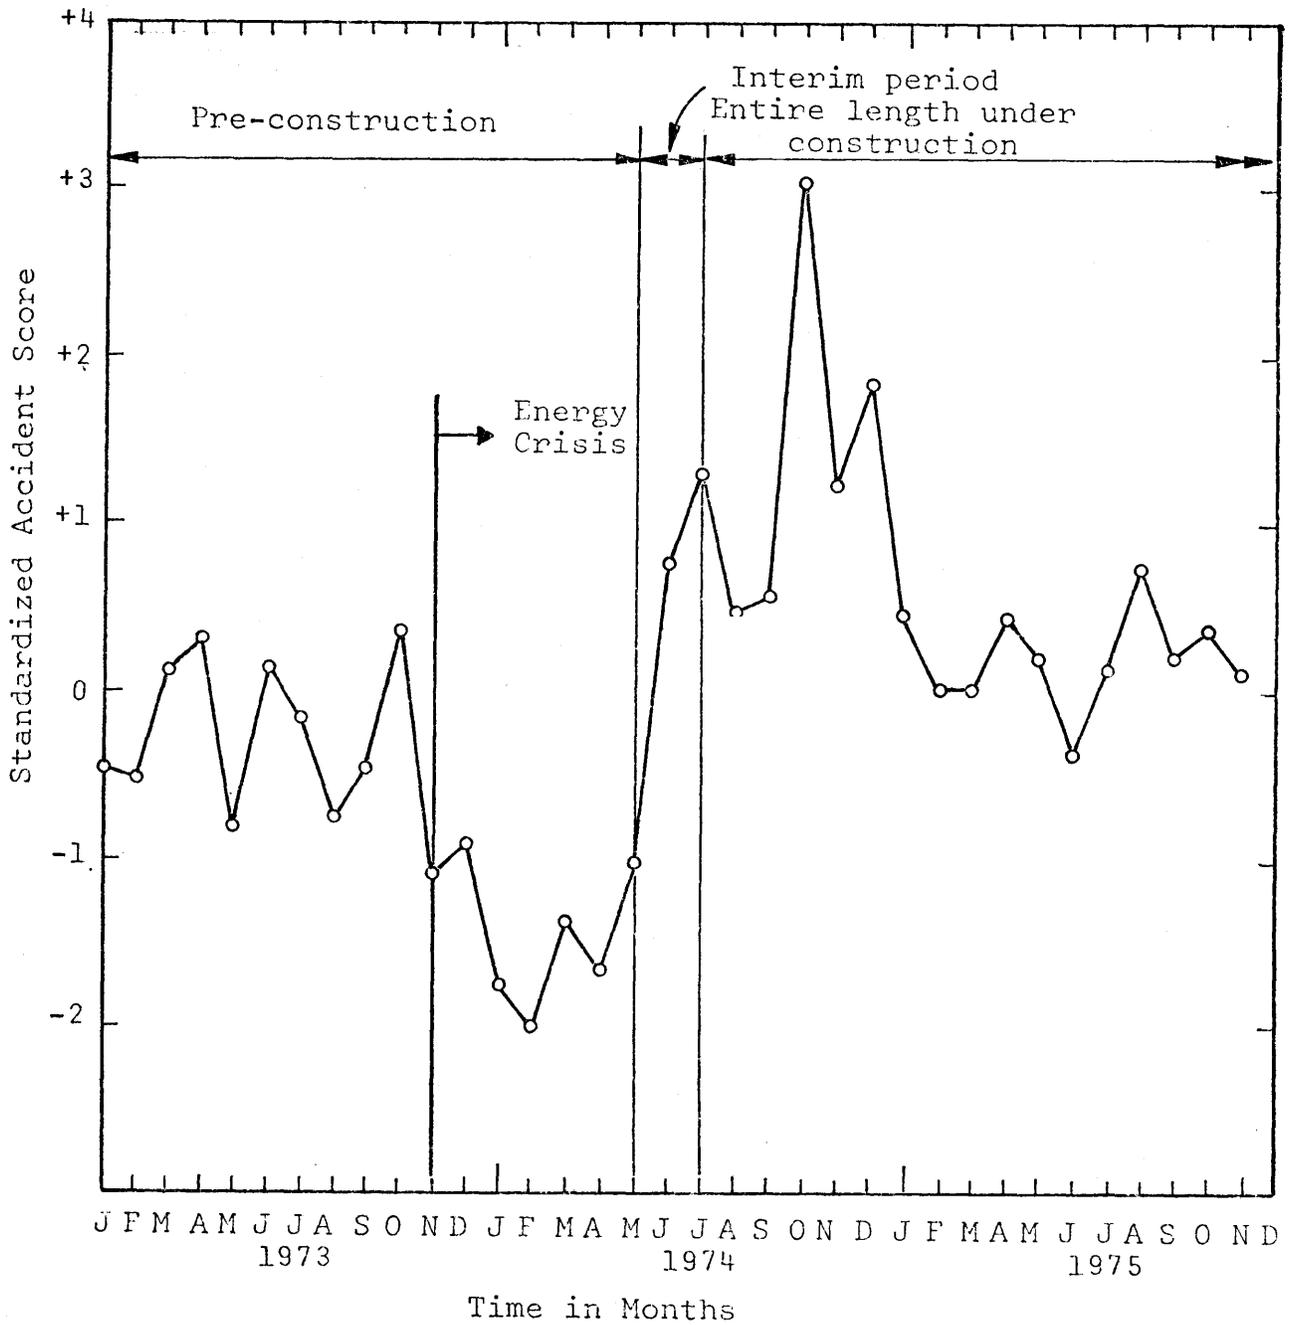
Figure 9. Standardized accident scores for construction contract No. 2

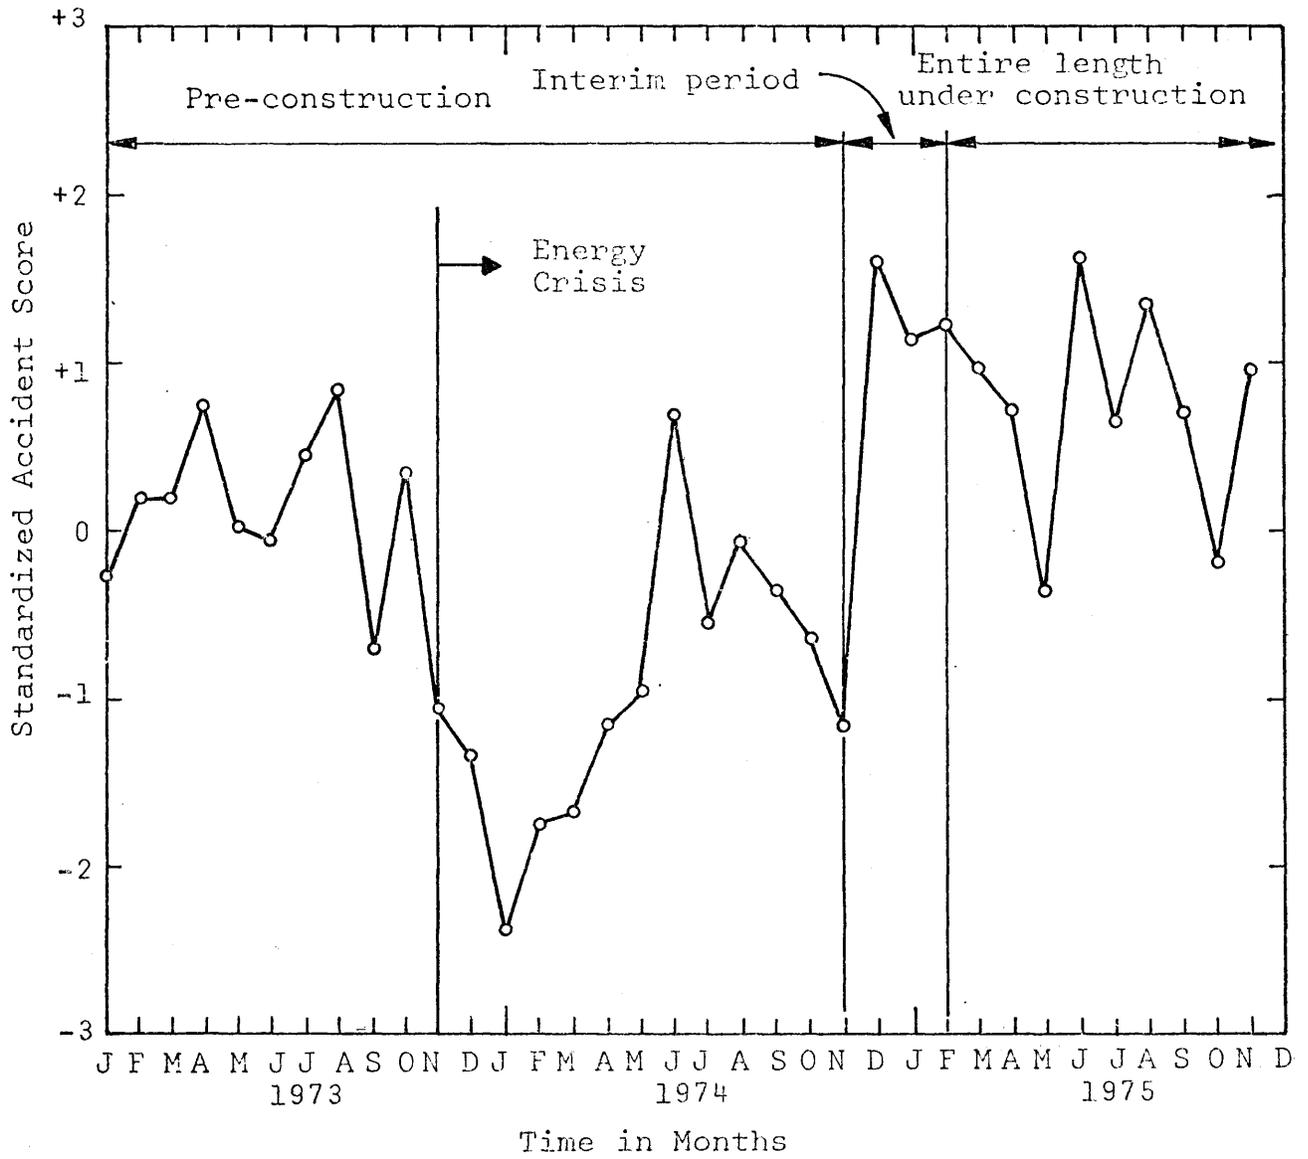
Figure 10. Standardized accident scores for construction contract No. 3.

However, instead of the scores increasing and remaining high after June as happened on contract No. 1 and 2, the scores for contract No. 3, on which work had not begun, declined and remained low until construction started. This finding would indicate that the construction activity was a major factor in changing the accident trends and that the energy crisis recovery trend played less of a role in the increase.

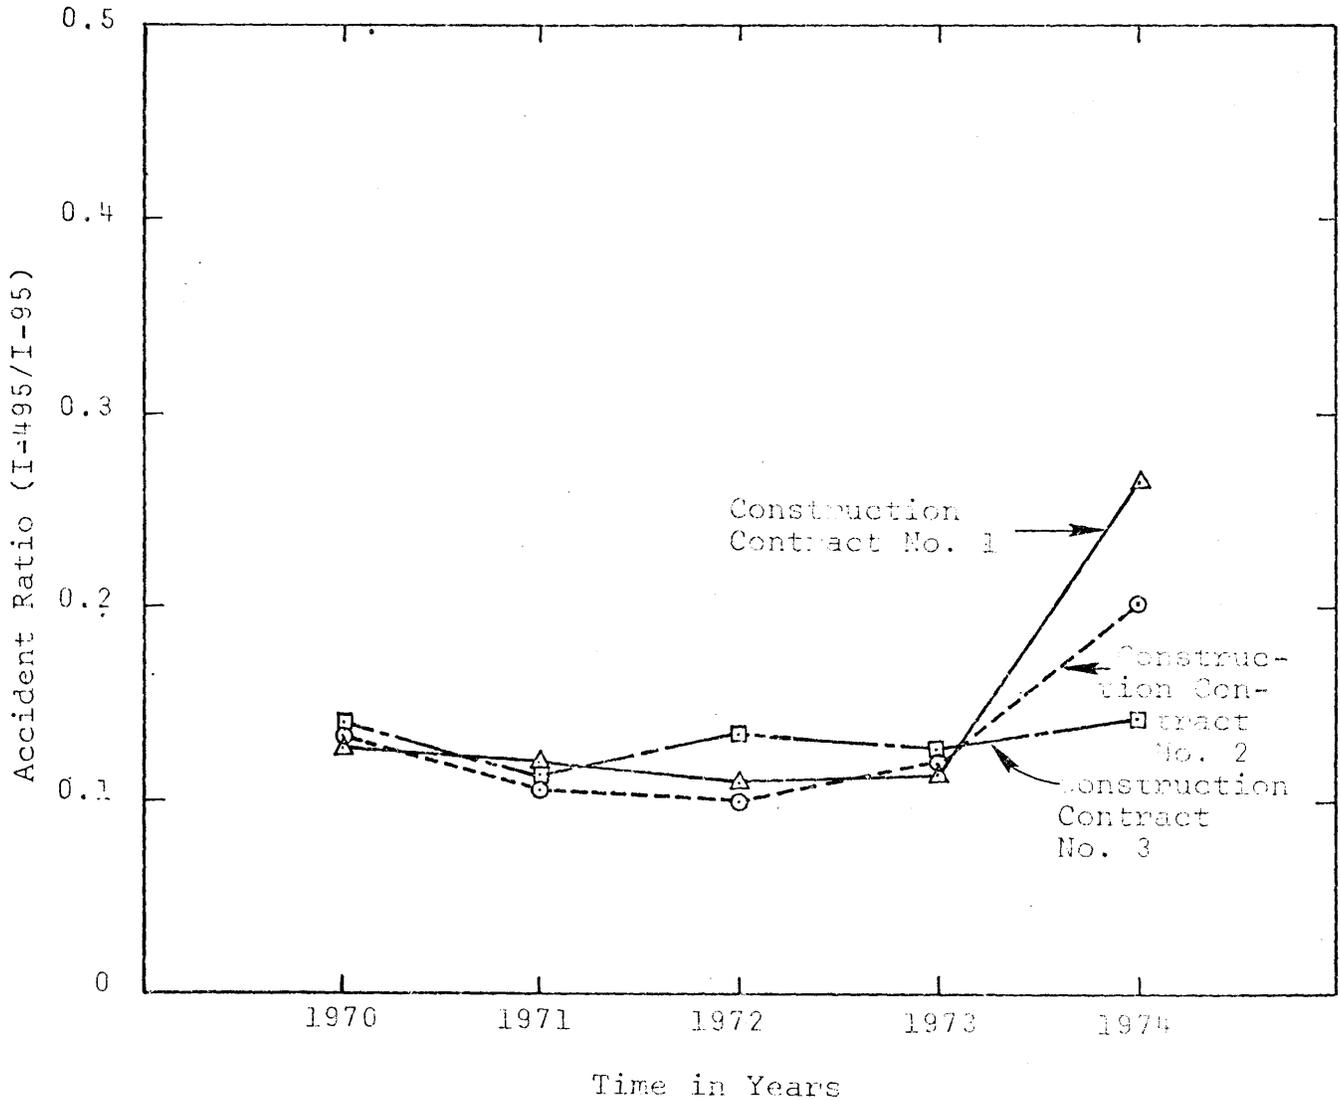
Figure 11. Ratio of the number of accidents on I-495 to those on I-95.

A ratio was computed by dividing the number of accidents on I-495 during a given month by the number of accidents on I-95 during the same time. In using this ratio, it was hypothesized that if I-495 and I-95 were similar, at least before the construction period, the accident ratios between each segment of I-495 and I-95 should be constant or linear across time. As seen in Figure 11, this assumption proved to be true. The accident ratios for the years 1970-1973 inclusive were almost constant. However, in 1974 this relationship changed. At that time the ratio for the segment covered by construction contract No. 1, the segment which was under construction for the longest time period (11 months), exhibited the highest ratio, which indicated that accidents on that section of I-495 increased relative to those on I-95. Since the only major

change in either I-495 or I-95 roadways was the construction on I-495, this change in the accident ratio in 1974 must have been due to something involved with the construction on I-495. The segment covered by contract No. 2, the portion which was under construction for the second longest time period (8 months), exhibited the second highest ratio; while that covered by contract No. 3, which was under construction for only 2 months, had the lowest ratio.

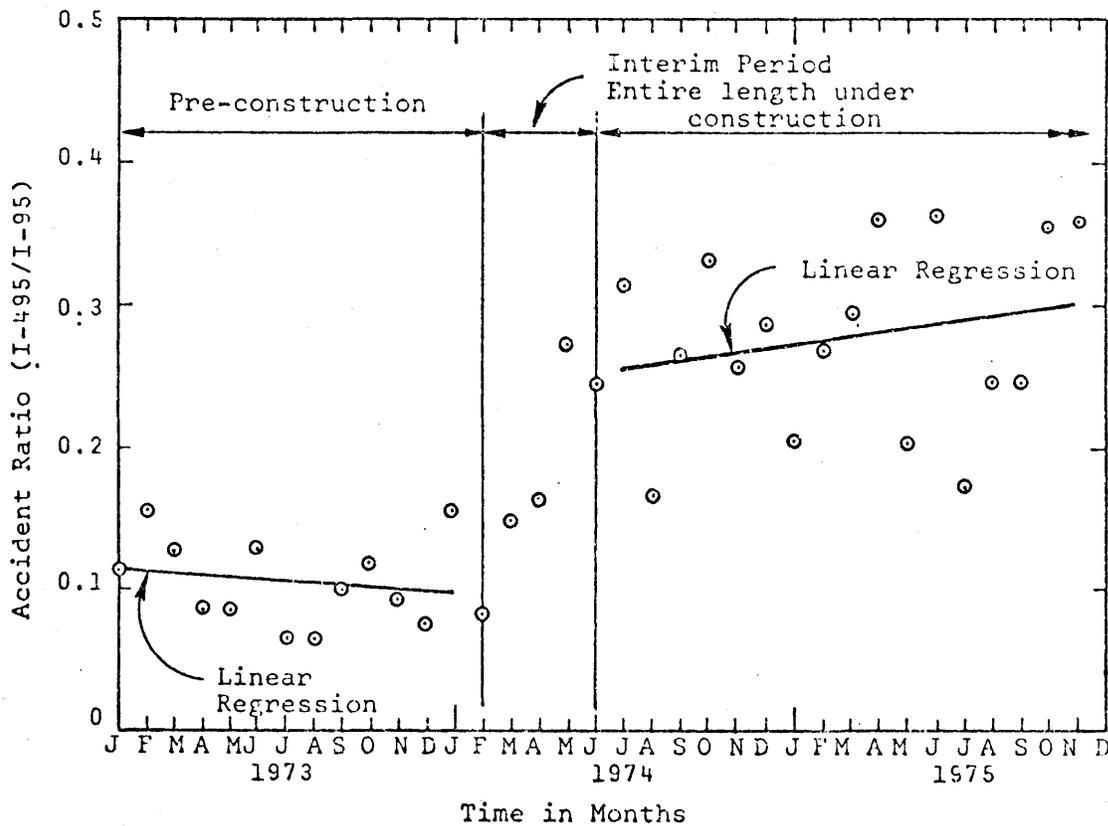
Figure 12. Accident ratio trend analysis for construction contract No. 1.

A more detailed analysis was then performed on a month by month basis using these accident ratios. Figure 12 depicts accident ratio trends for construction contract No. 1. For each of the study periods, a mean line representing all the points in that period was constructed using linear regression analysis. During the pre-construction phase on contract No. 1, the mean line was nearly constant at a ratio of 0.105, with a very small negative slope. During construction, however, this ratio increased 162% to 0.276, and the slope was then steeper and positive; that is, the number of accidents on I-495 increased across time relative to that for I-95. Note that the dispersion of data points during construction is greater than before construction. The dispersion of data points during construction may be an indication of the effects of the dynamic nature of construction activities on the traffic safety environment. A similar trend is shown in Figure 13 for contract No. 2. The mean line exhibited a negative slope at an accident ratio of about 0.114. During construction, this ratio rose 114% to 0.243. Finally, on the third construction contract (see Figure 14), the mean line exhibited a very small positive slope at an accident ratio of 0.135 prior to construction. During construction, this ratio rose 108% to 0.281, and the slope of the mean line became more strongly positive.

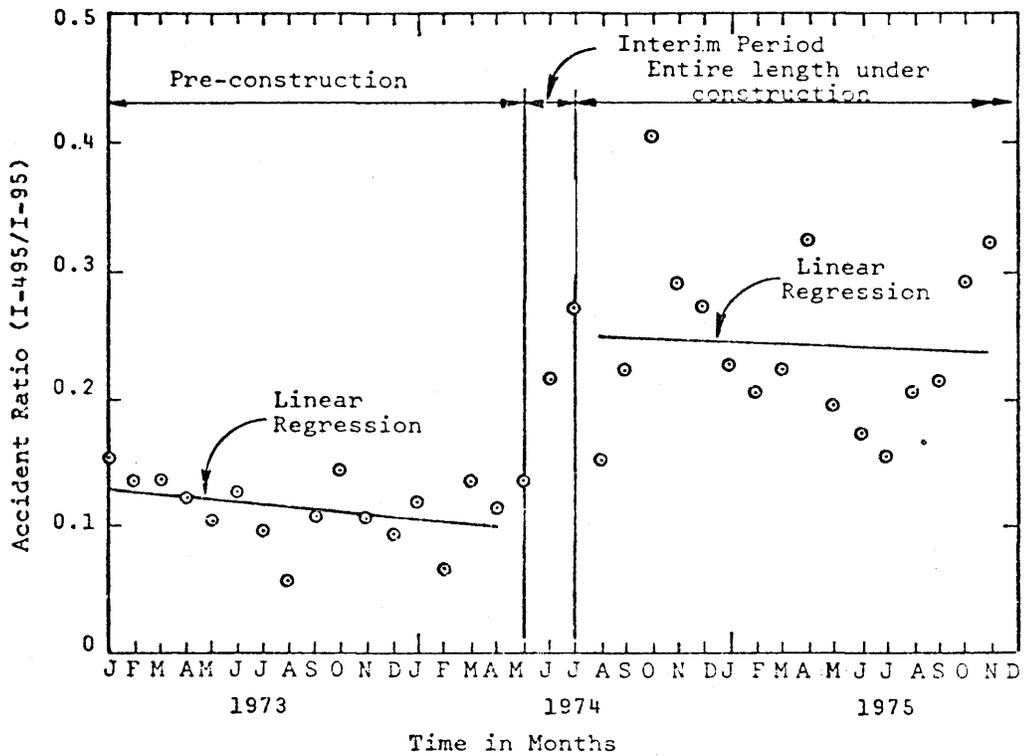
Figure 13. Accident ratio trend analysis for construction contract No. 2.

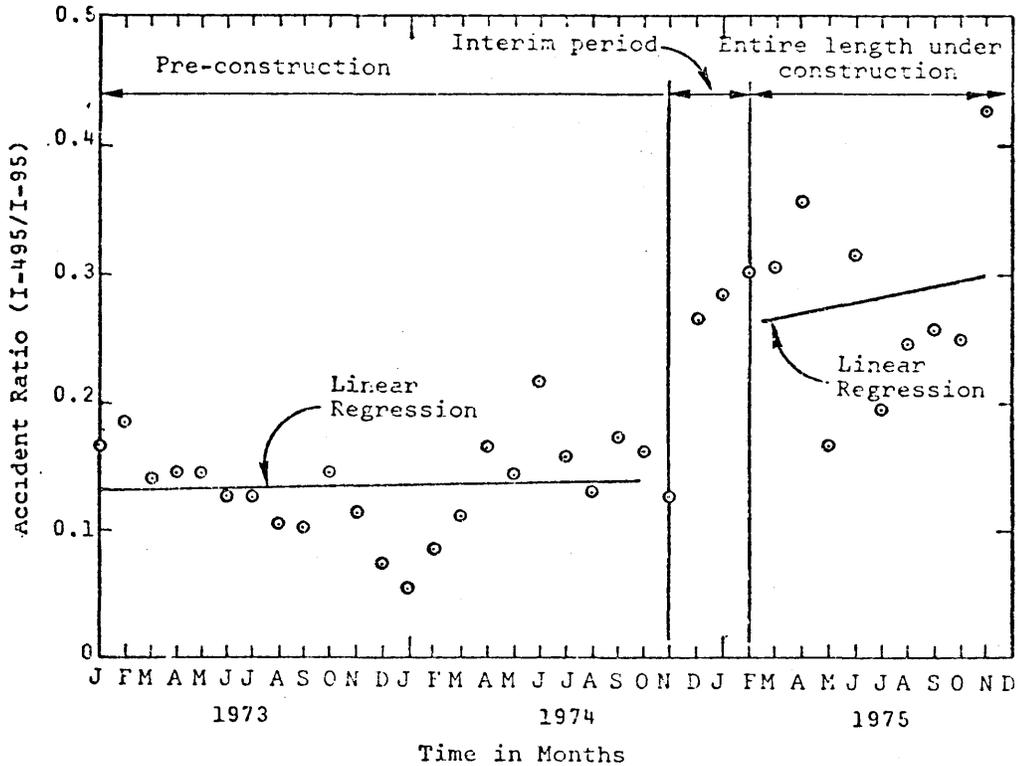
Figure 14. Accident ratio trend analysis for construction contract No. 3.

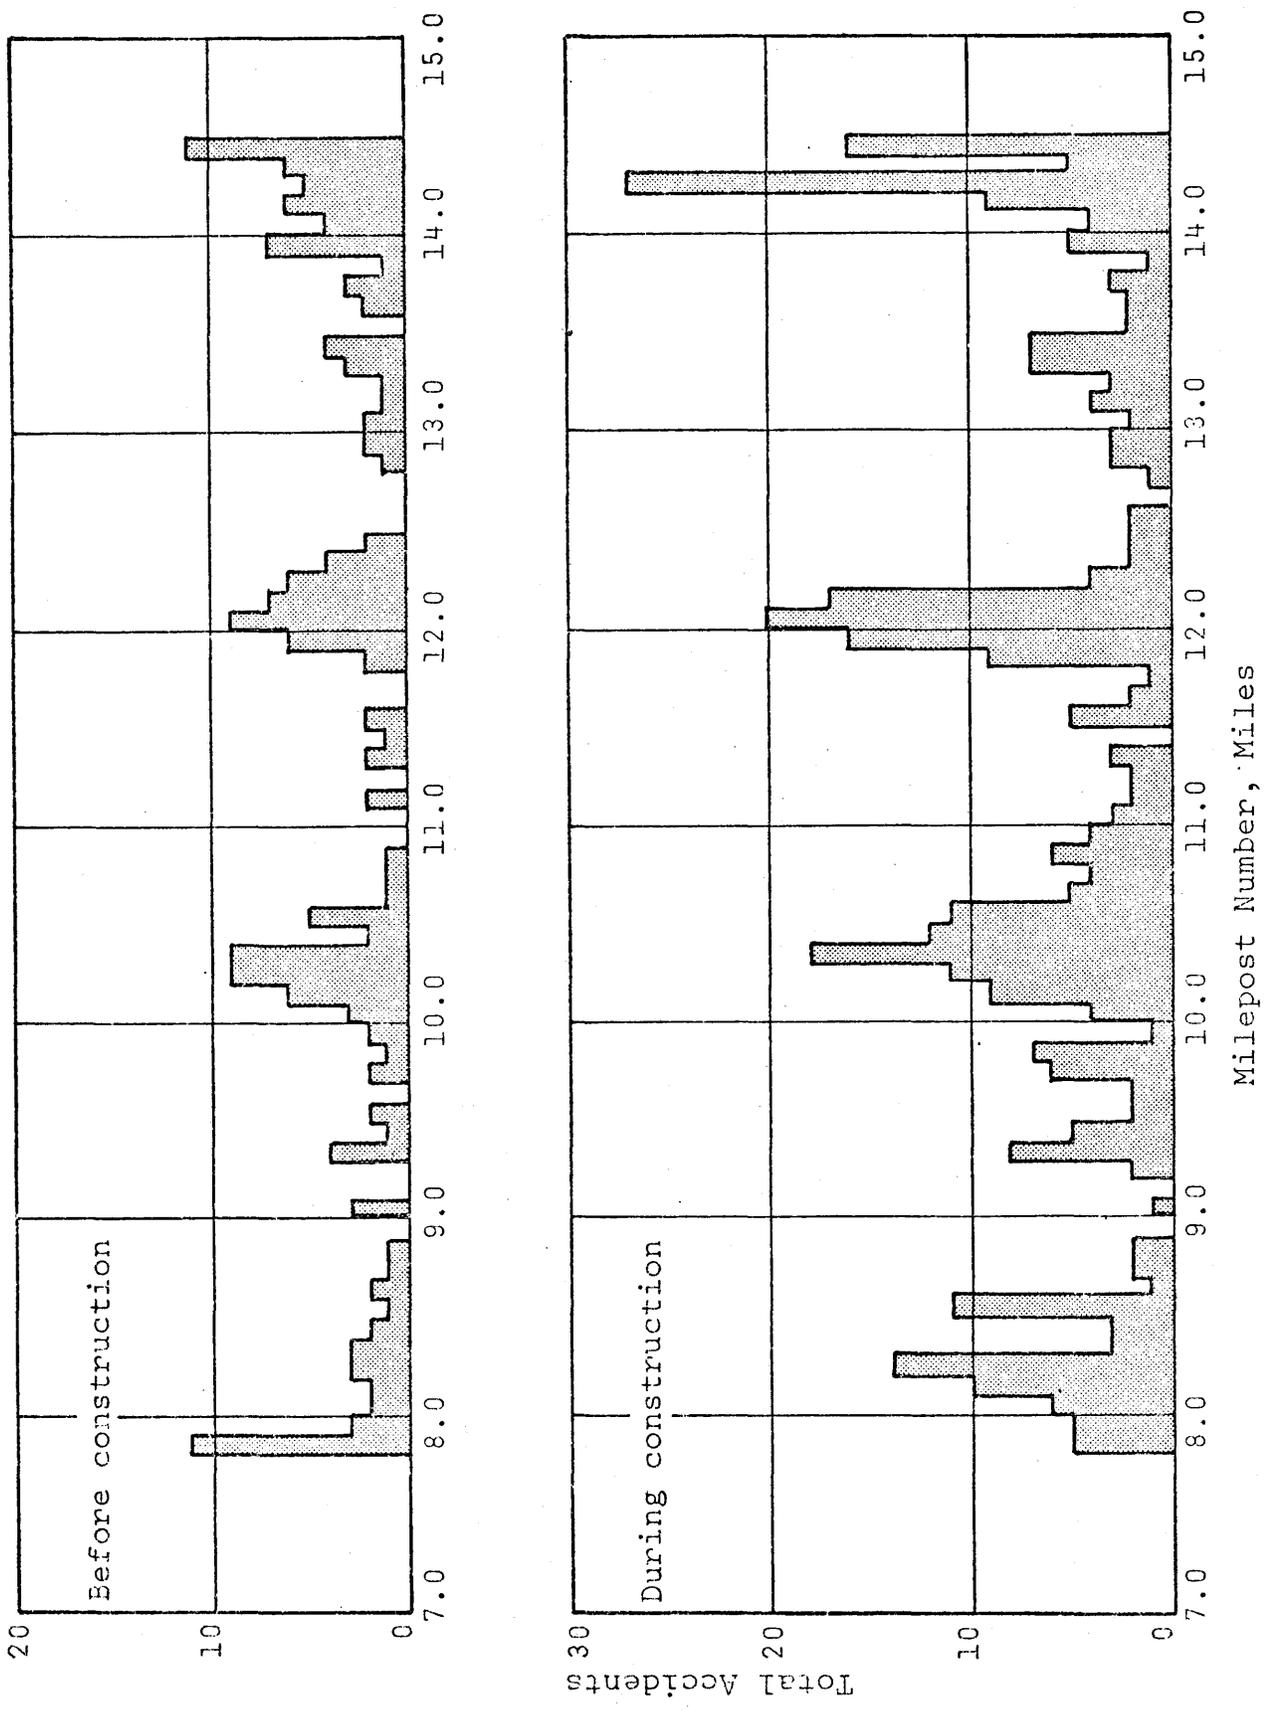
Figure 15. Accident histogram for construction project No. 2.

Further analysis of the data presented in Figure 15 revealed that there were a number of clusters of accidents during construction which had no counterpart in the before construction period. The most prominent of these clusters was at milepost 8.2, which is the Backlick Road overpass. At this site, the bridge overpass was being widened on the median side, so traffic was shifted to the right lane of the existing roadway and the right shoulder. The 0.30-mile section of roadway adjacent to the Backlick Road overpass had 4.3 times more accidents during construction than before construction. A closer examination of the accident data for the area of the Backlick Road overpass showed that the traffic accidents were not evenly distributed. Of the 24 accidents occurring within 0.10 mile of the overpass during construction, 17 (68%) occurred within 0.03 mile (160') of the bridge. These data indicate that the construction environment at Backlick Road during the study period was a contributing factor in the increase in the number of accidents.

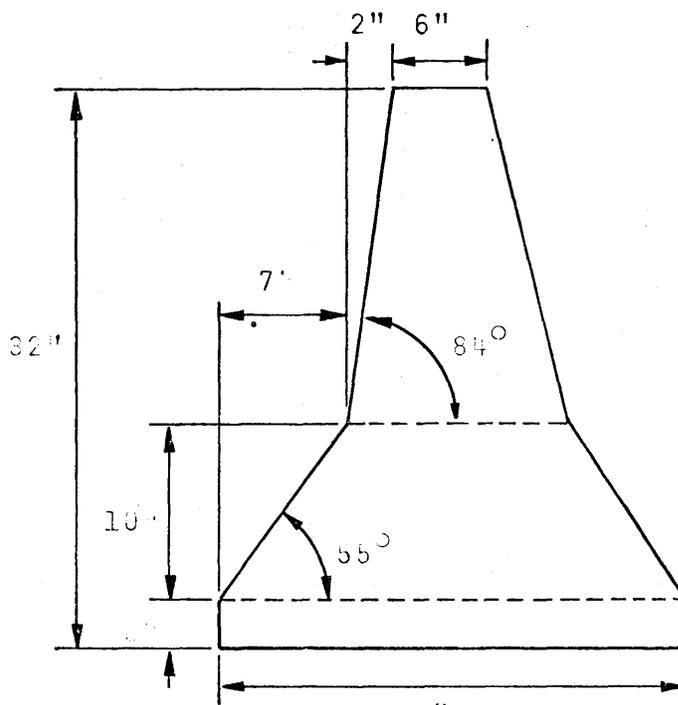
Figure 16. Profile of the New Jersey "Safety Shaped" concrete median barrier.

Today's standard New Jersey barrier, often referred to as the "Safety Shaped" barrier, is 32" high and has a 24" base with a 6" top width as shown in Figure 16. It incorporates a 55° batter curb face with an upper portion which is almost vertical.

The theory of the CMB performance in the field is relatively simple. When a vehicle strikes the barrier at angles less than 15°, the initial contact is between the 3" vertical curb and the vehicle tire. This contact deforms the tire and tends to slow the vehicle. The front wheel then climbs up the 55° batter curb face, and the vehicle body on the impact side lifts from the roadway. Through this action, energy is absorbed by the barrier, and the driver may be able to regain control of his vehicle and guide it back into the roadway. If the impact speed is high and the impact angle is more than a few degrees, the vehicle may not be controllable immediately following impact but may continue to climb up the sloped face until the upper (near-vertical) portion of the barrier is reached. Contact in this area creates a strong counterforce on the vehicle wheel, and redirects the vehicle back into the roadway.<sup>(42)</sup>

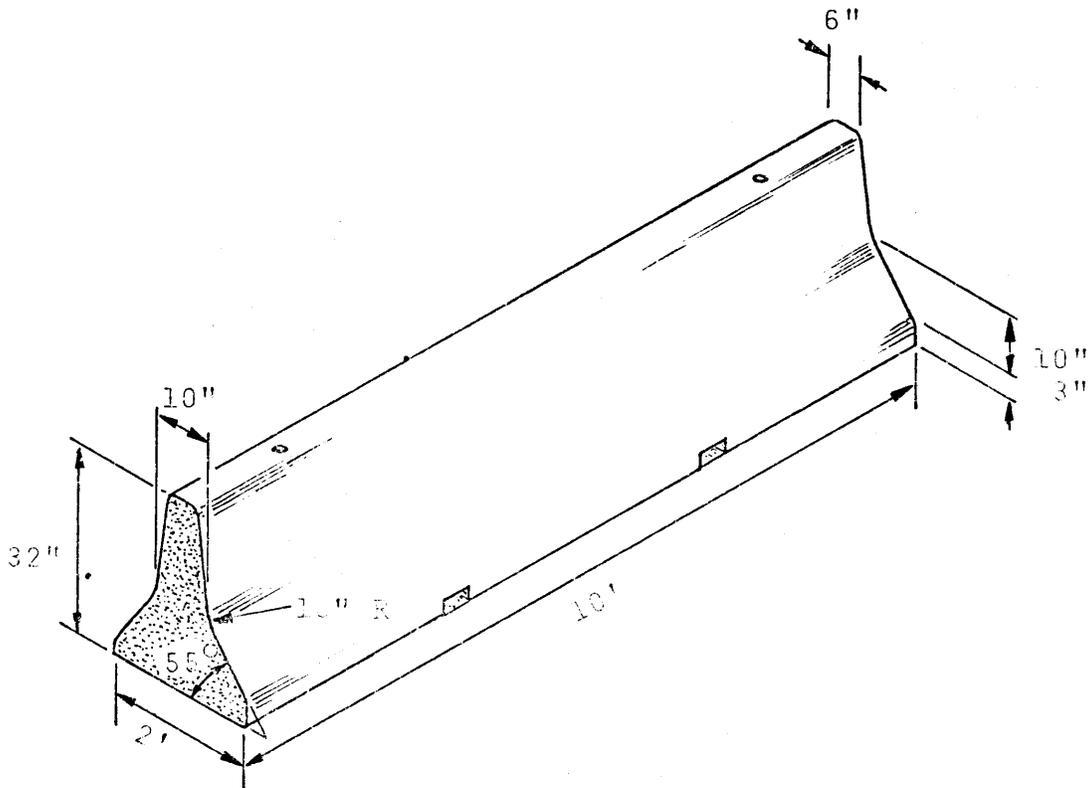
Figure 17. A New Jersey shaped precast concrete traffic barrier.

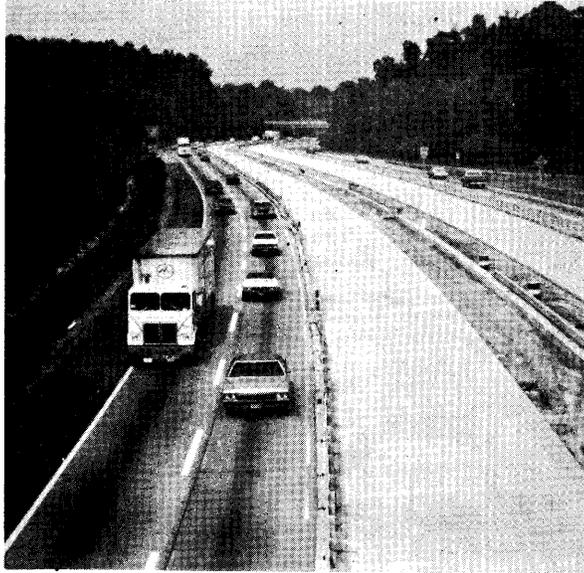
Figure 18. Timber barricades placed on edge of existing roadway adjacent to the median during construction stage one. Source: NTSB.

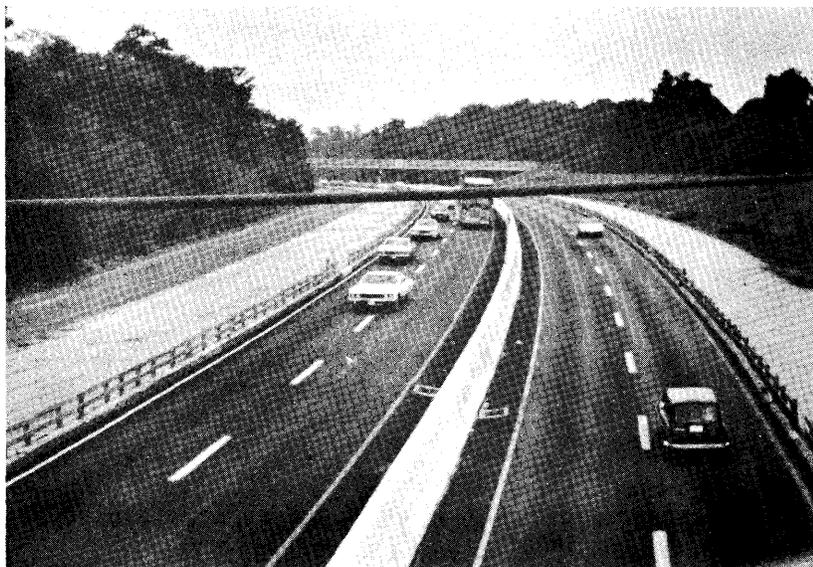
Figure 19. Timber barricades placed on the right edge of new roadway during construction stage two. Source: NTSB.

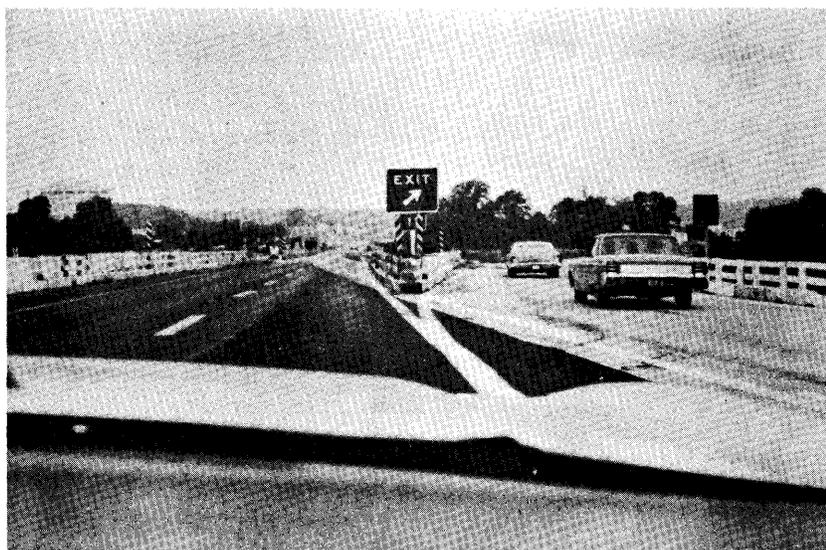
Figure 20. Timber barricades used for channelization at Exit 11 on I-495. Source: NTSB.

The timber barricades were also placed in interchange gore areas where no work was being performed. Figure 20 shows the use of timber barricades at Exit 11 on I-495. The purpose of the timber barricades in these instances appeared to be for channelization. The gore areas are hazardous locations and should be free of fixed objects. In addition, "timber barricades were placed along the full length of the roadway at the time contract work was commenced."<sup>(58)</sup> Figure 21 shows a section of roadway on which "as

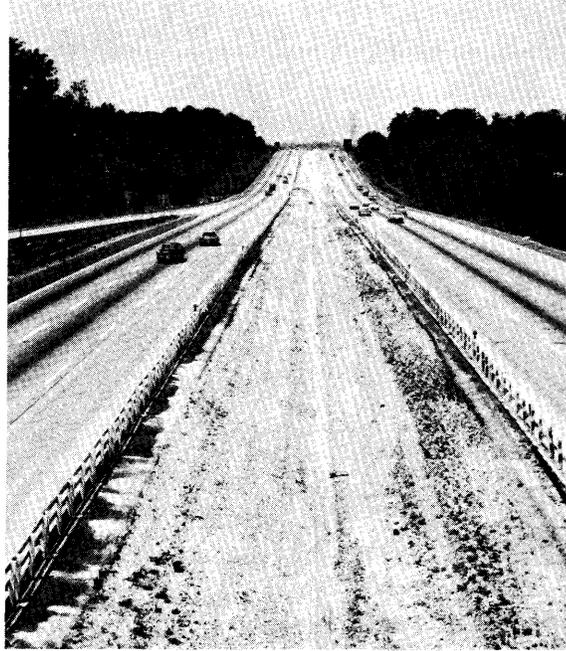
Figure 21. Timber barricades on a section of I-495 where for long periods of time no substantive work was being performed. Source: NTSB.

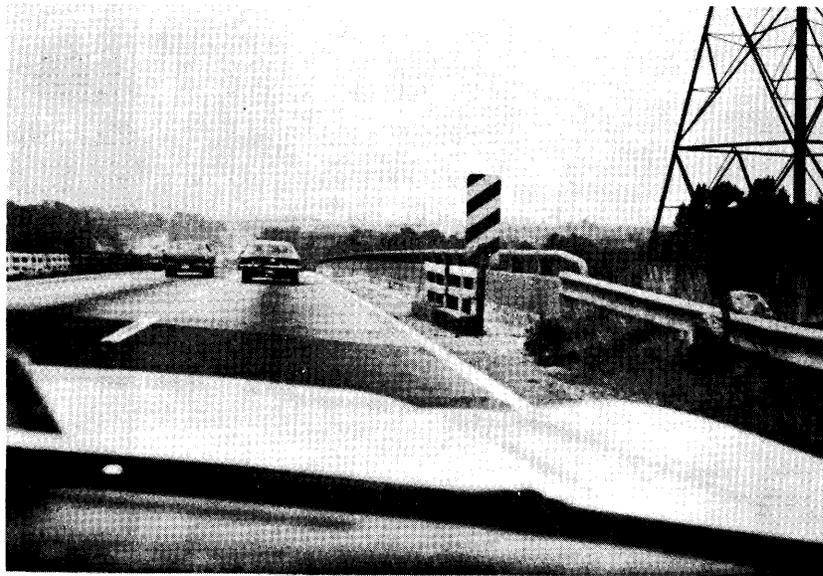
Figure 22. Timber barricades used to support traffic signs. Source: NTSB.

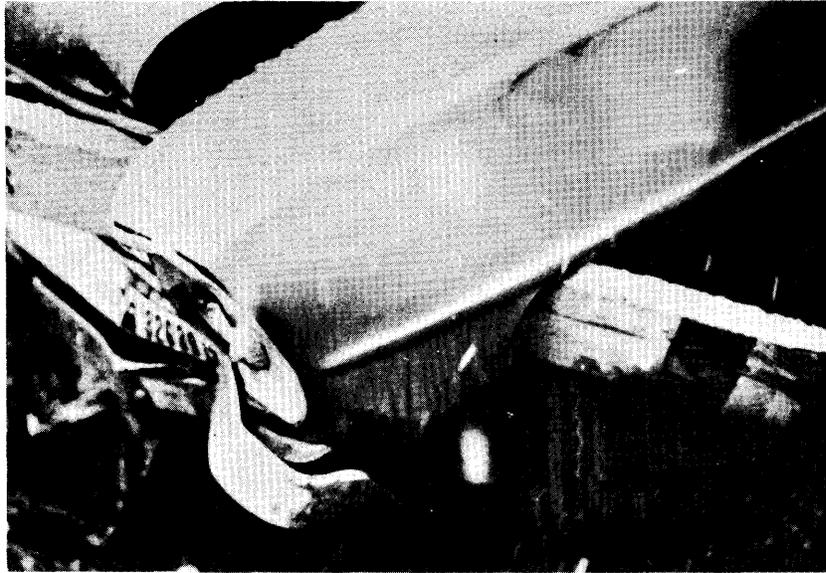
Figure 23. Vehicle "speared" by a timber barricade rail. Source: NTSB.

The 10' length of the rail is ineffective since "the traffic barrier rail [must] ... be continuous to prevent a vehicle from pocketing into the rail. The short lengths of individual rails create a continuous exposure of vehicles, that may encroach, to the possibility of being speared by the numerous rail ends."(67) Figure 23 shows a vehicle that was speared by a timber barricade rail.

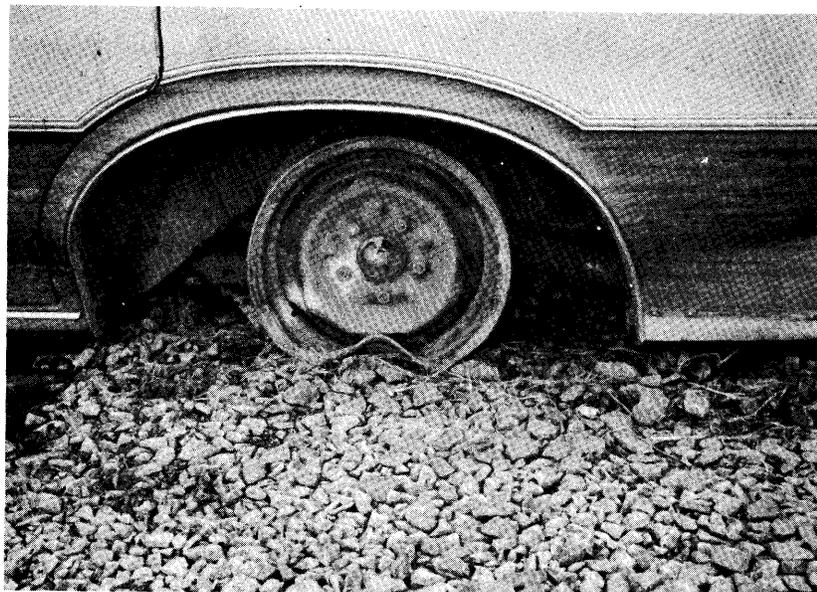
Figure 24. Vehicle wheel bent while mounting the 10" x 10" timber barricade base. Source: NTSB.
