EVALUATION OF TIMBER BARRICADES AND PRECAST CONCRETE  
TRAFFIC BARRIERS FOR USE  
IN HIGHWAY CONSTRUCTION AREAS

September 1976  
VHTRC 77-R13

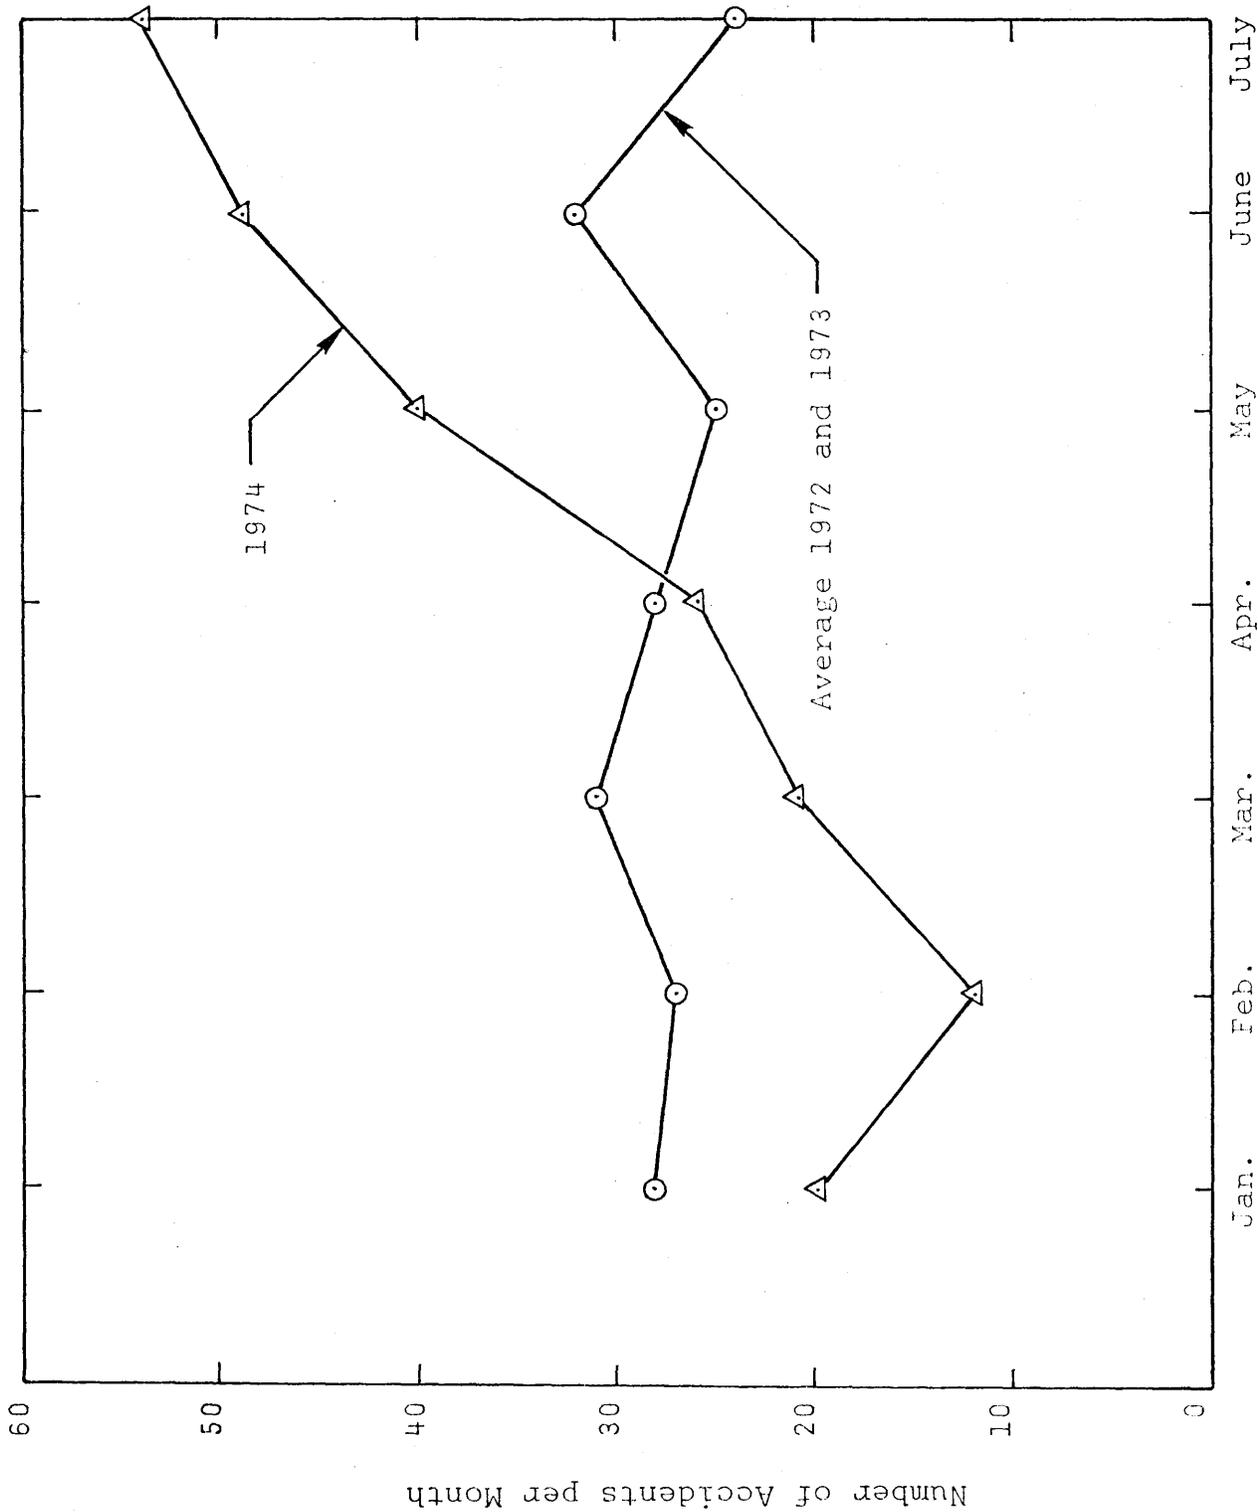
Figure 25. Number of accidents occurring on I-495 between Cabin John Bridge and U. S. Route 50. Source: NTSB.

The performance of the timber barricades can be measured in terms of the number and characteristics of accidents occurring on I-495. The numbers of traffic accidents occurring on the section between Cabin John Bridge and U. S. Route 50 (7.64 miles) during the first seven months of 1972, 1973, and 1974 were identified. The total numbers of accidents so identified for 1972 and 1973 were averaged and are plotted in Figure 25 along with the accidents for the corresponding period in 1974. "Note that 1974 accidents prior to construction were lower than the average of 1972 and 1973 combined, which could reflect the effects of the energy crisis." (74) However, by May the monthly number of accidents in 1974 was greater than the average monthly number of accidents in 1972 and 1973. By the end of July, the monthly number of accidents in 1974 was more than twice the average monthly number of accidents in 1972 and 1973.
