Craniofacial Trauma. Resorbable and titanium plating application.

Case Study

Craniofacial Trauma

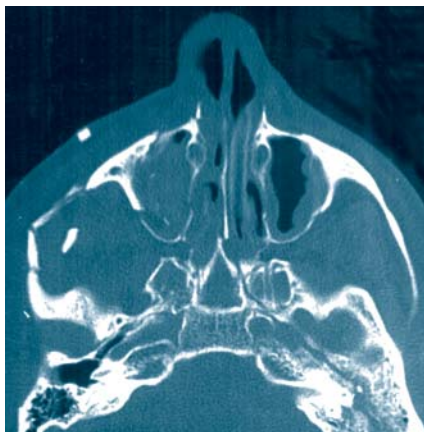
Preoperative radiograph

A 36-year-old male was involved in a motorcycle accident. Patient suffered basilar skull fracture, multiple facial fractures, head injuries and soft tissue injuries of the cervical spine. Patient was not wearing a helmet at the time of the accident.

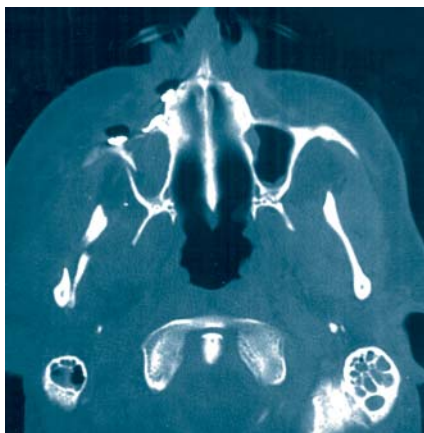
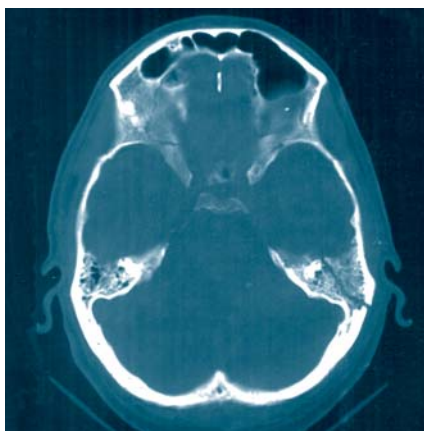
Immediate postoperative radiograph

One week later an open reduction and internal fixation of the right orbital floor blowout and right zygoma/malar fracture was performed. A 2.1 mm taper Fisher burr was used to make a hole in the thickest portion of the malar buttress. The zygoma was manipulated until the fracture was anatomically reduced. A 1.5 mm Synthes orbital rim plate was placed across the zygomatico-frontal suture. A 2.0 mm plate was placed across the zygomatic buttress. A 2.0 mm 4-hole plate was placed on the piriform rim. With the zygoma secured, attention was given to the orbital floor.

A 1.5 mm Resorbable Contourable Mesh Plate (50 mm x 50 mm, 0.5 mm thick) was heated in the hot water bath, contoured over the thin comminuted orbital floor, and secured with one 1.5 mm screw. The resorbable mesh provided contourability and adequate support for the globe.

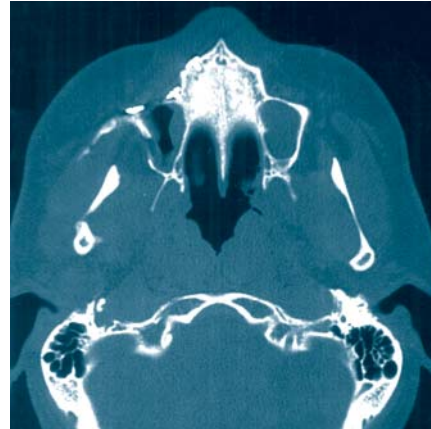
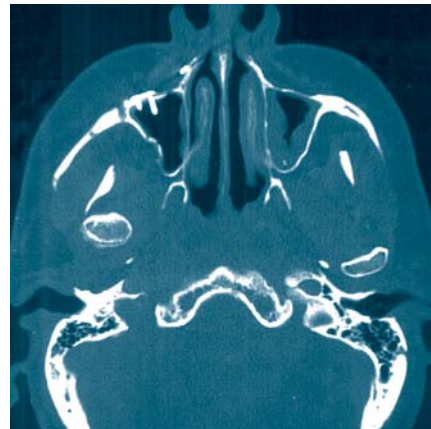
3-month postoperative radiograph

Patient was kept in IMF for two weeks due to the mandible fracture, then progressed to elastics and physical therapy. Approximately 3 months postoperative the patient experienced conductive hearing loss. A CT of the temporal bones was performed. A fracture of the left temporal bone appears to extend through the middle ear. The fracture line is considerably less distinct than seen on the immediate postoperative scan. No obvious consequence is noted to explain the patient's conductive hearing loss.

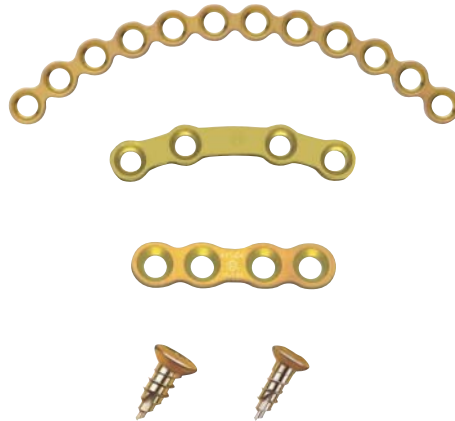
Metal

- 1.5 mm Orbital Rim Plate
- 2.0 mm Tension Band Plate
- 2.0 mm Curved Broad Plate
- 1.5 mm and 2.0 mm Titanium Screws

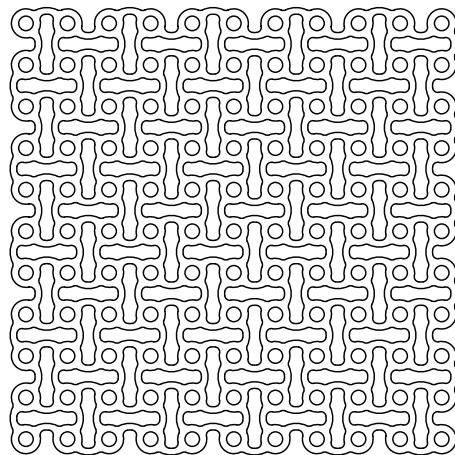
Biomaterials

- 1.5 mm Resorbable Contourable Mesh
- 1.5 mm Resorbable Cortex Screw
