# Service Action

## Code: 60E2

| Subject | Front Sunroof Drain Cleaning & Modification | | | | | | | | | | | | | | |
|---|---|---|---|---|---|---|---|---|---|---|---|---|---|---|---|
| Release Date | December 03, 2019 | | | | | | | | | | | | | | |
| Affected Vehicles |

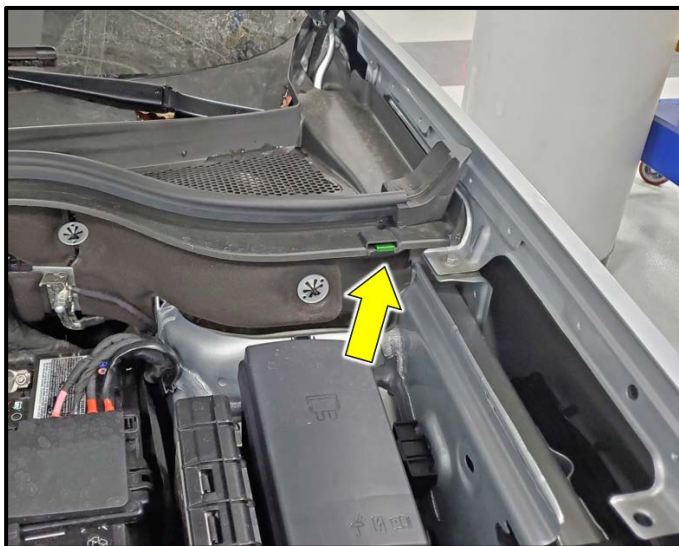
### Remove plenum chamber cover clips:

- Remove the outer most plenum chamber cover clip <arrow> on the left and right plenum chamber covers.

Left side shown. Procedure for right side is similar.

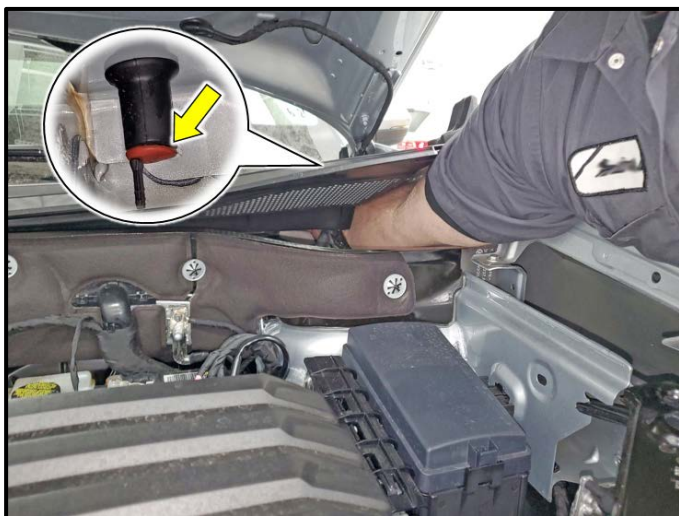
### Removing sunroof drain flap:

- Carefully lift the plenum chamber cover approximately 15 cm.
- Reach in along the outer edge of the plenum chamber (between the wiper transmission and the plenum chamber on the left side).
- Carefully remove the red sunroof drain flap <arrow> downward off the sunroof drain.
- Repeat on the opposite side.

When working during extreme temperatures, it is recommended that the vehicle be allowed to acclimate inside the shop to avoid temperature-related component damage/breakage. Damage to plenum chamber covers will not be covered under this action.

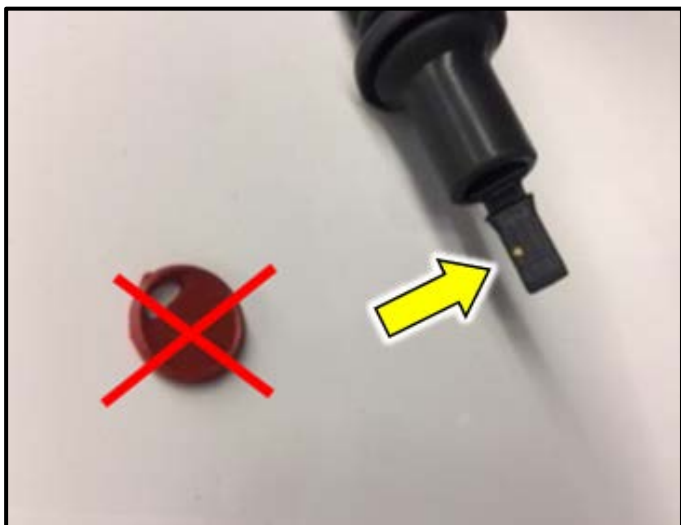
DO NOT remove the sunroof drain from the vehicle. The tab <arrow> on the sunroof drain remains on the sunroof drain. The red flap can be discarded.

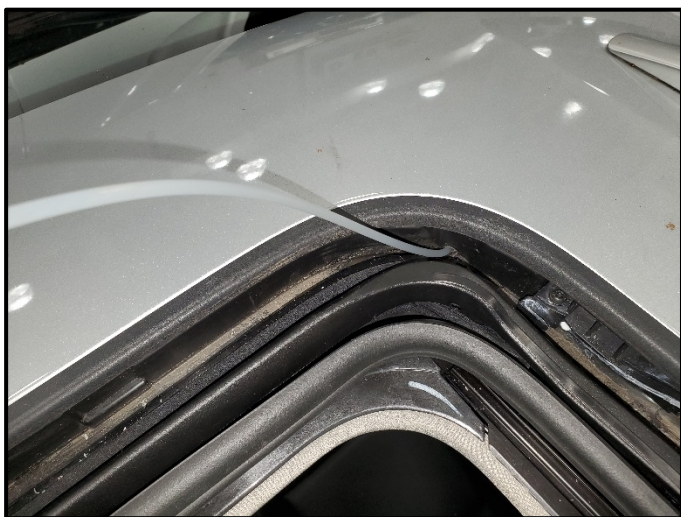
#### Clean the sunroof drains:

- Clean both front sunroof drains using the -VAS6620- (or equivalent).

DO NOT use extra force if resistance is encountered when using the -VAS6620-. Doing so could result in damaging the sunroof drain or disengaging the sunroof drain from the sunroof. Damage to the sunroof drain or time to reattach the sunroof drains to the sunroof will not be covered under this action.

The -VAS6620- will exit the sunroof drain tube in the plenum chamber after approximately 120 cm.

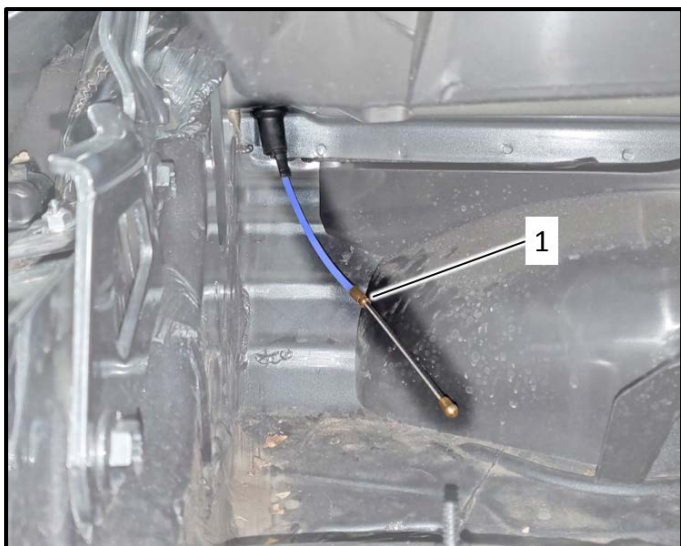
If the -VAS6620- cannot be removed out of the sunroof drain, the end of the tool <1> can be unscrewed and the tool can then be easily removed.

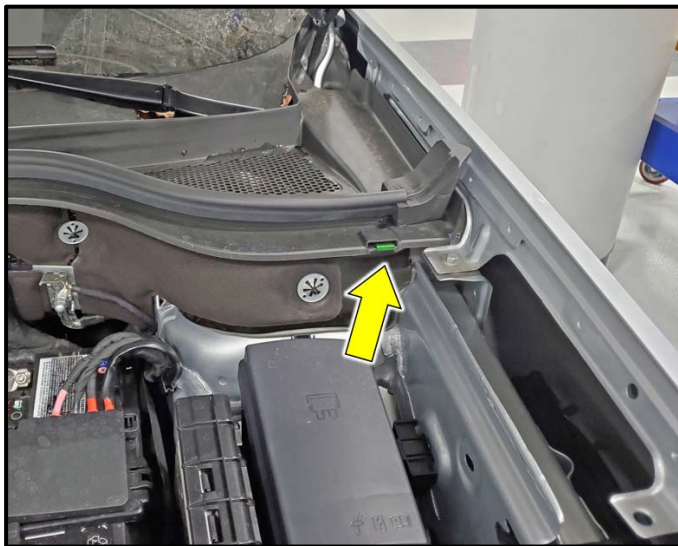
#### Reinstall the plenum chamber covers:

- Installation is the reverse order of removal.
- Ensure all seals are in place.
