# FOUNDATION DRILLING

## Condon-Johnson & Associates Installs Dramatic Supports to Keep Building Safe

By Simon Burnworth, P.E., Project Manager, Condon-Johnson & Associates

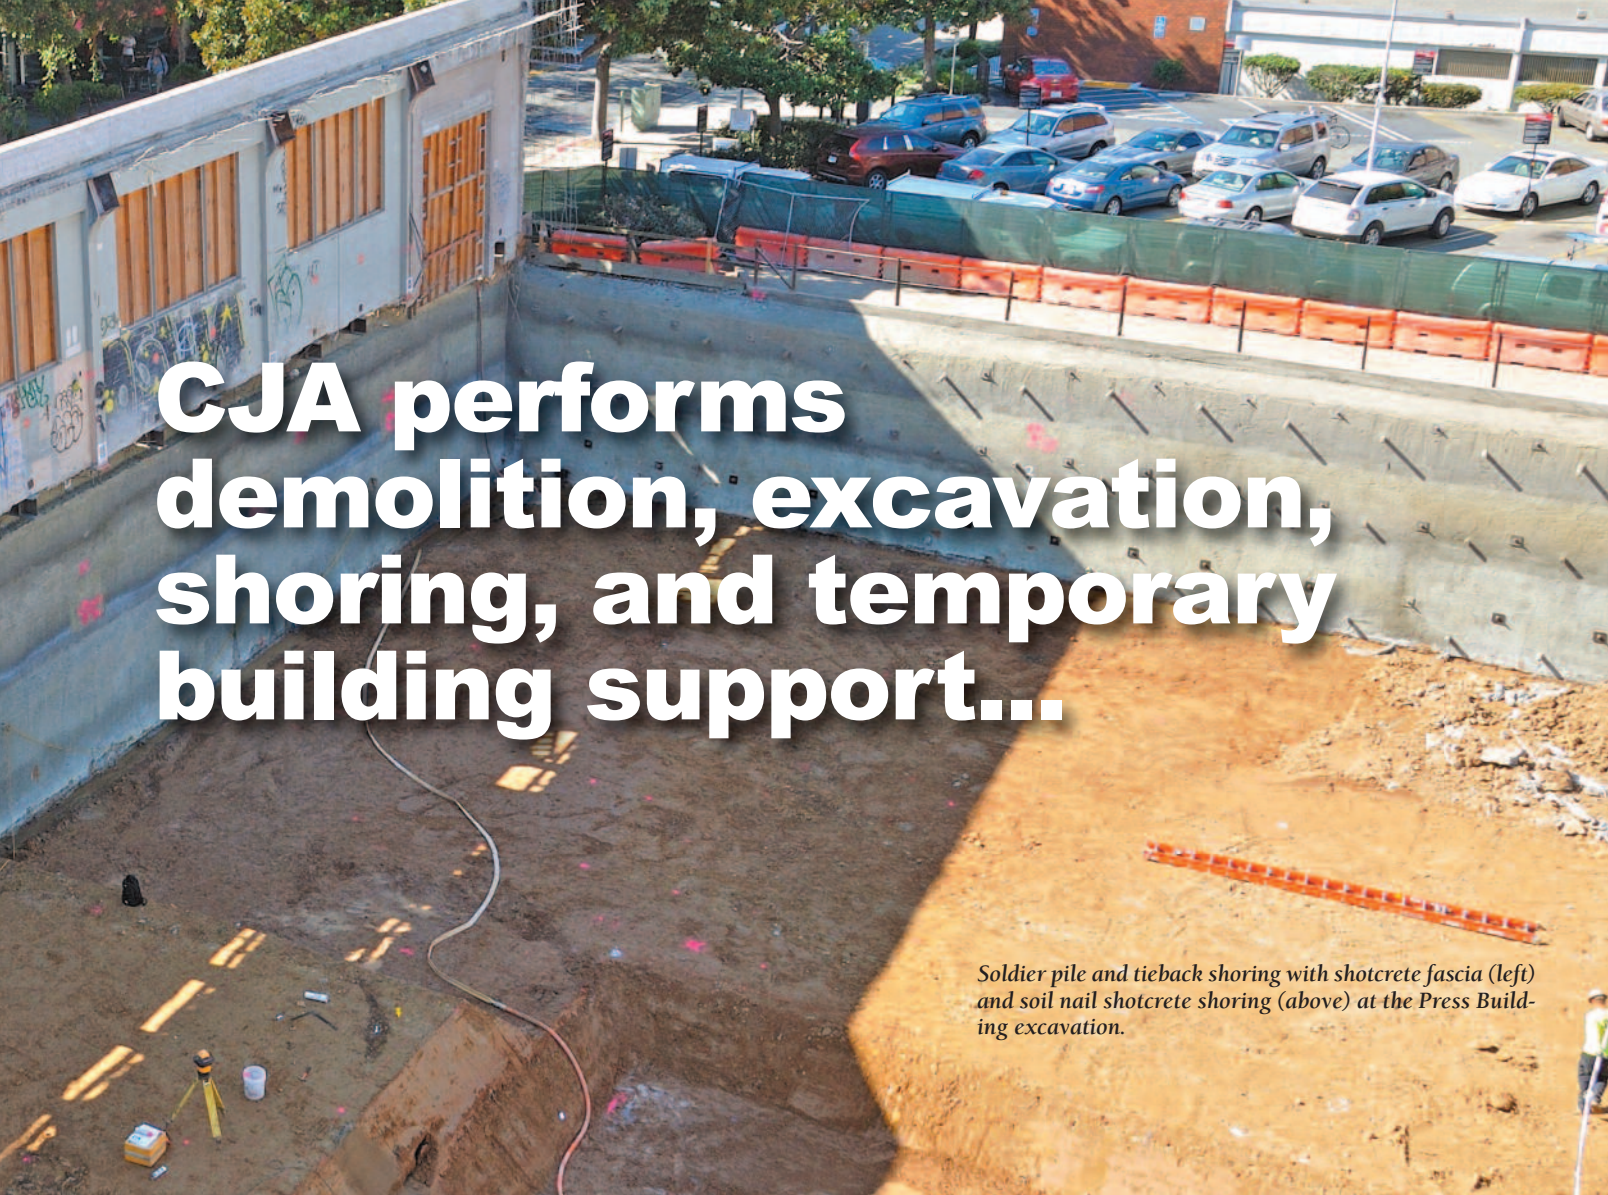
Soldier pile and tieback shoring with shotcrete fascia (left) and soil nail shotcrete shoring (above) at the Press Building excavation.

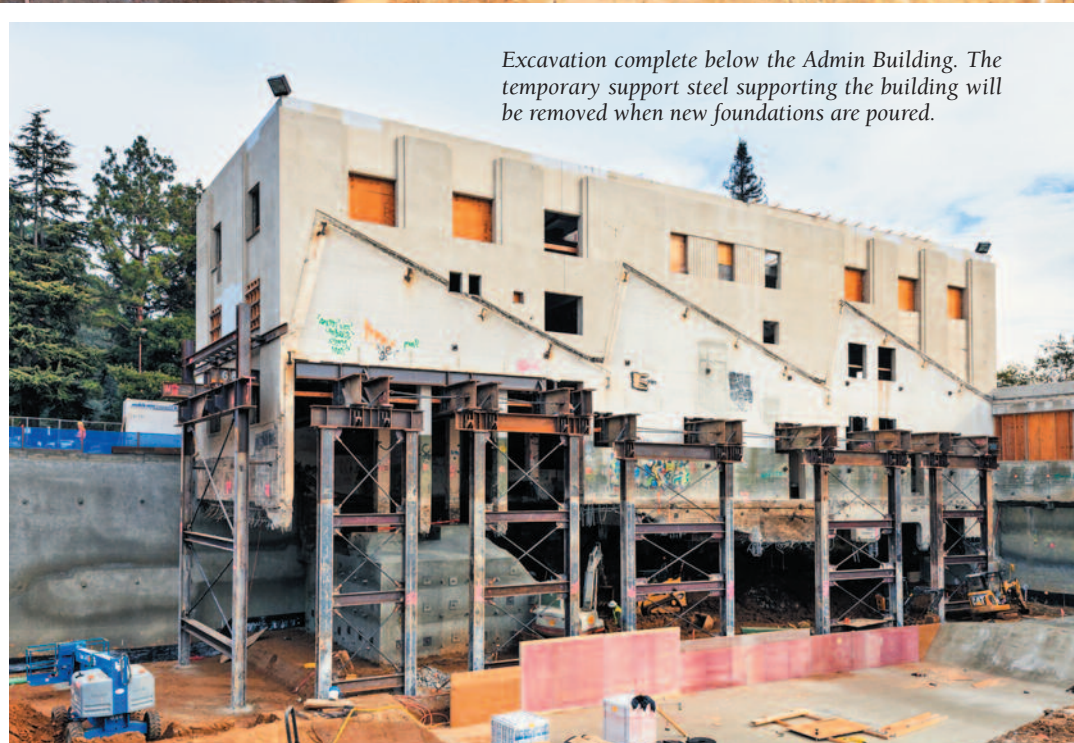
Excavation complete below the Admin Building. The temporary support steel supporting the building will be removed when new foundations are poured.

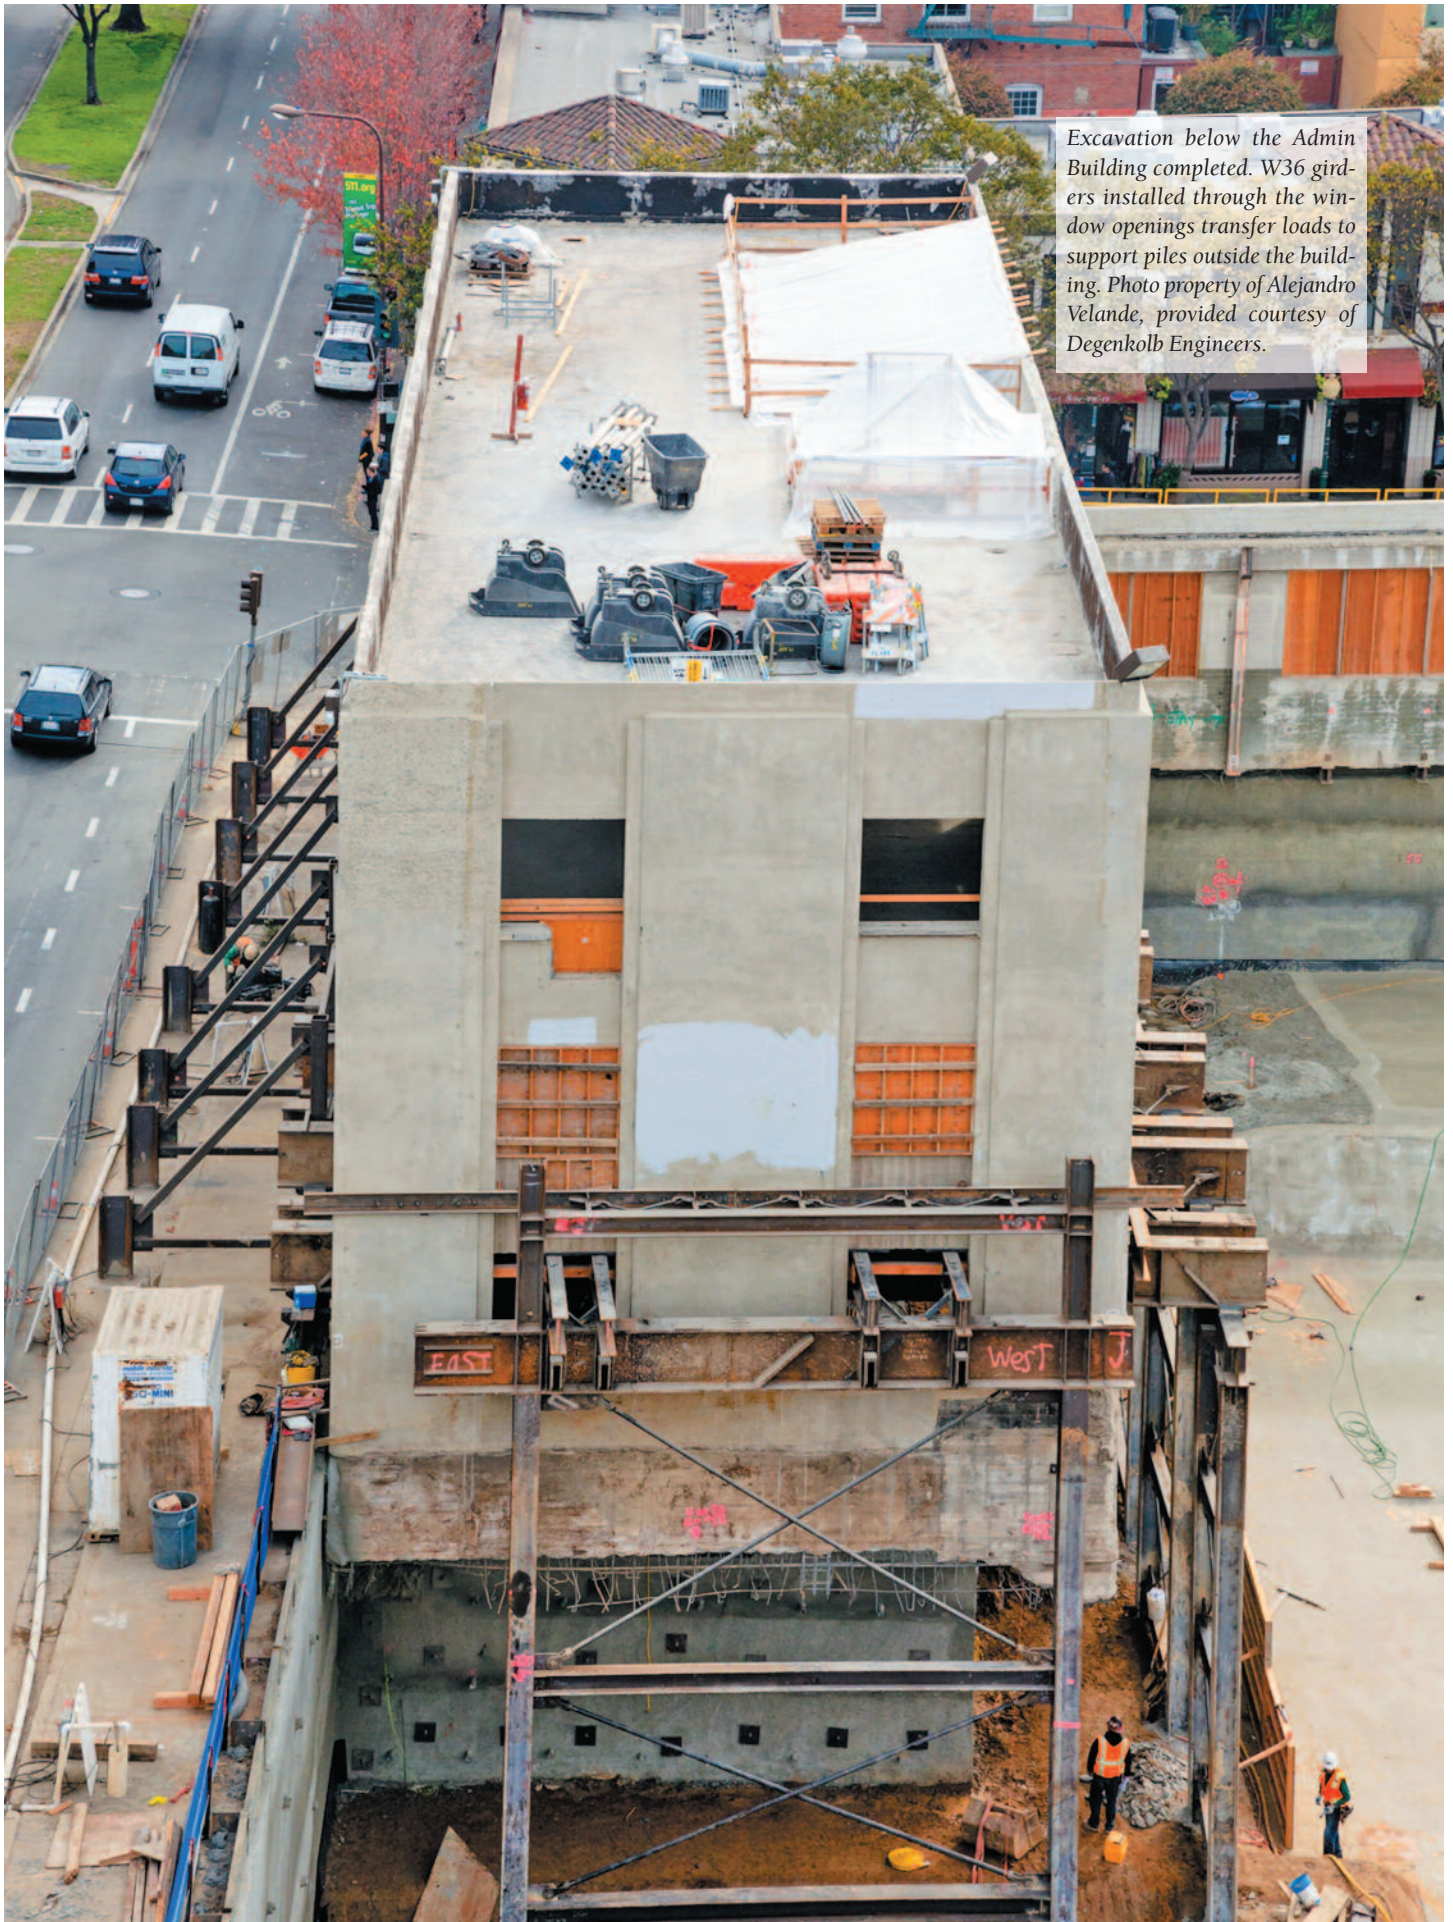
Excavation below the Admin Building completed. W36 girders installed through the window openings transfer loads to support piles outside the building. Photo property of Alejandro Velande, provided courtesy of Degenkolb Engineers.

To temporarily support the weight of the building, 27 soldier piles were installed to depths of 70 feet around the perimeter of the structure. On top of the piles horizontal spreader beams spanned the distance between support piles. Resting on top of the spreader beams, all loads were collected by 18 each W36x393 girder beams 48 feet long. The girders, referred to on the project as “needle” girders, were threaded through the window openings on the east

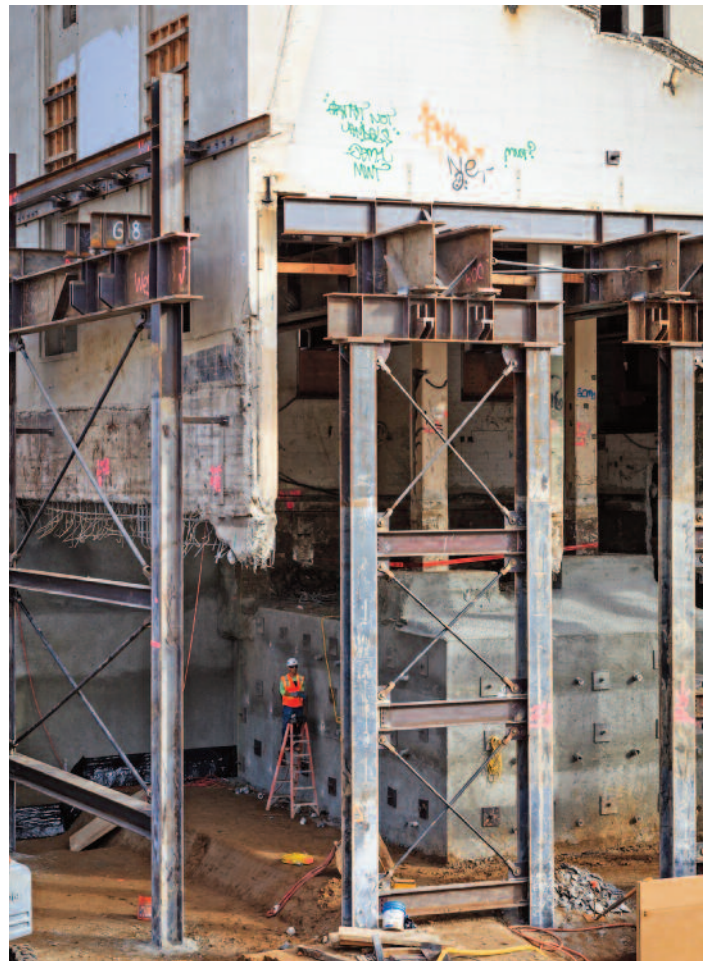
*Bracing between building support piles installed as excavation progressed. Photo property of Alejandro Velarde, provided courtesy of Degenkolb Engineers.*

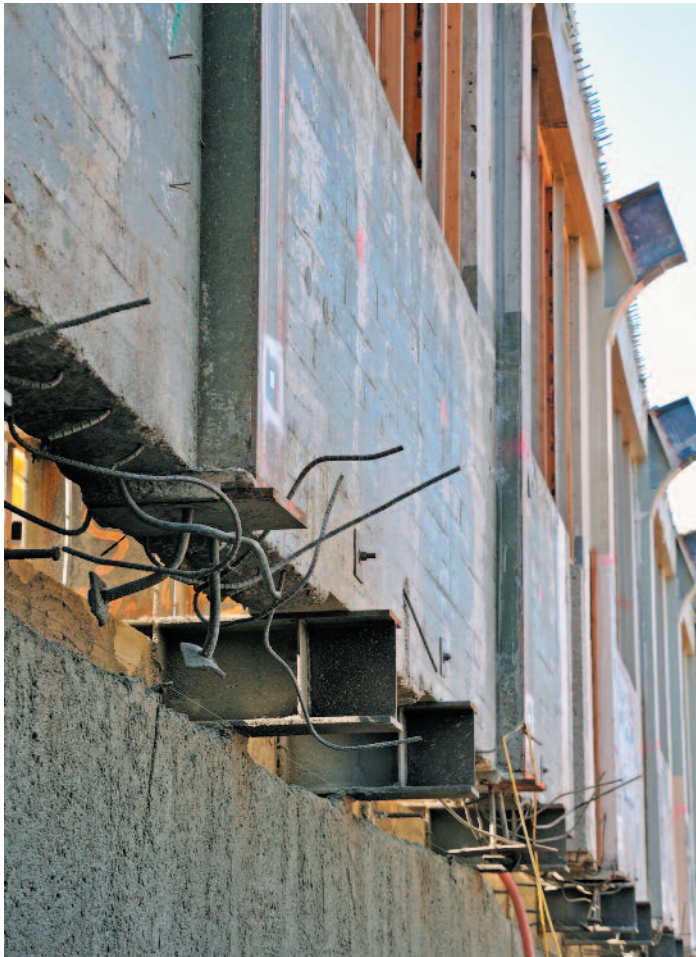
Stub beams attached to shoring piles behind the Press Building Wall "floats" the wall above excavation and shoring

Connecting the press building wall to the soldier pile supports were stub beams with welded connections to the original steel embedded in the structure. The basement wall was then removed in sections and lagging boards installed between soldier beams to re-

tain the soil behind. The result was a system that allowed for the excavation to continue below the “floating” wall and for the permanent structure to be built beneath it.

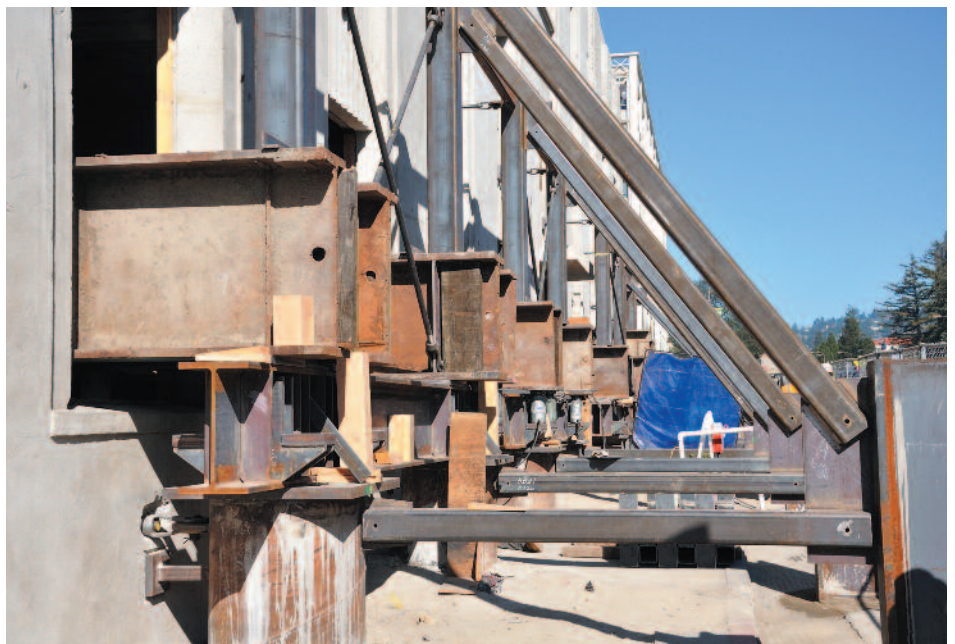
East Buttress frame at Admin building captures vertical loads through W36 girders and horizontal loads through high strength rods attached to floor slabs at 1st and 2nd levels.

The lateral support system was constructed to resist seismic and soil pressure forces. Although the building supports will not remain in place after the new museum is finished, earthquake loading was considered since the project was located less than a mile from the Hayward Fault. A second row of piles was installed to the east of the building, acting as a backstay to the braced frame capturing loads from the first and second floors. Horizontal rods bolted to the floor slabs transferred loads to the east brace frame, eliminating the need for a braced frame on the west side of the building.

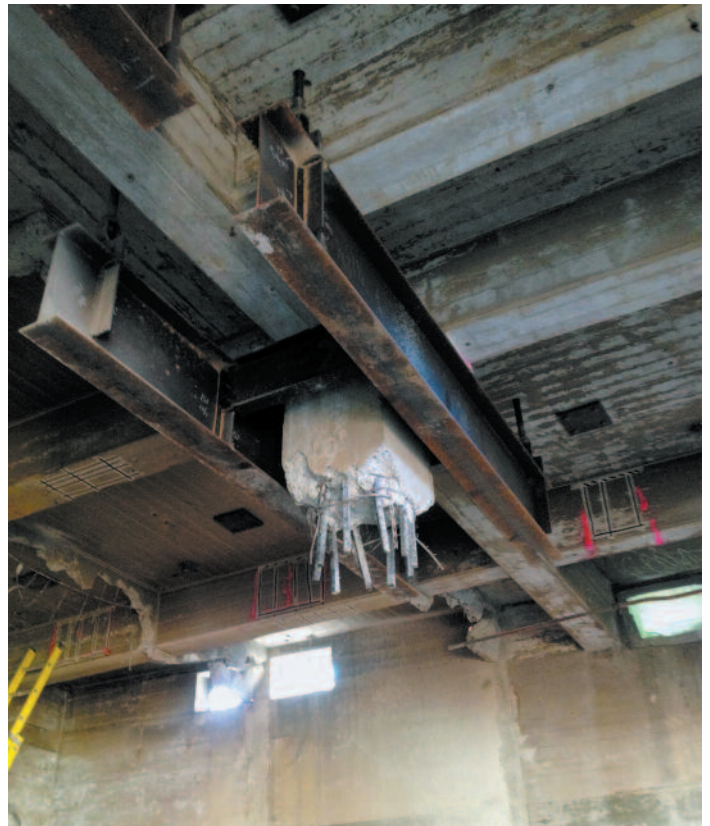
*Support beams hanging from W36 girders above capture loads from columns in the Admin Building basement. Columns were demolished after jacking procedure transferred building weight to temporary supports.*

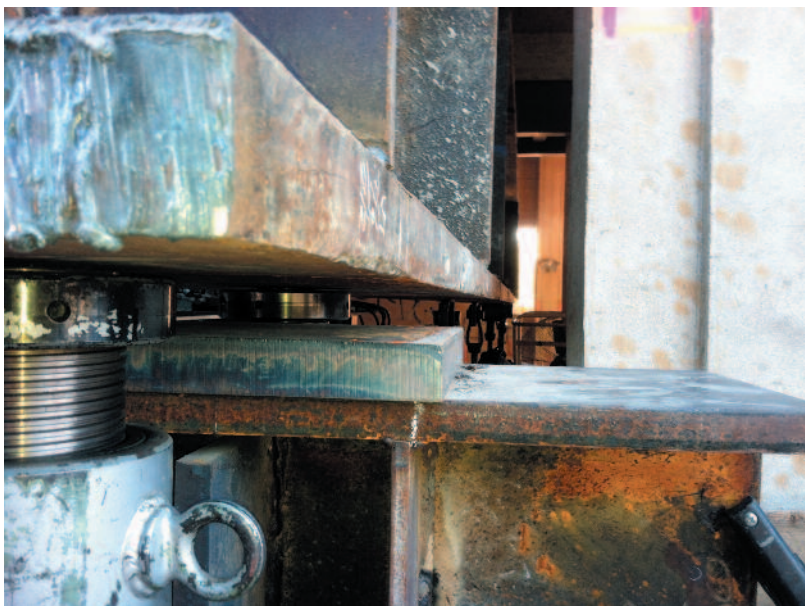
*Jacking the W36 needle girders using two hydraulic jacks to lift each end of the beam. Under the weight of the building, the middle of the beam did not move.*

construction and excavation. Degenkolb Engineers developed the multi-part sequence of jacking, cutting, shimming, and setting down to limit deflection of the existing structure. Condon-Johnson used a total of eight 100 ton jacks and a manifold system to load 58 jacking points around the perimeter of the building. Survey monitoring was performed full time during jacking to ensure movement remained within allowable limits.

The multi-part sequence succeeded in keeping the building flat, offsetting the needle girders over three inches deflection in the middle. In sequence, the columns in the interior of the building were jacked first, then the concrete support columns chipped and rebar cut to separate the interior columns from their footings. Jacks then lifted the building very slightly while shims were installed beneath the severed columns. Finally, the exterior walls were shimmed tight to the needle girder and the entire girder jacked to load. This process was repeated for each pair of girder beams, one after the other, until the entire building was resting on the steel supports and removed from its original foundations. With the building weight transferred to the temporary supports, the needle girders raised three inches at the jacking points while moving

less than 1/16 of an inch in the middle. The entire jacking process took eleven days to complete.

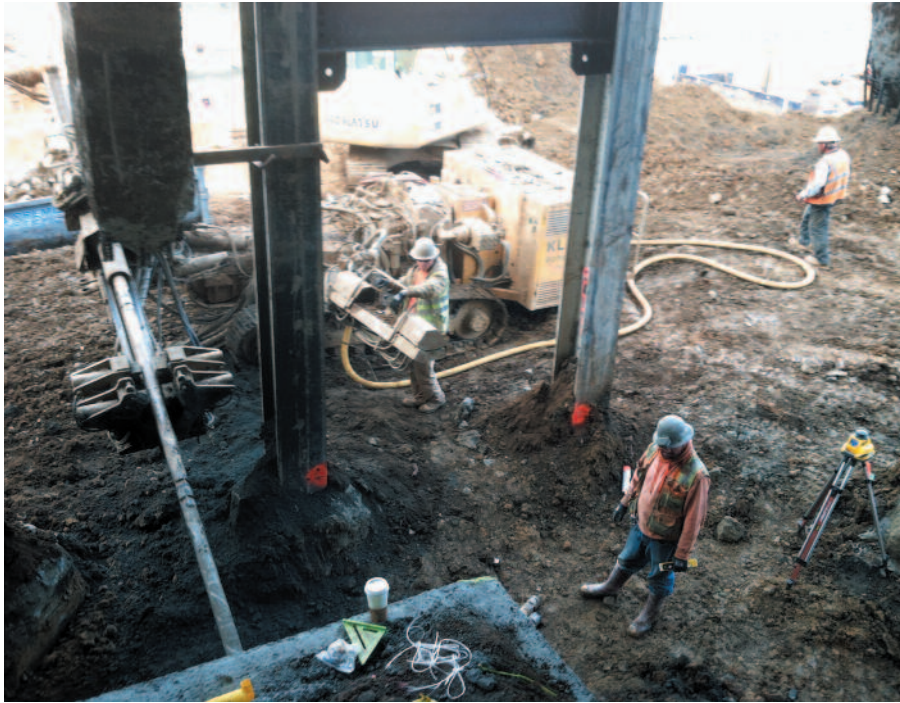
Drilling soil nails to support columns in the Admin Building basement while building "floats" overhead.

Of the existing columns supporting the building, two were identified as needing to remain in service when the rest of the building was on temporary supports. An inventive solution was needed to keep the columns in service, while at the same time allowing for excavation to occur around them. The solution was to install a three sided soil nail wall boxing in the columns and installing select nails flat, effectively acting as tie rods to secure the third side of the wall. The nails had to be installed from the outside and the building and exterior support steel with the rig positioned over 20 feet from the face of cut. ADSC Associate Member, Williams Form Engineering supplied the No. 8 soil nail bar used on the project.
