# MDS89745RA/H (2304) Troubleshooting Guide

Revision 1 - 12/03/2019 – Released by William Laubach

- Knockdown Bath Bench with Arms and Back
- MDS89745RA, MDS89745RAH
- Features aluminum frame with **weight capacity of 350lbs.**

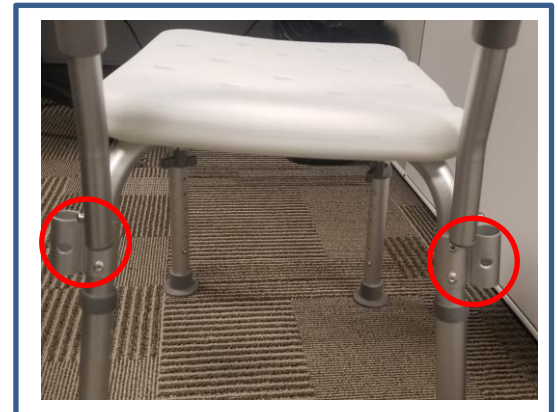
Figure 2 - Top Issue #2, Side view

- ☐ ☐ Is the complaint for the arms not fitting like in Figure 2 (holster are on the front and back sides of the frame)?
  - If yes, continue to the next question.
  - If no, continue to Complaint Form on Page 2 and elaborate on what they are experiencing.
- ☐ ☐ Are there any dents, fractures or other damage to the product?
  - If no, continue to next question.
  - If yes, continue to Complaint Form on Page 2 and note what specific part, per Appendix A, is damaged.
- ☐ ☐ Are the arm holsters located on the outside as shown in Figure 2?
  - If yes, reference Appendix B on how to assemble the bench.
  - If no, continue to Complaint Form on Page 2 and elaborate on what they are experiencing in regards to the arms not fitting.

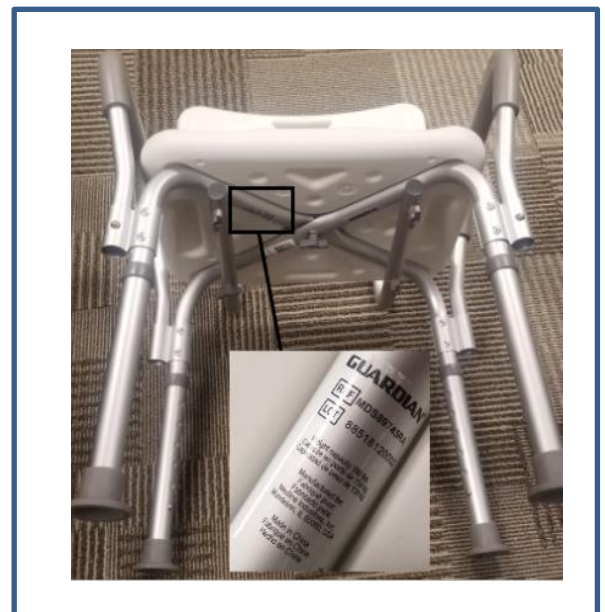
Figure 4 – Lot/Serial Number Location

- Lot Number/Serial Placement:
  - Lot number is located on a sticker placed on the cross frame.
  - **There are some differences in the components and vary by version. The lot number is crucial to identify which version the customer purchased.**

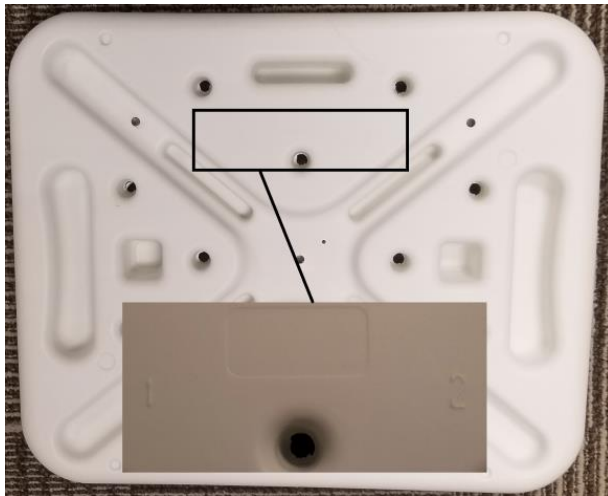
1. Place the seat upside down on top of a raised flat surface. You should be able to see the indentations of where the frame should be placed.
2. Note the seat will be imprinted with '1' and '2' for the version with lots numbers beginning with '885'. This will be the **back** end of the seat.

Note the seat will be imprinted with 'A' and 'B' for the version with lots numbers beginning with '956'. This will be the **front** of the seat.

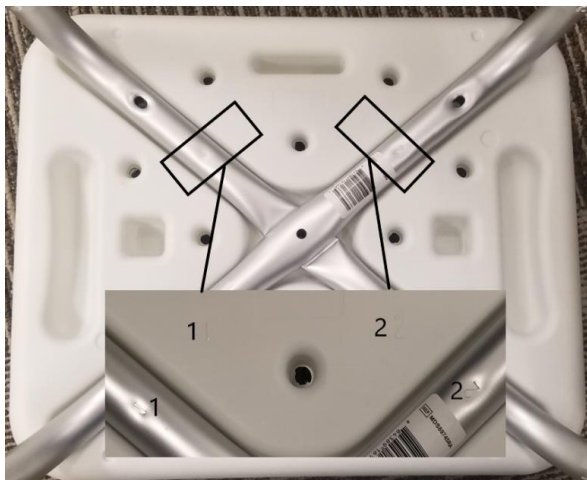
3. Locate the main frames, these are imprinted with '1' and '2'. Match the frame imprinted with '1' to the indentation on the seat imprinted '1' or 'A' (depending on the version). Do the same for the frame and seat imprinted with '2' or 'B'. **Note:** the '1' / 'A' frame is on the bottom, while the '2' / 'B' rests on top of '1' / 'A' as shown below.

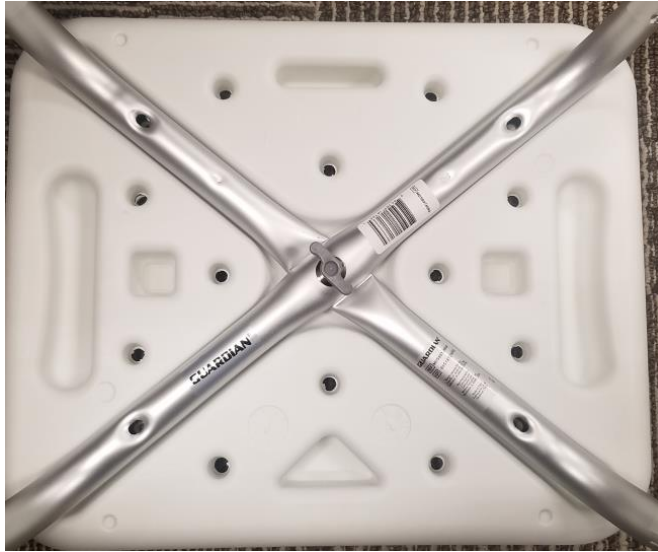
4. Use the washer and one (1) of the five (5) short hand screws provided to secure the center cross section.  
Note: items with lot numbers beginning with '885' will all have the same size short hand screws. Items with lot numbers beginning with '956' will have one that is longest of the short screws and this one will be used to secure the cross section.

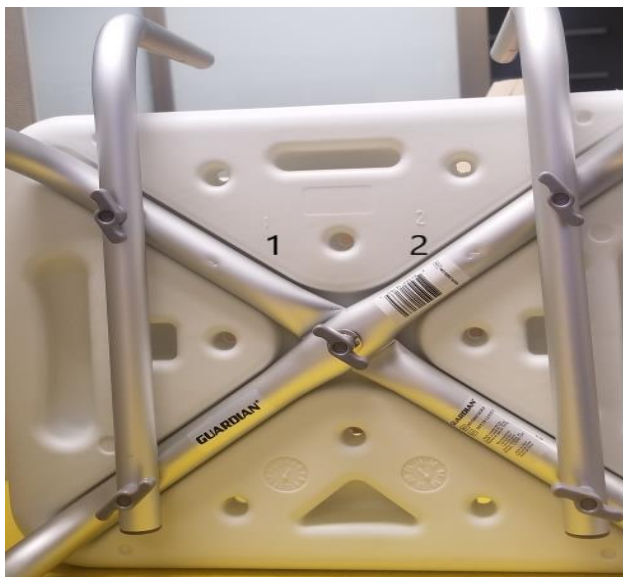
5. Lay the bench on its side.
6. To attach the backrest tubes to the bottom of the bench, use the four (4) long hand screws. Each hand screw should be inserted through the back rest tube and leg tube. Ensure that the back rest tubes to attach the backrest pad is towards the back end of the seat. **Reminder:** the back end of the seat is where the imprinted '1' and '2' are located for items with lot numbers beginning with '885'. Items with lot numbers beginning with '956' will have 'A' and 'B' imprinted on the front side of the seat.

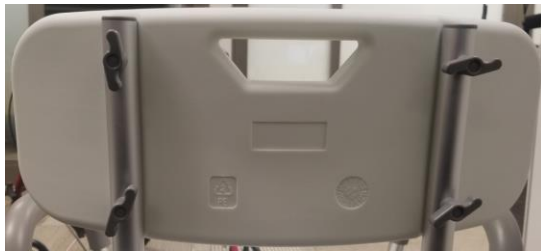
8. Stand the chair upright and use the remaining four (4) short hand screws to attach the backrest pad.

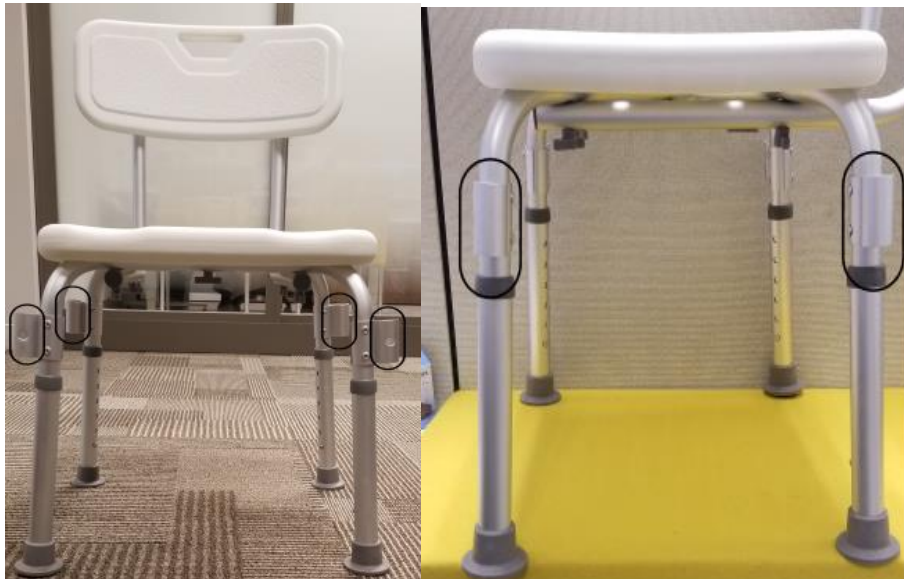
9. Please note that the armrest holsters are on the side of the frame as shown below.

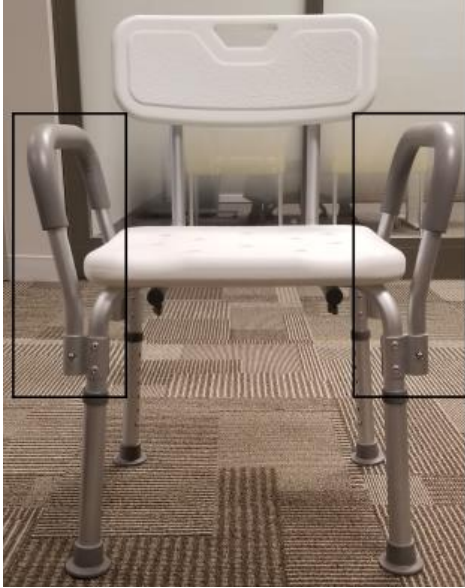
10. Insert one arm rest into the armrest holders as shown below. Please note that the arm rests should flare outward.
