# Cross River Rail Project

## Monthly Environmental Report

April 2020

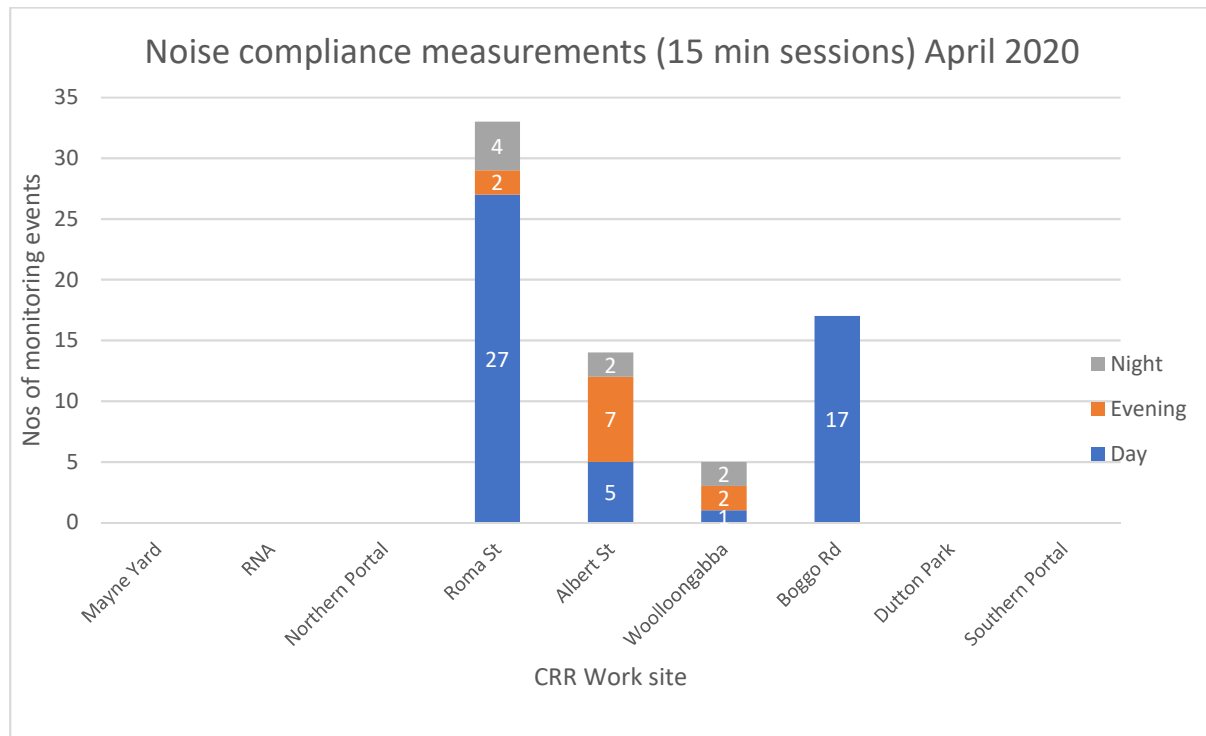
TSD undertook noise monitoring on 69 occasions during April as summarised in the graph below and detailed in **Appendix B**. Compliance monitoring was completed at the Albert Street, Boggo Road, Roma

Street and Woolloongabba worksites as well as Dutton Park Station. It should be noted that the noise goals have been nominated as internal levels. Where internal monitoring has not been possible for the contractors, they have undertaken external monitoring at nominated locations pending their work activities. The contractors noise consultants have then nominated suitable façade attenuation corrections, considering receiver property type, to determine compliance against the project’s noise goals and to provide further calibration of the completed modelled predictions. The contractors have reported that the project noise goals have been met during this reporting month.

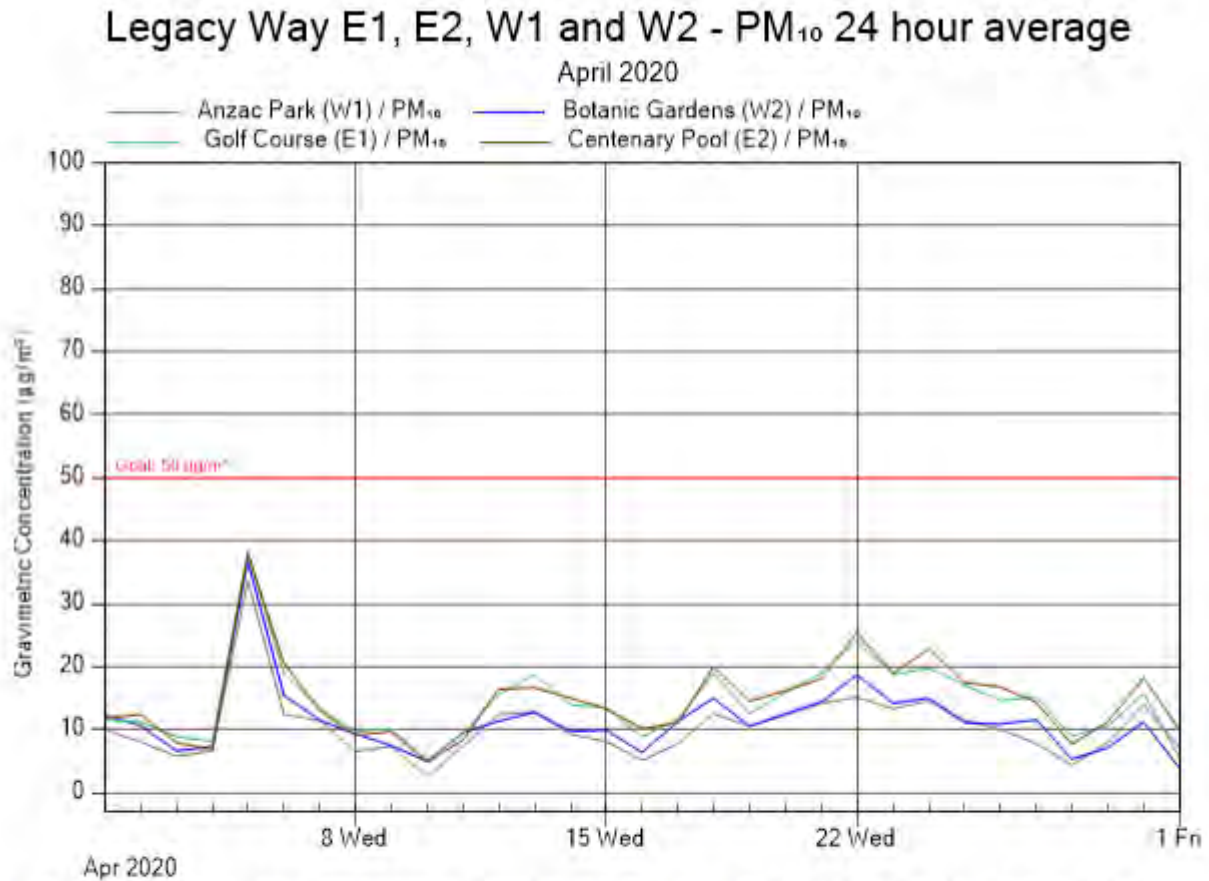
**Figure 5: Transurban QLD Legacy Way (E1, E2, W1 and W2) - PM<sub>10</sub> graph for April 2020**

There were no exceedances recorded for the reporting period for PM<sub>10</sub> near the northern corridor.

Figure 1: PM<sub>10</sub> Monitoring for the Northern Corridor - April 20 Results – reproduced from Legacy Way Air Monitoring report accessed 18 May 2020

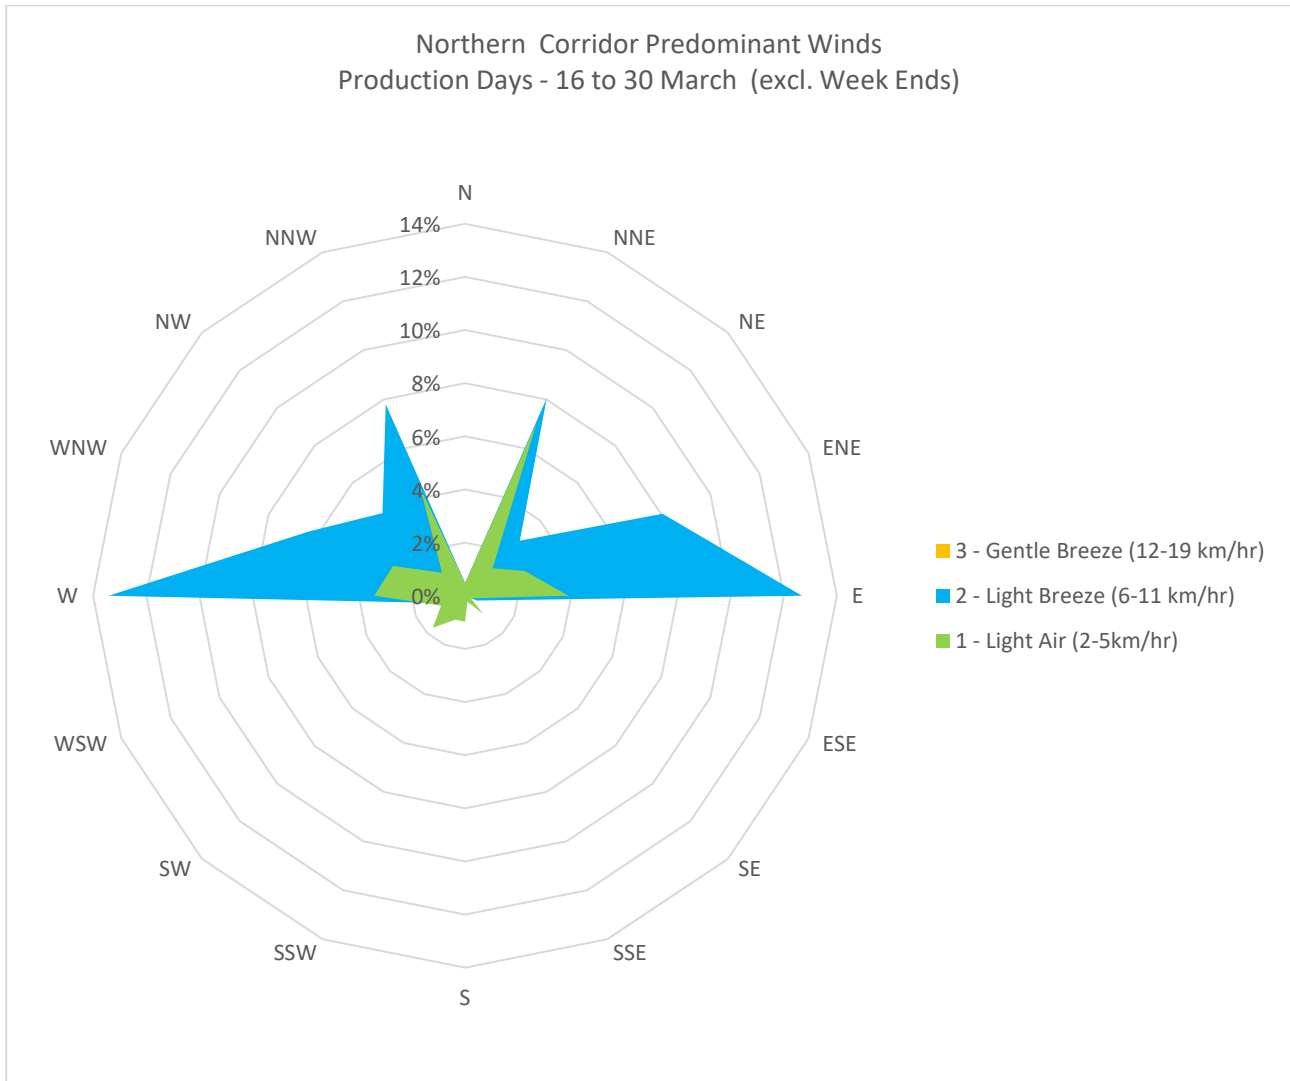
Plate 1: Prevalent Wind Conditions

- The prevalent wind conditions between 16 March and 30 March 2020 are presented in Plate 1 and summarised on Figure 5.
  - The winds were predominantly from the North-Eastern quadrant in the mornings, meaning AQ-02 dust deposition gauge was Upwind of the earthworks.
  - The winds were predominantly from the North Western quadrant in the afternoons meaning
    - AQ-02 dust deposition gauge was downwind of the haulage but not from the earthworks
    - AQ-03 dust deposition gauge was downwind of the earthworks
  - All the winds were deemed a light breeze under the Beaufort Scale.

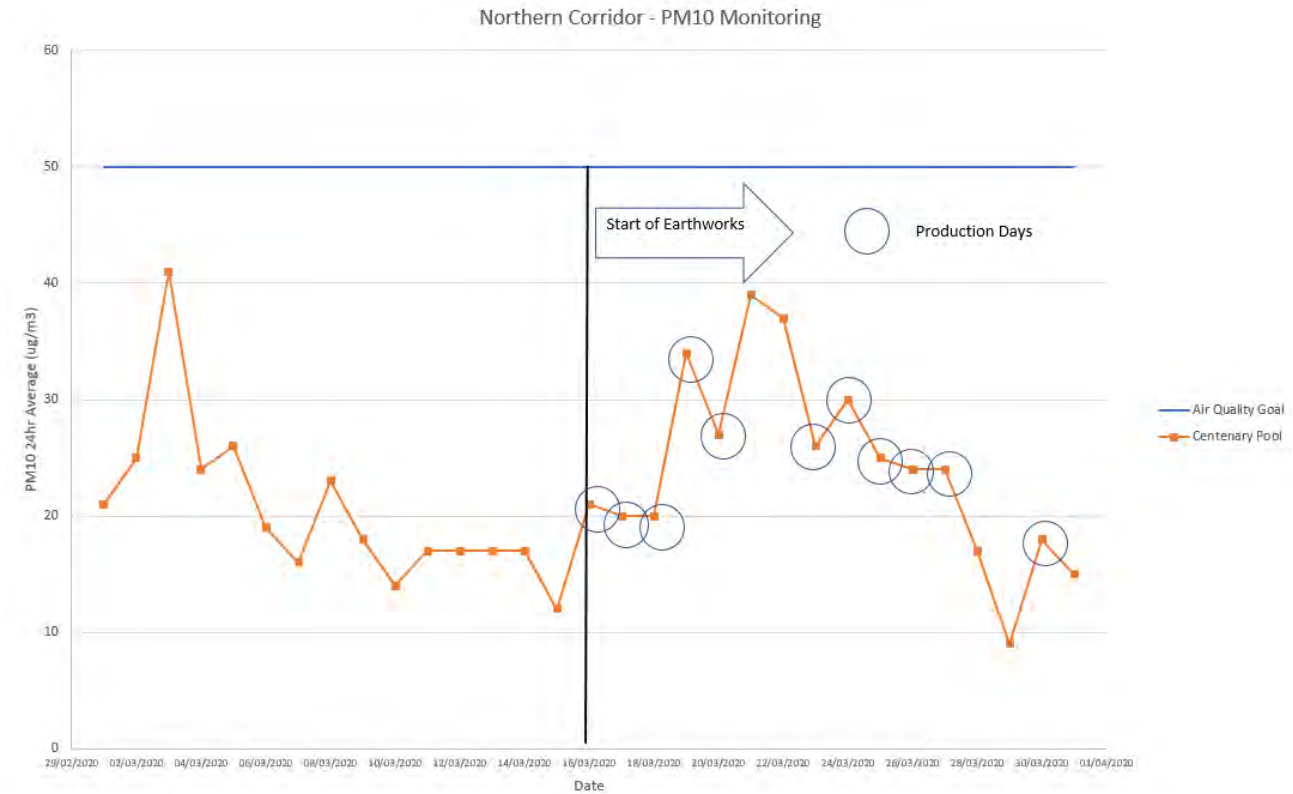
Figure 6: PM10 Results

- Field observations for visible dust during routine surveillance did not record visible dust beyond the project boundaries
- There were nil complaints related to air quality within the Northern Corridor Air Shed during the monitoring period.
- Other available data were
  - The results from the dust deposition gauge AQ-02, the closest to the works and typically downwind of the earthworks in the afternoons, did not exceed the Deposited Dust Air Quality Goal (120 mg/m<sup>2</sup>/day) with a reading of 47 mg/m<sup>2</sup>/day.
  - There was no recorded exceedance of the daily PM<sub>10</sub> Air Quality Goal during the days of earthworks.
  - The highest PM<sub>10</sub> results were recorded when no earthworks activities were being undertaken. The results have been reproduced below in Figure 6.

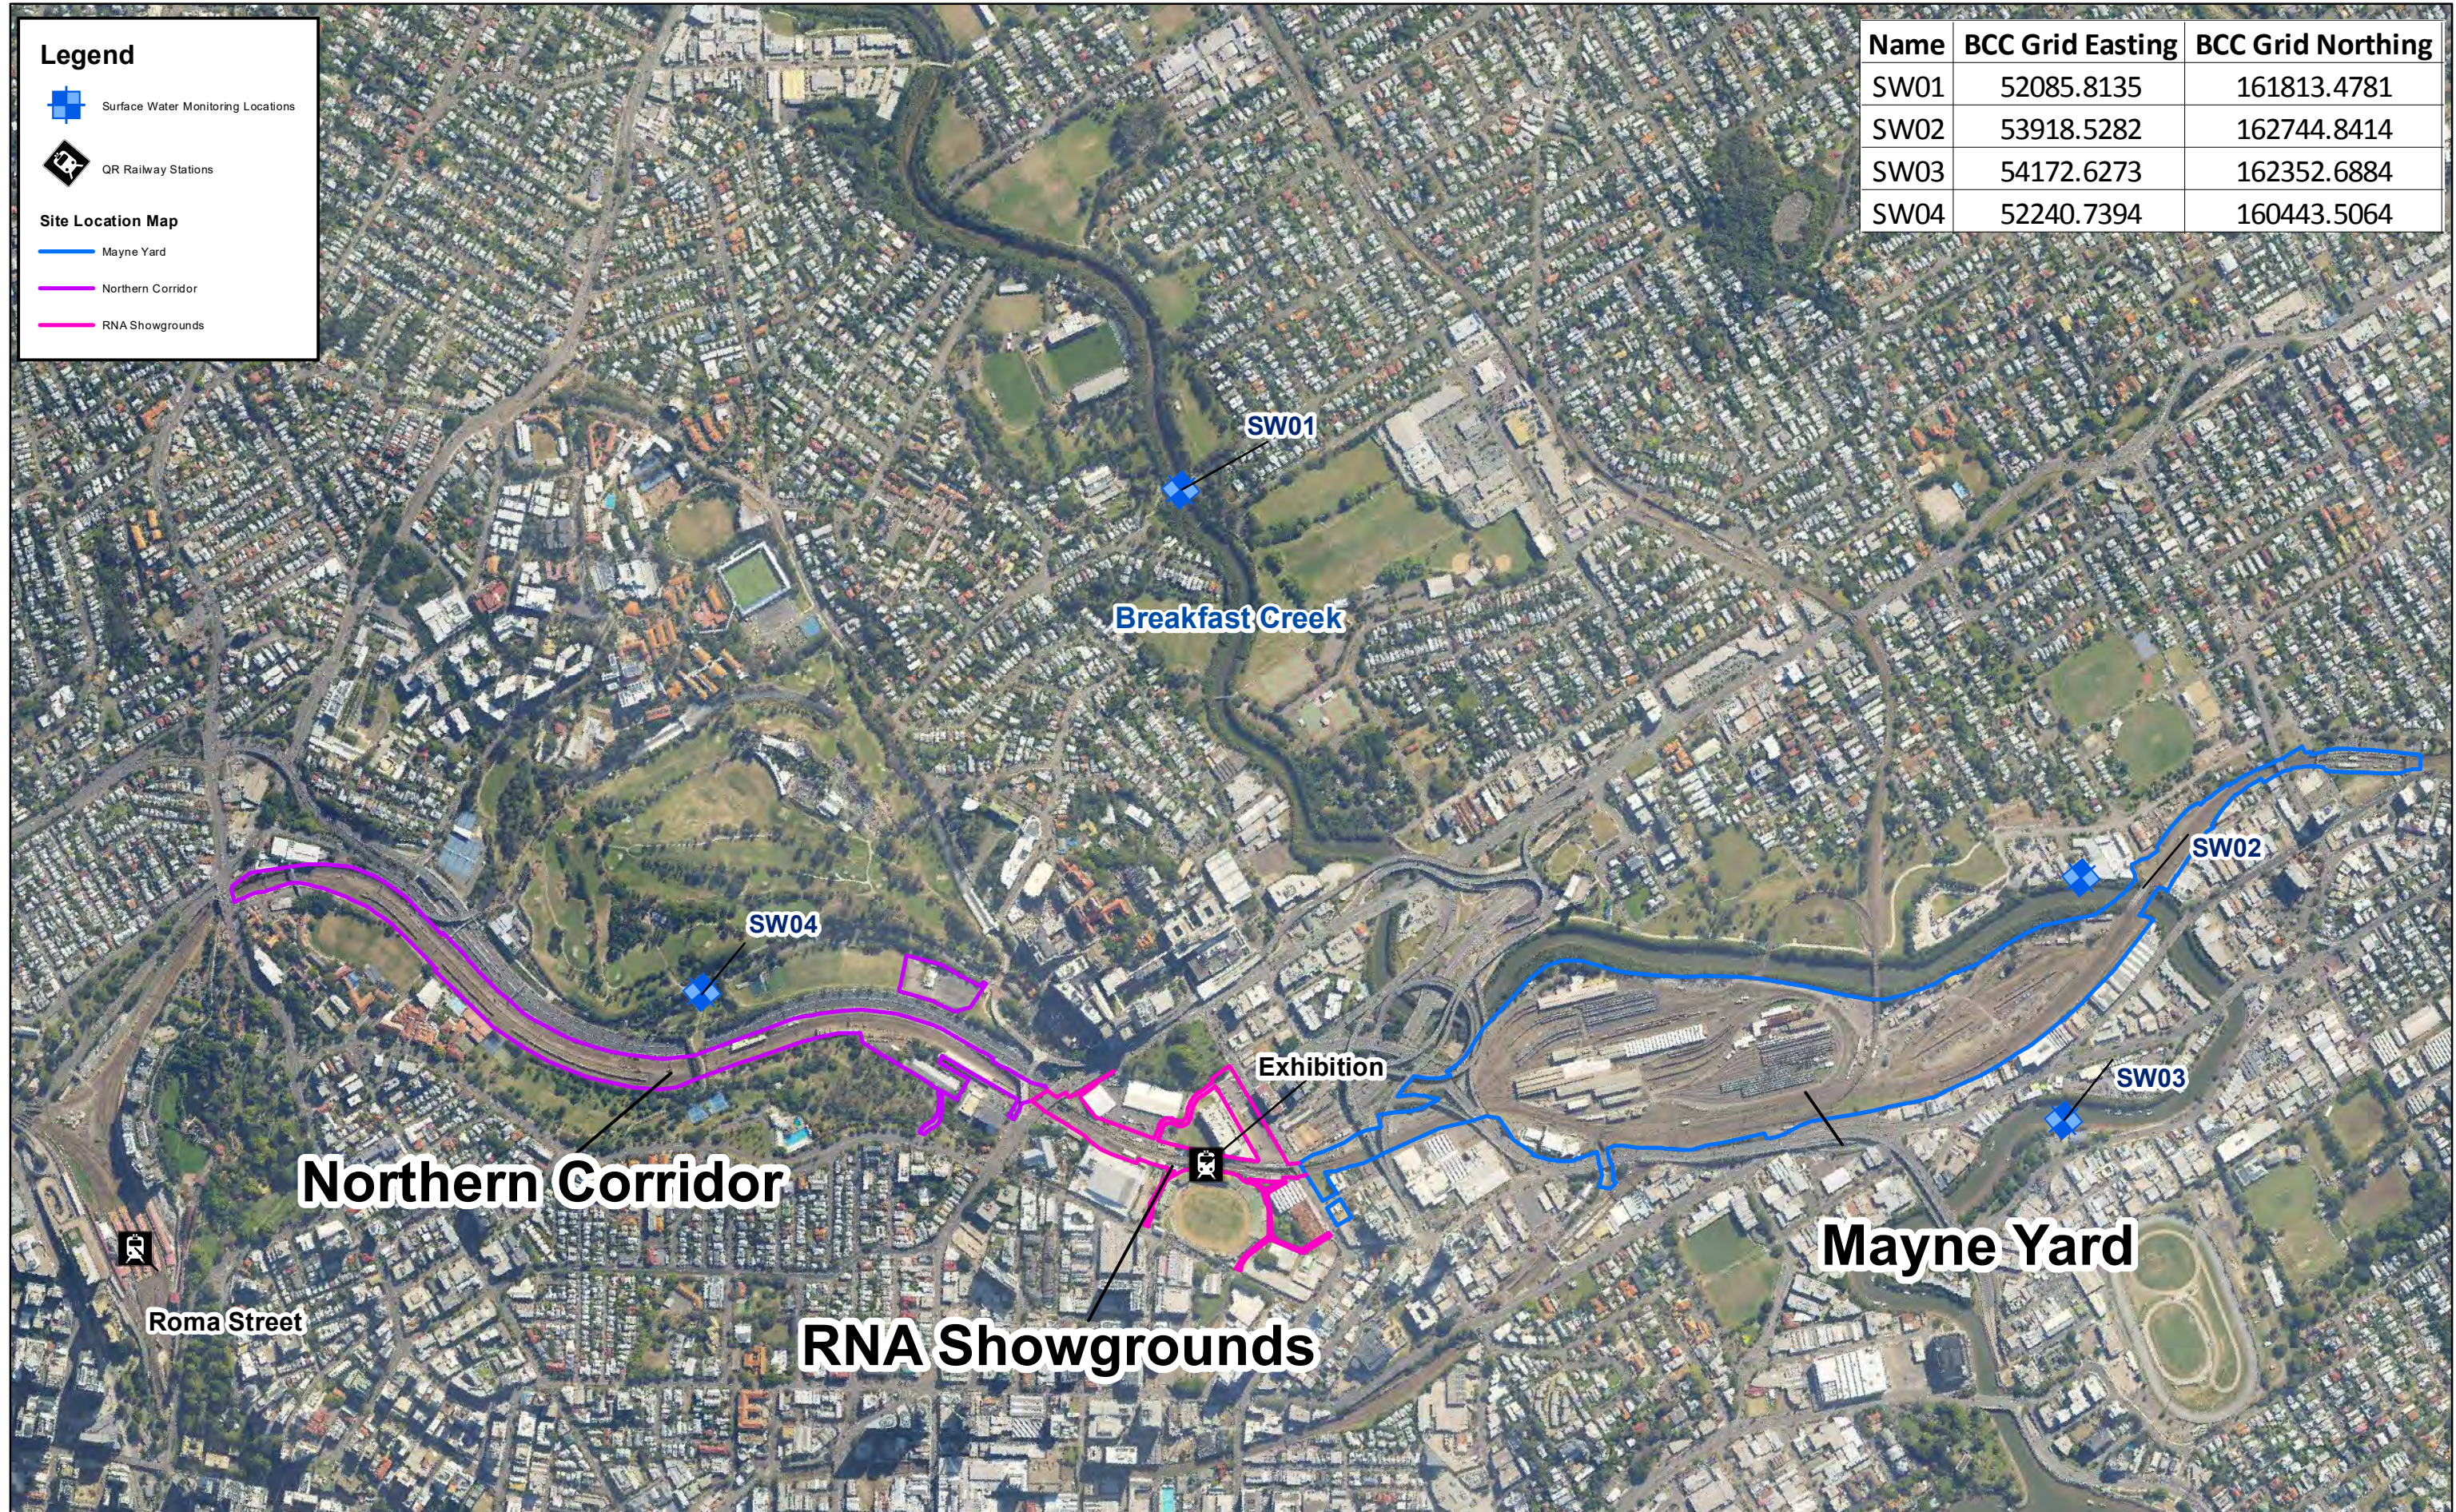
Rev	Description	Date	Approved
1	Overview Map	17/09/2019	J Perry

Name	BCC Grid Easting	BCC Grid Northing
SW01	52085.8135	161813.4781
SW02	53918.5282	162744.8414
SW03	54172.6273	162352.6884
SW04	52240.7394	160443.5064

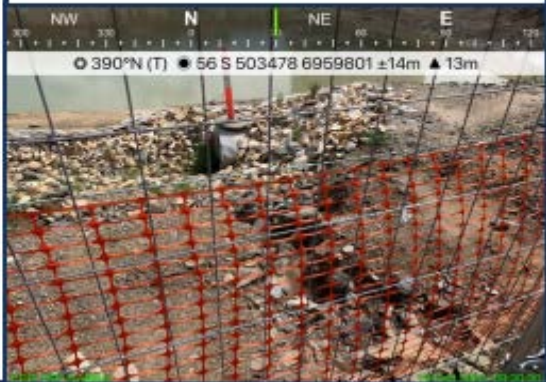
<b>Circumstances under which the non-compliance event occurred (include activity being undertaken, predictive modelling, monitoring etc)</b>	<p>The Woolloongabba worksite has been undergoing regular change in type of groundcover, landform, gradients and site drainage as a result of ongoing civil works within the site. During a site inspection completed by the Environmental Monitor on 19/02/202, he observed through site scouring, that overland flow had left the site through a damaged erosion and sediment control (earth-bund) and entered into a stormwater inlet. Refer to photos below captured on the day of the inspection which formed part of the Environmental Monitor Inspection Record (19/02/2020).</p> <p>19 February 2020 - Environmental Monitor Inspection Report.</p> <div style="display: flex; align-items: flex-start;"> <div style="margin-right: 10px;"> <p>Southern side internal haul road</p> </div> <div style="border: 1px solid black; padding: 5px;"> <p>Overland flow rilling by sediment laden runoff entering un-protected stormwater inlet.</p>

NCE Ref	CRRDA-NCE-TSD -001	NCE Ref (DA)	CRRDA-002
<b>Root cause of non-compliance</b>	<ul style="list-style-type: none"> <li>The erosion and sediment controls not properly maintained which allowed site water to travel to open drain.</li> <li>The ESC design drawing had not captured all latest site conditions and had not nominated an erosion and sediment control for this location within the worksite.</li> </ul>		
<b>Description of environmental effects and impacts</b>	Site water (unknown quality) entered stormwater inlet on site during a rain event breaking through bunding that wasn't repaired following the disturbance from plant and equipment moving along the haul road.		
<b>Was sampling or monitoring performed in relation to this event? (if so attach results)</b>	No. Visual observation by the Environmental Monitor only.		
<b>Actions already undertaken to mitigation environmental effects of this NCE</b>	Update of ESC design drawing to reflect site condition and inclusion of additional erosion and sediment control for this location, i.e. earth-bund.

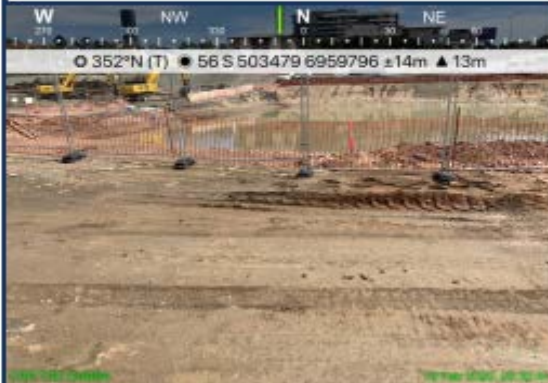
NCE Ref	CRRDA-NCE-TSD -001	NCE Ref (DA)	CRRDA-002
	<p>Southern side internal haul road</p>	<p>Large pooling zone of dirty runoff prior to entering un-protected stormwater inlet (Item 08.03).</p>

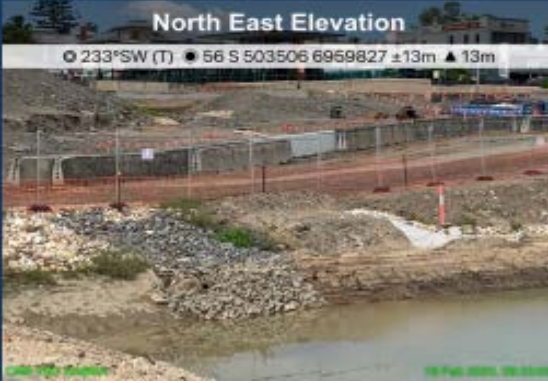
<p>Southern catchment above sediment basin.</p>	<p>Upstream stormwater runoff zone draining to un-protected stormwater inlet (Item 08.03).</p>
