**HYUNDAI**NEW THINKING.
NEW POSSIBILITIES.**Technical Service Bulletin**

17-01-021

See Below**SUBJECT: STOP LAMP SWITCH REPLACEMENT (RECALL 110)**

Description: This bulletin describes the procedure to replace the stop lamp switch.

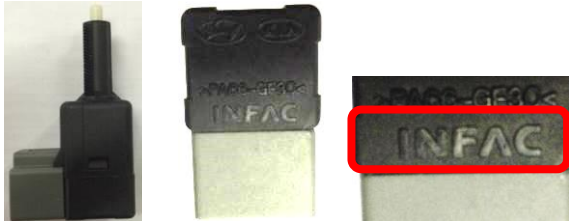
PICTURE	EXPLANATION

For vehicles under this recall, never install the previous version of the stop lamp switch. Refer to the picture in the table below.

The previous version is molded with "INFAC".

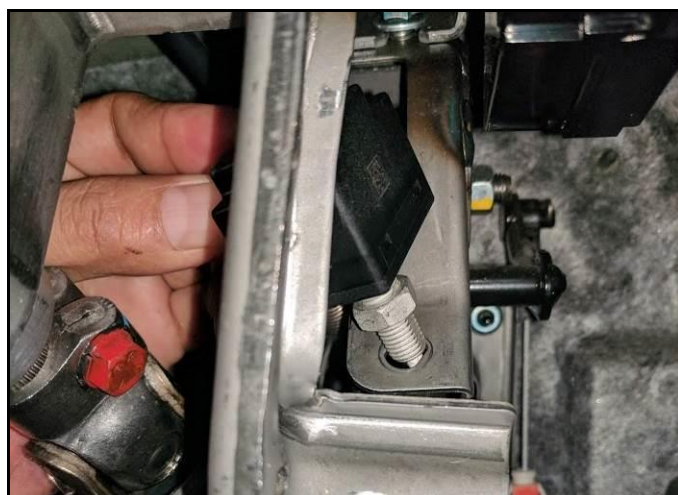
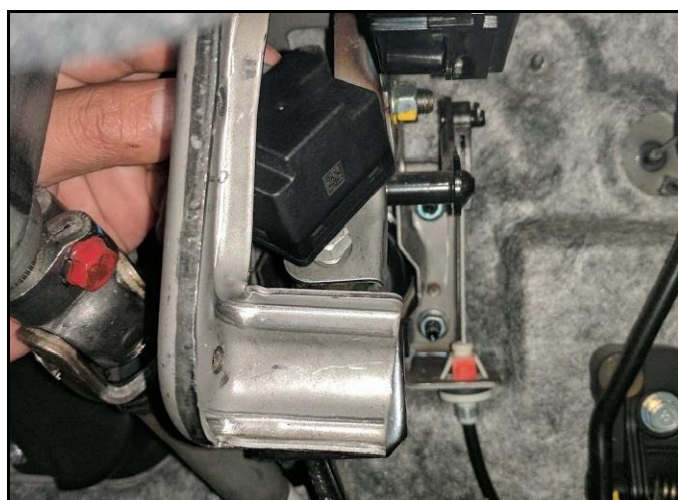
Accent (MC) - Part number 93810-3KR0AQQH has been superseded with 93810-4DR0AQQH. The part is physically larger however; fitment and operation should not be an issue. See below on this page for installation tips.

For **non** cruise control equipped vehicles, it is slightly difficult to install the superseded switch due to space limitation.

1. Grab the stop lamp switch by the connector side with the switch facing downward and place hand behind the steering column.
2. Slide the switch from top to downward and place the switch into the mounting bracket port.
