MTT MicroTravel Technology

Service and Maintenance Manual

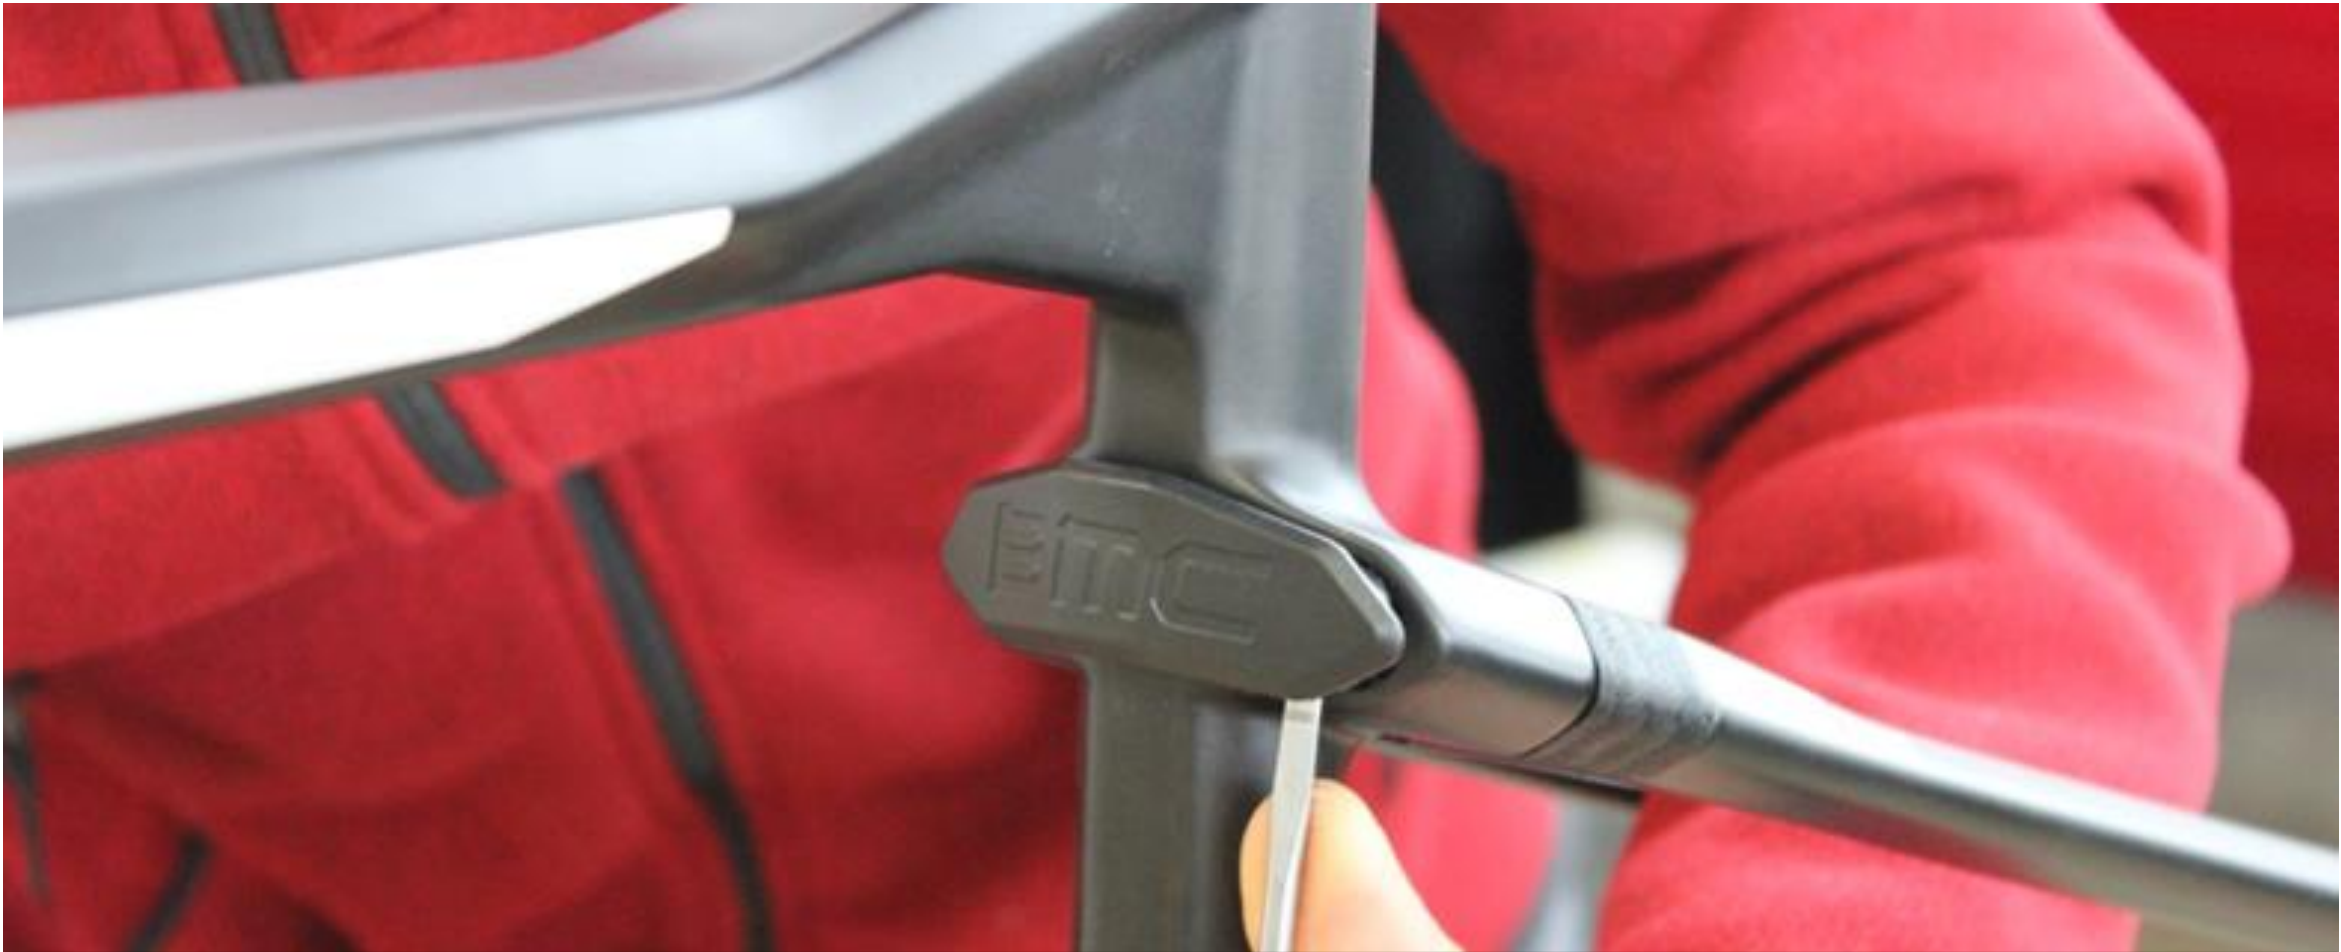
Remove the dust cover using a small flathead screwdriver, or other small, non-sharp utility. Be careful not to pry only one side, but rather work each side simultaneously – this protects the integrity of the cover.

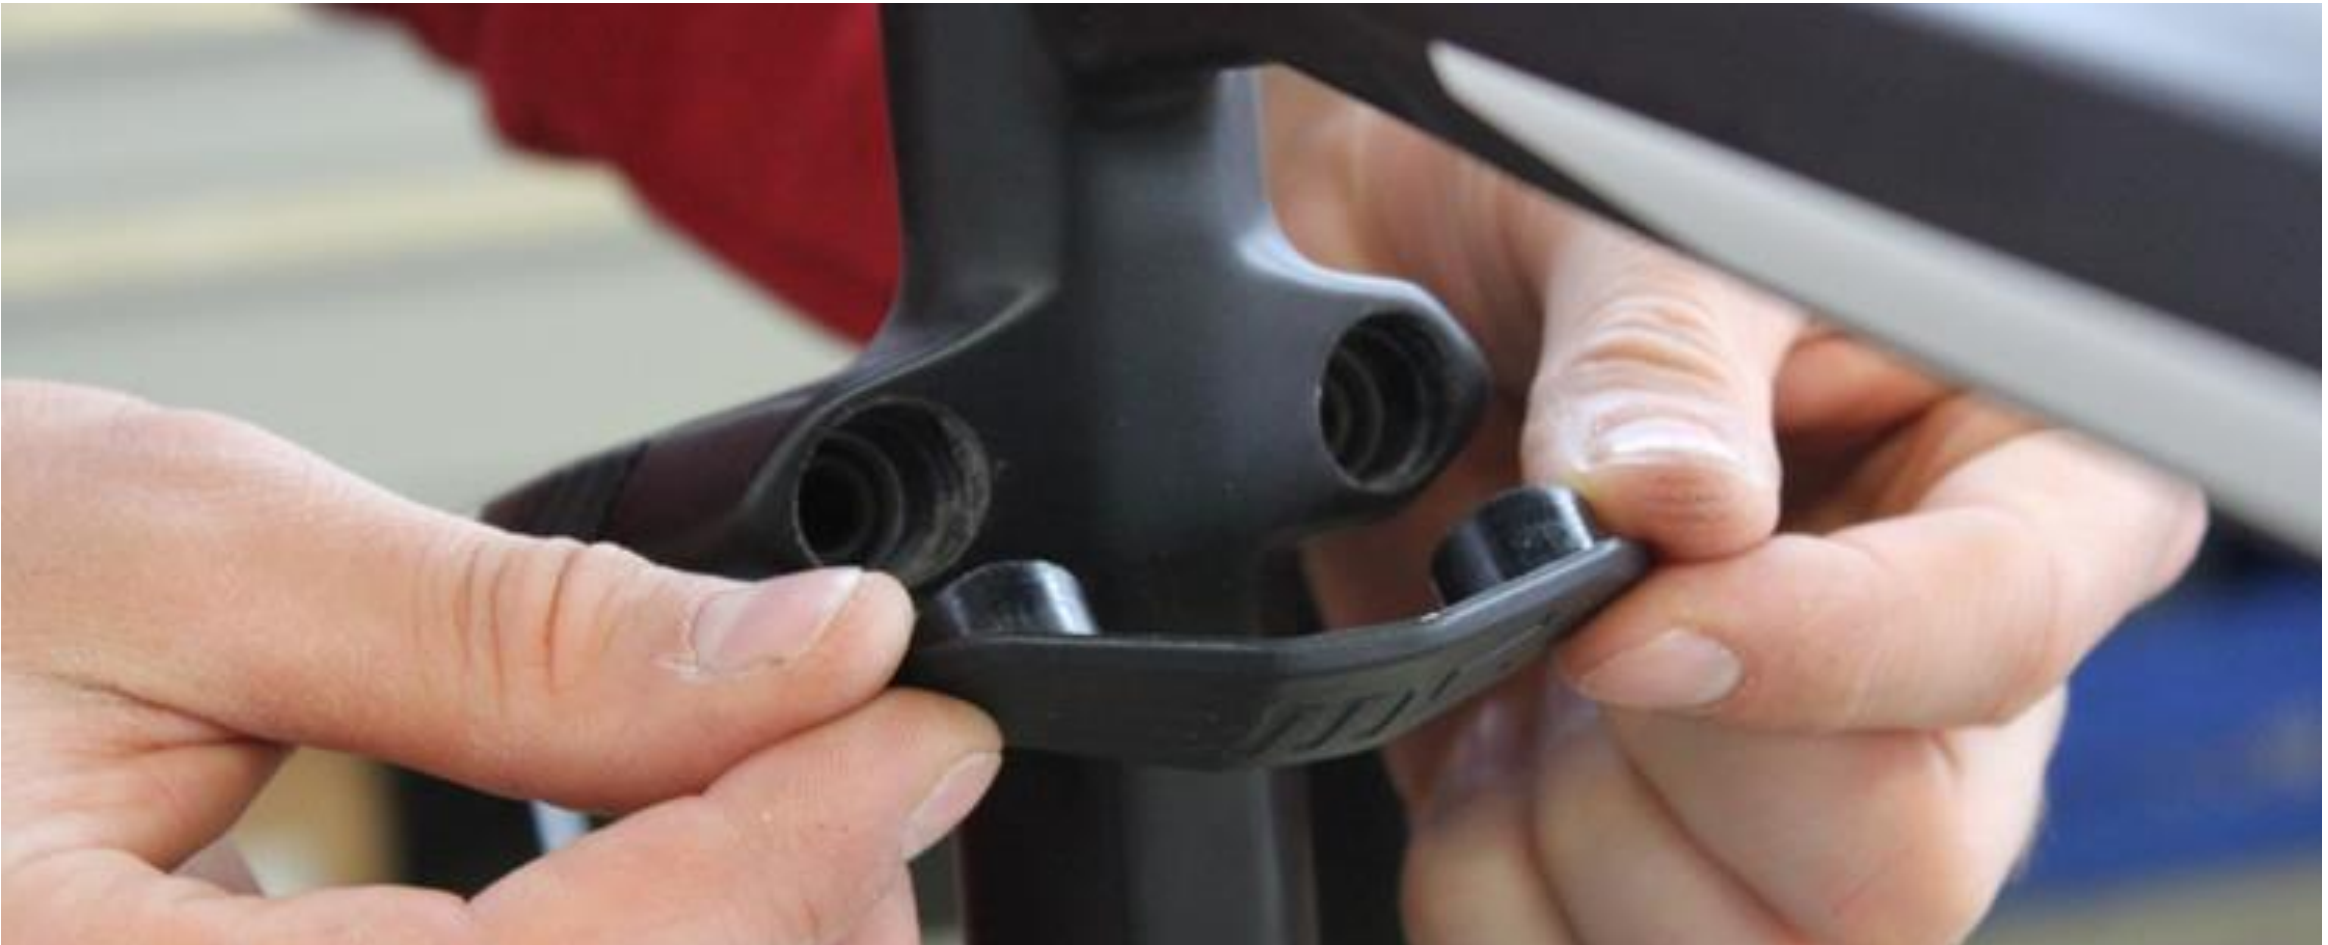
Removal of the dust cap exposes the 6mm allen key heads of the left (non-drive side) and right (drive side) guide shafts.

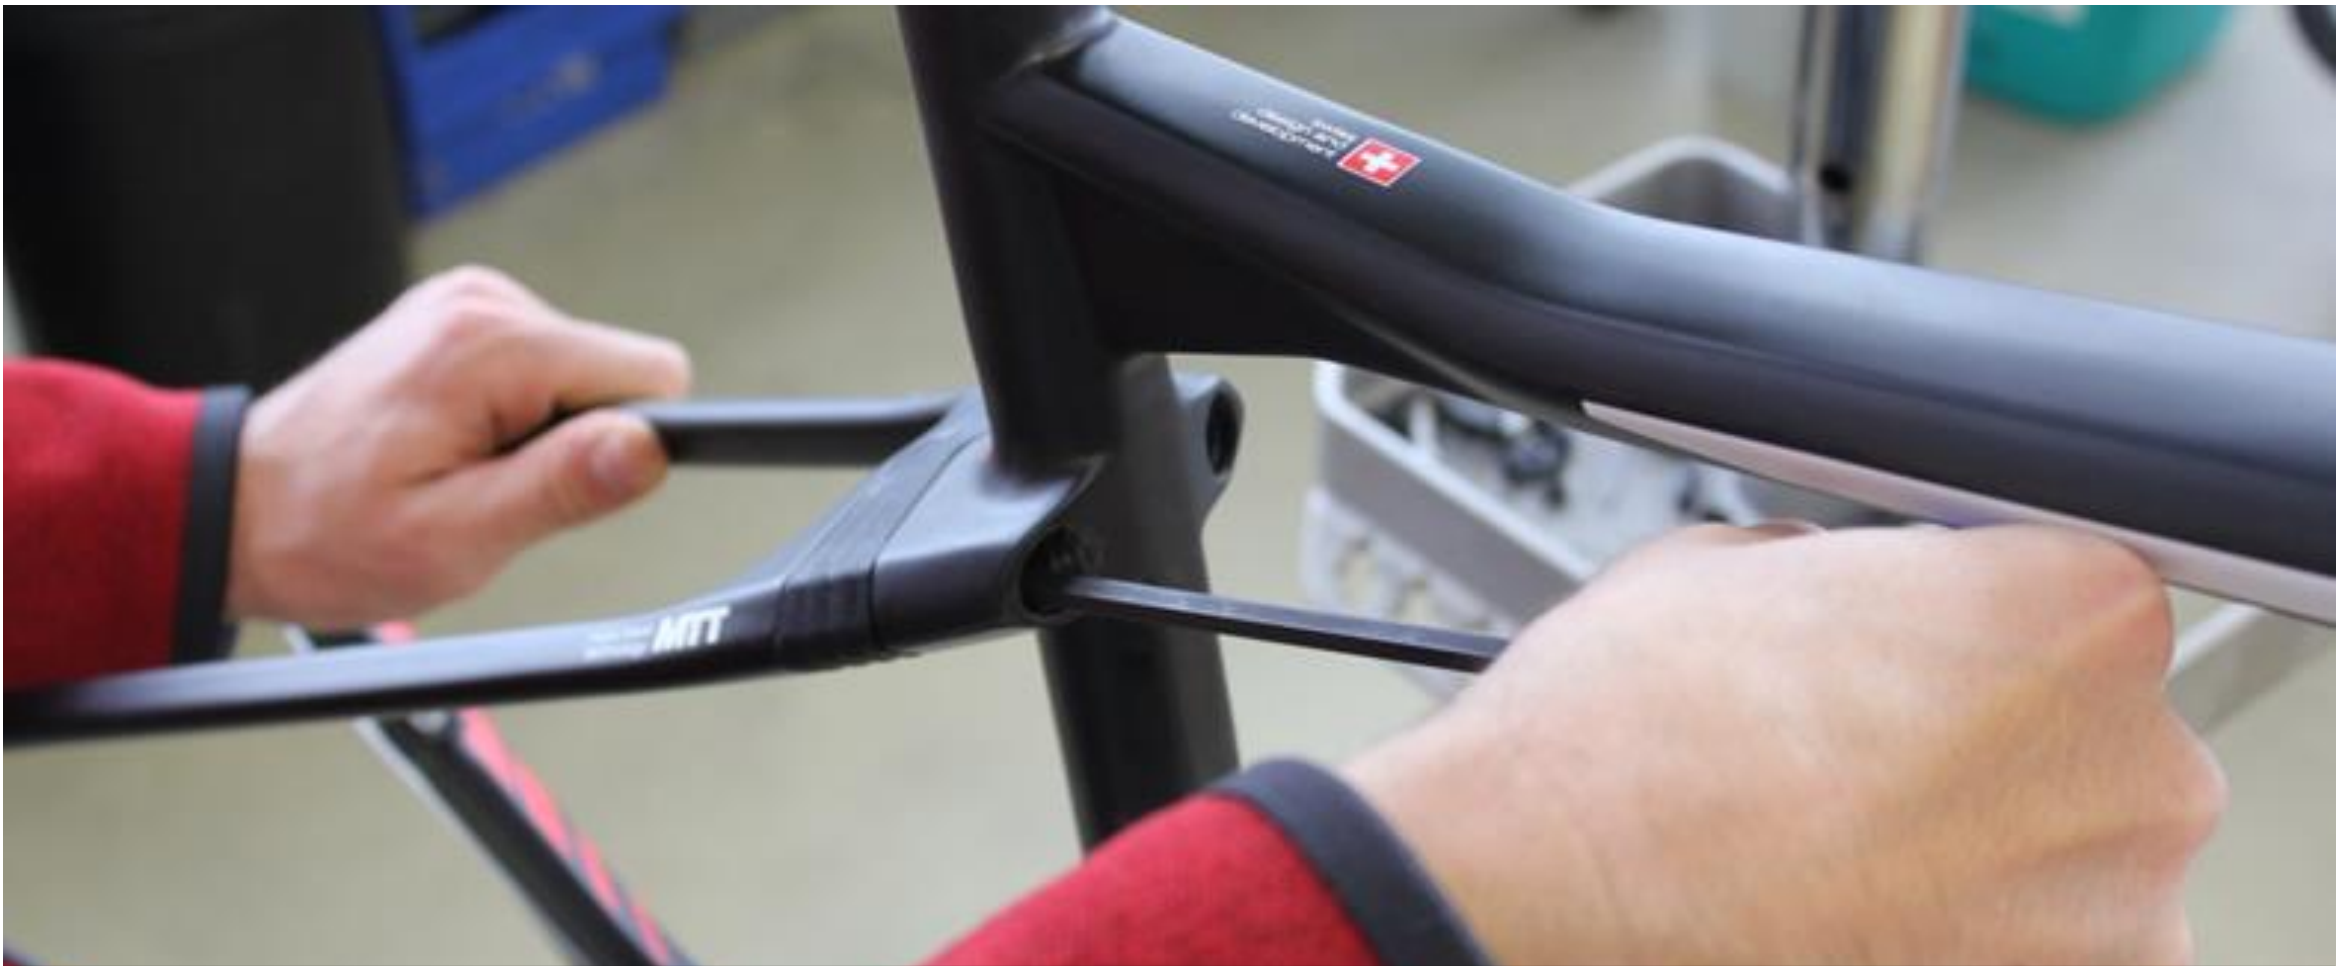
Using a 6mm P-handle or T-handle wrench, remove the left and right guide shafts until thread disengagement is complete. Both guide shafts are traditional thread – counterclockwise removal.

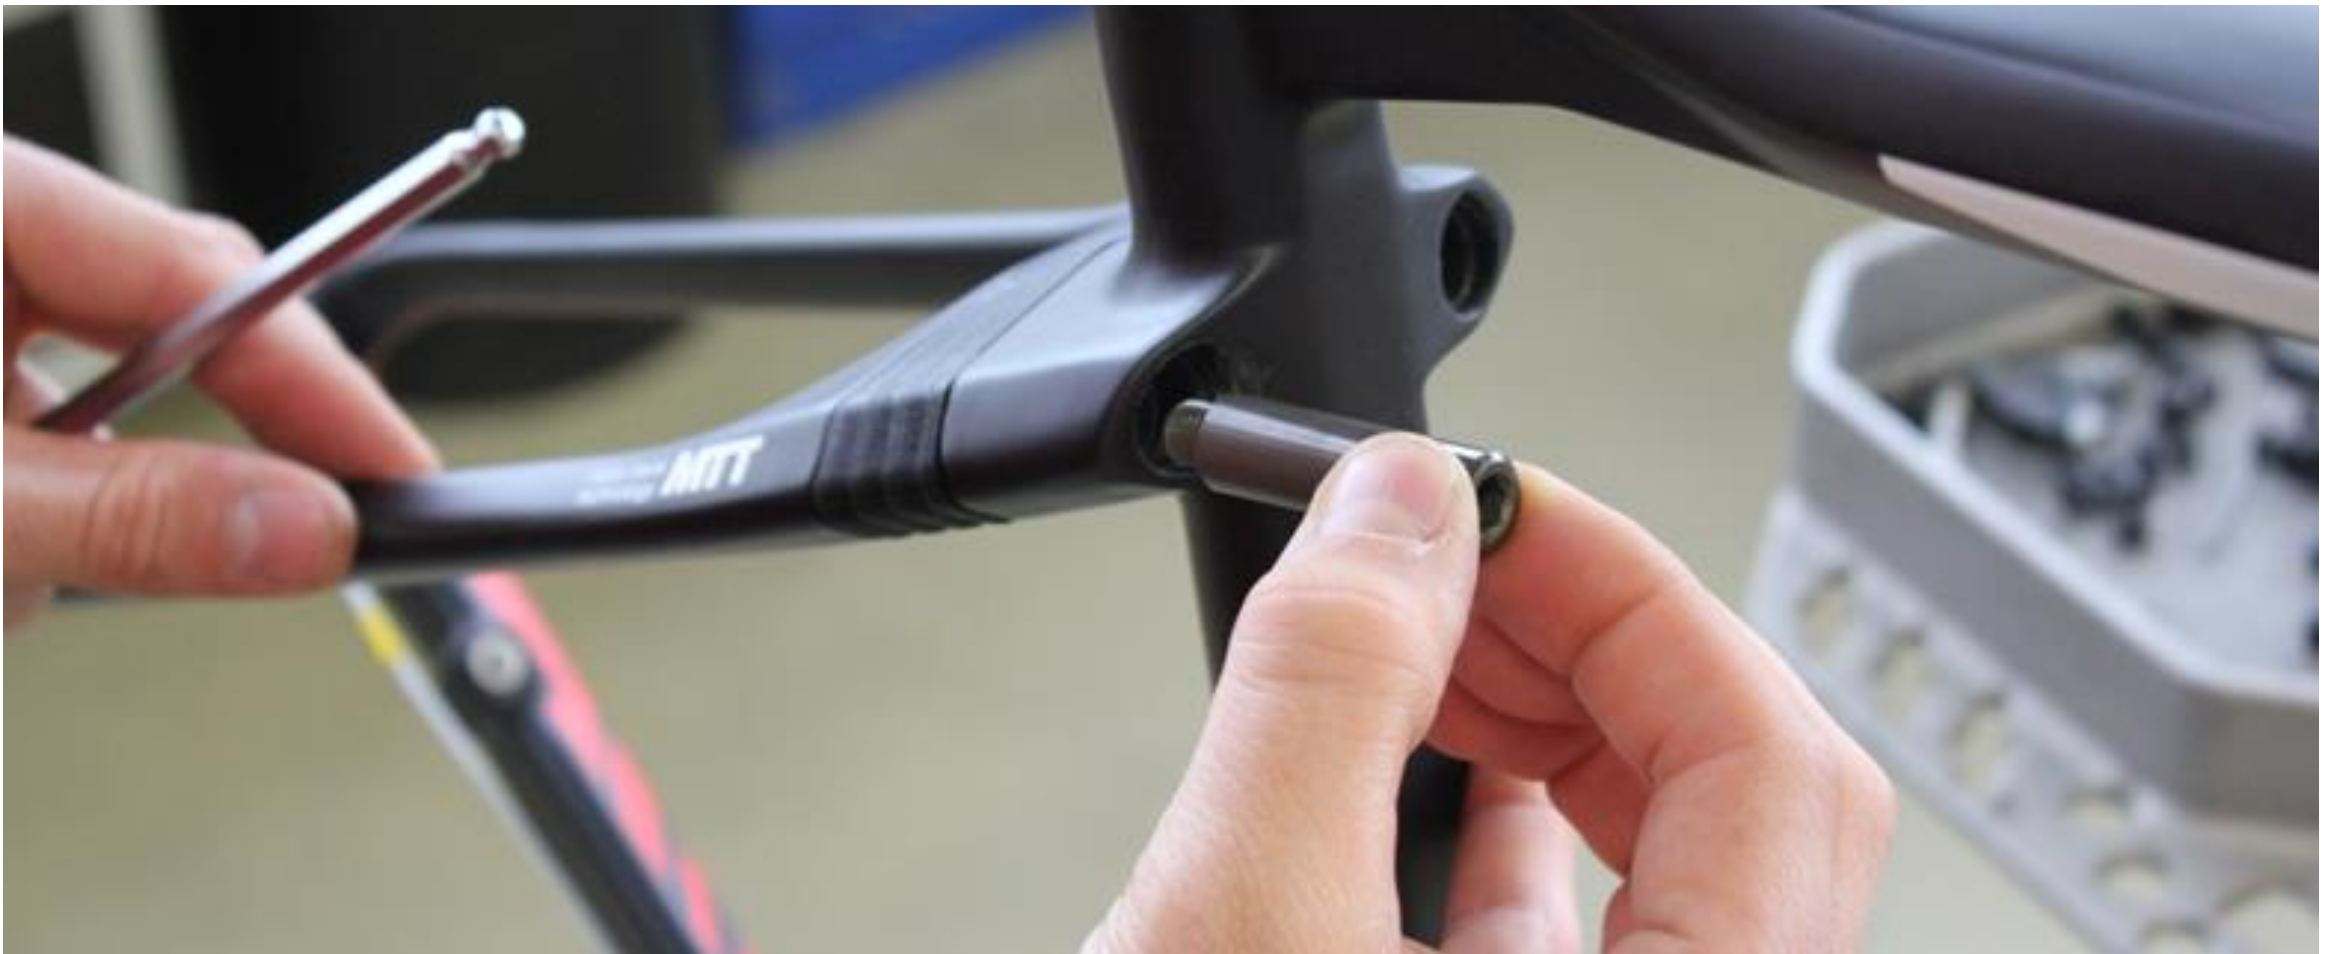
Carefully remove the left and right guide shafts from the seatstay assembly. Inspect guide shafts for wear.
Tip: with the allen key in place, rotate the allen key back and forth while withdrawing the guide.

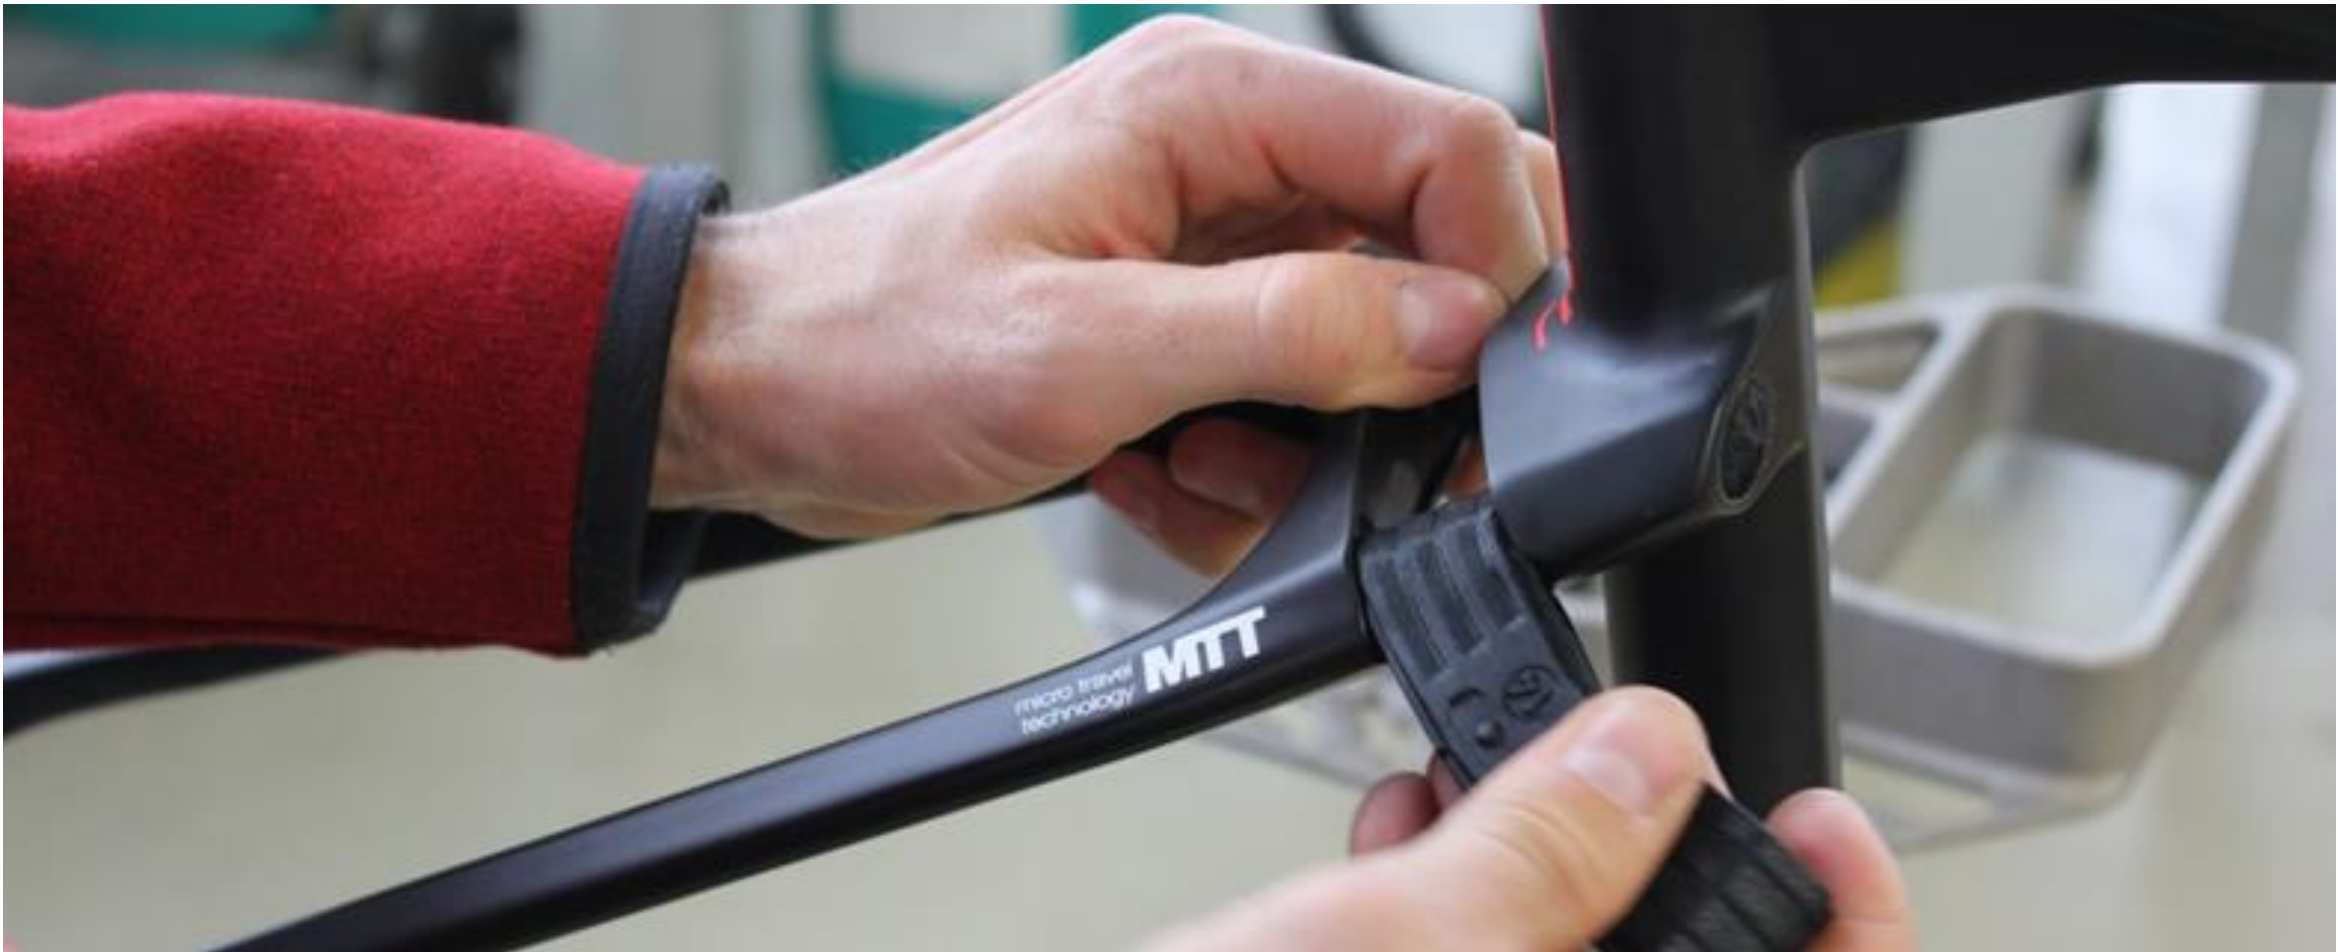
After both guides shafts are removed from the seatstay assembly, remove the **XCell Damper** from the **MTT** system.

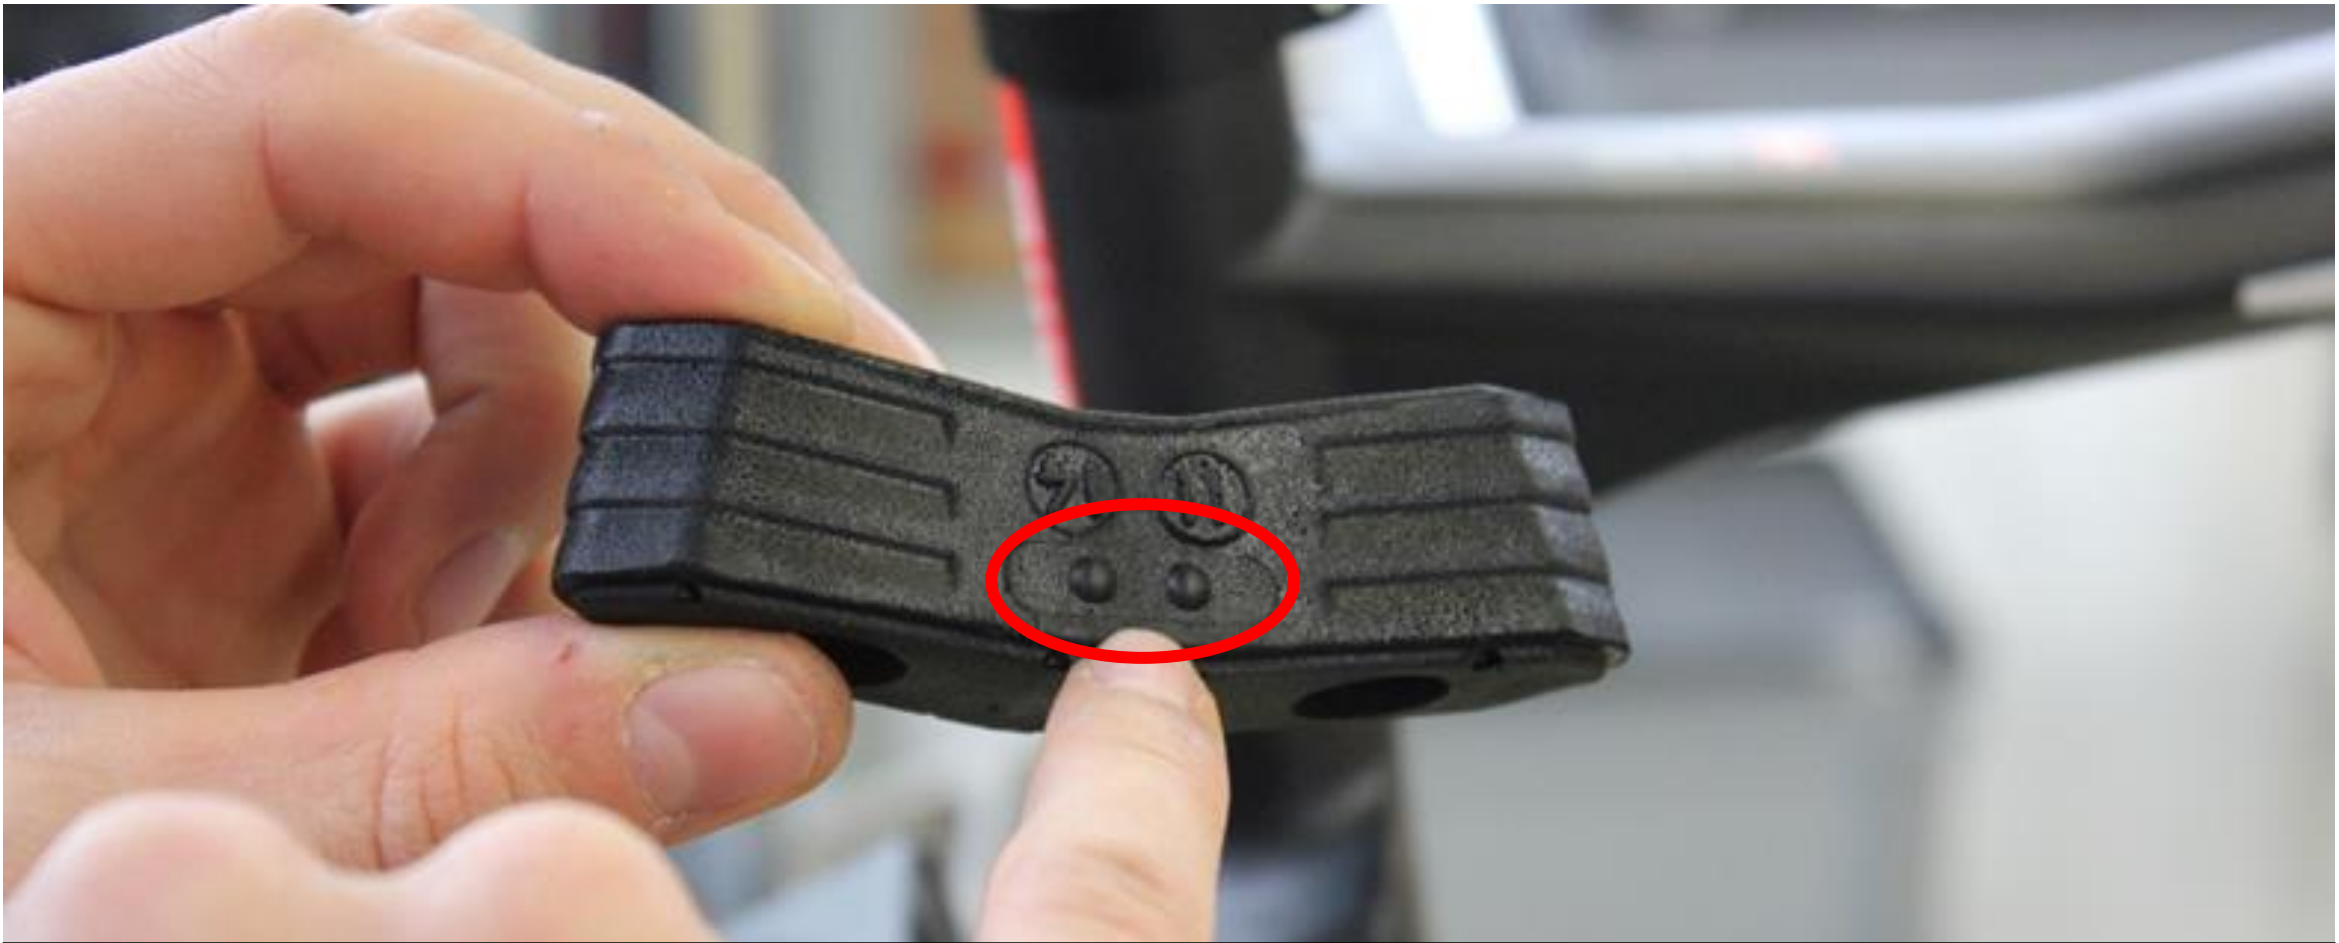
After removal from the MTT assembly, inspect the **XCell Damper** for evidence of wear, and make note of the damper level (• Soft, •• Medium, ••• Firm). The **XCell Damper** seen indicates •• Medium.

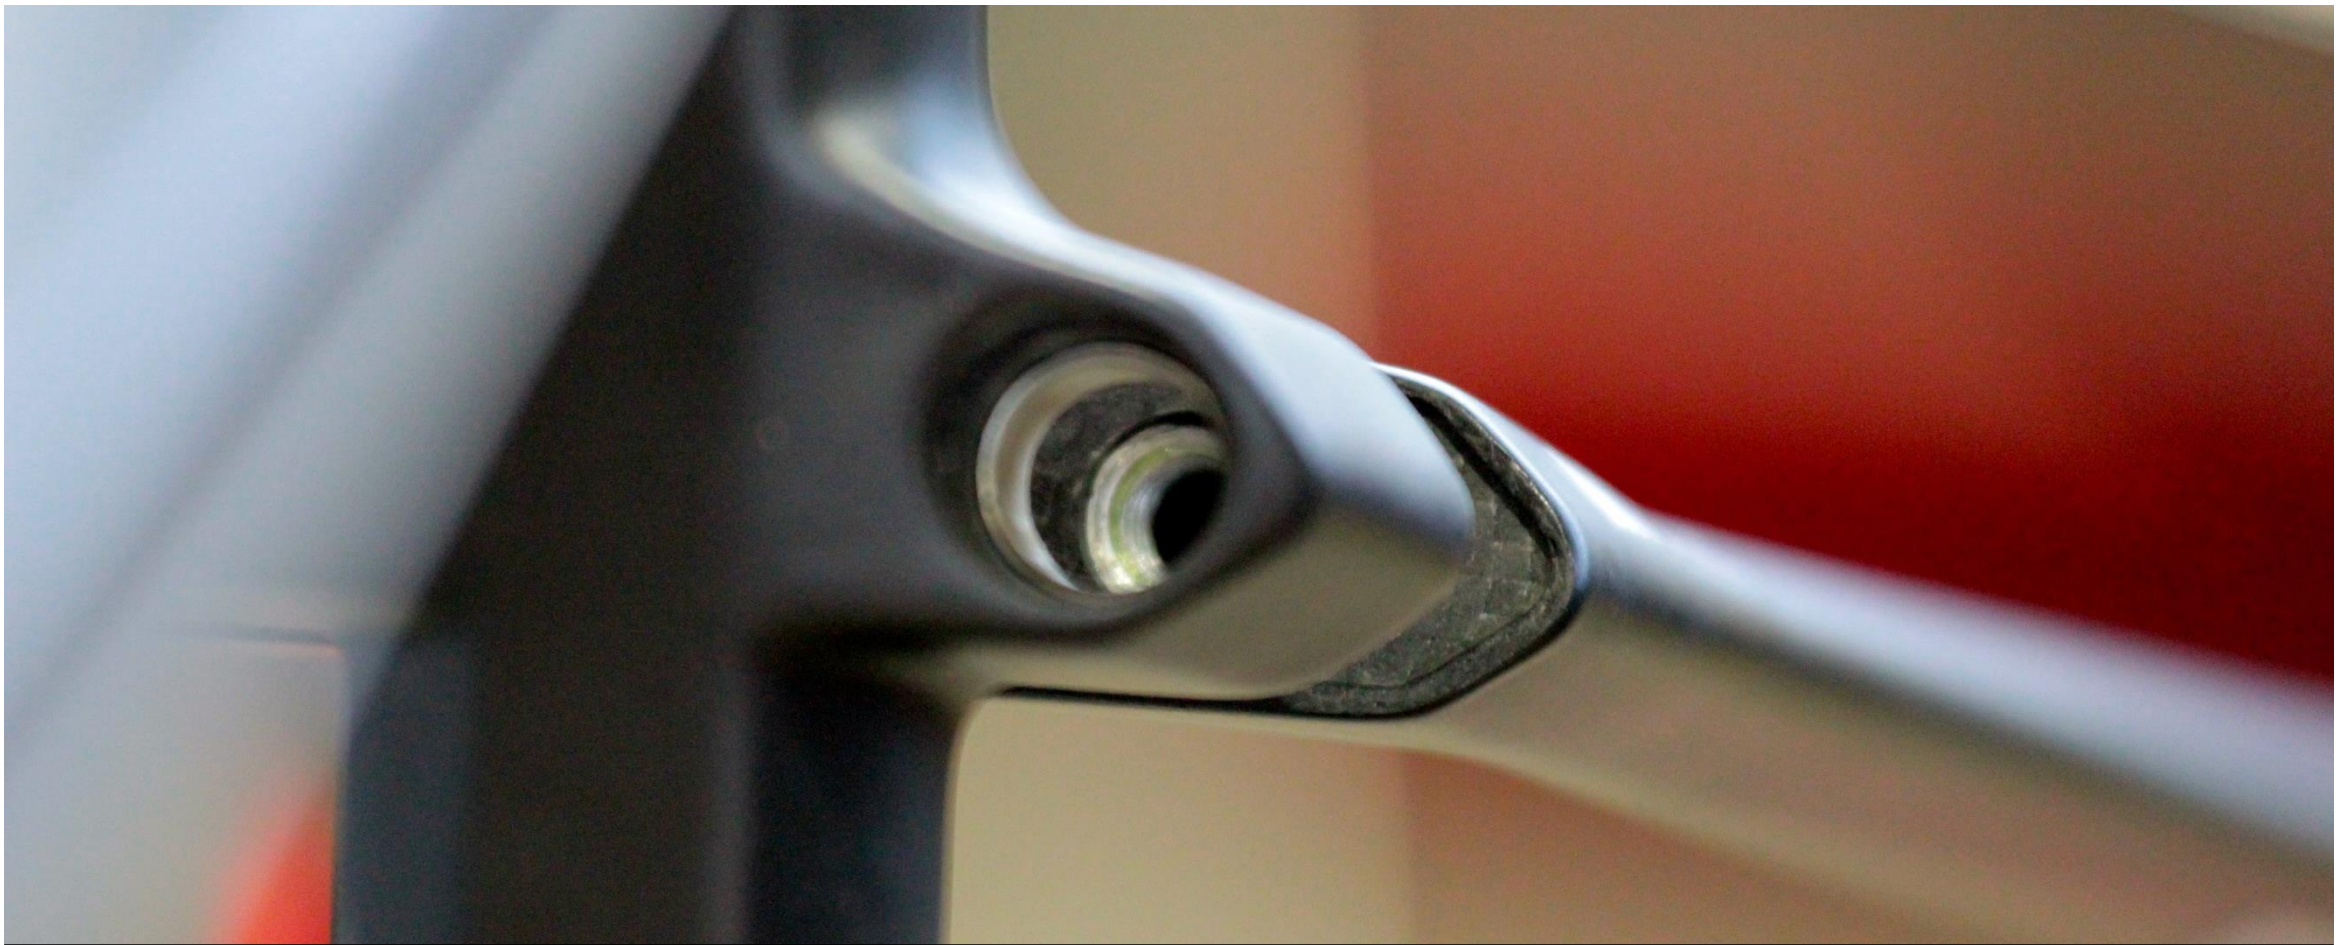
Visually inspect the internal bushings for signs of wear. It will be beneficial to remove any dirt or debris from the system before moving on to the next steps – this prevents avoidable wear on the MTT system.

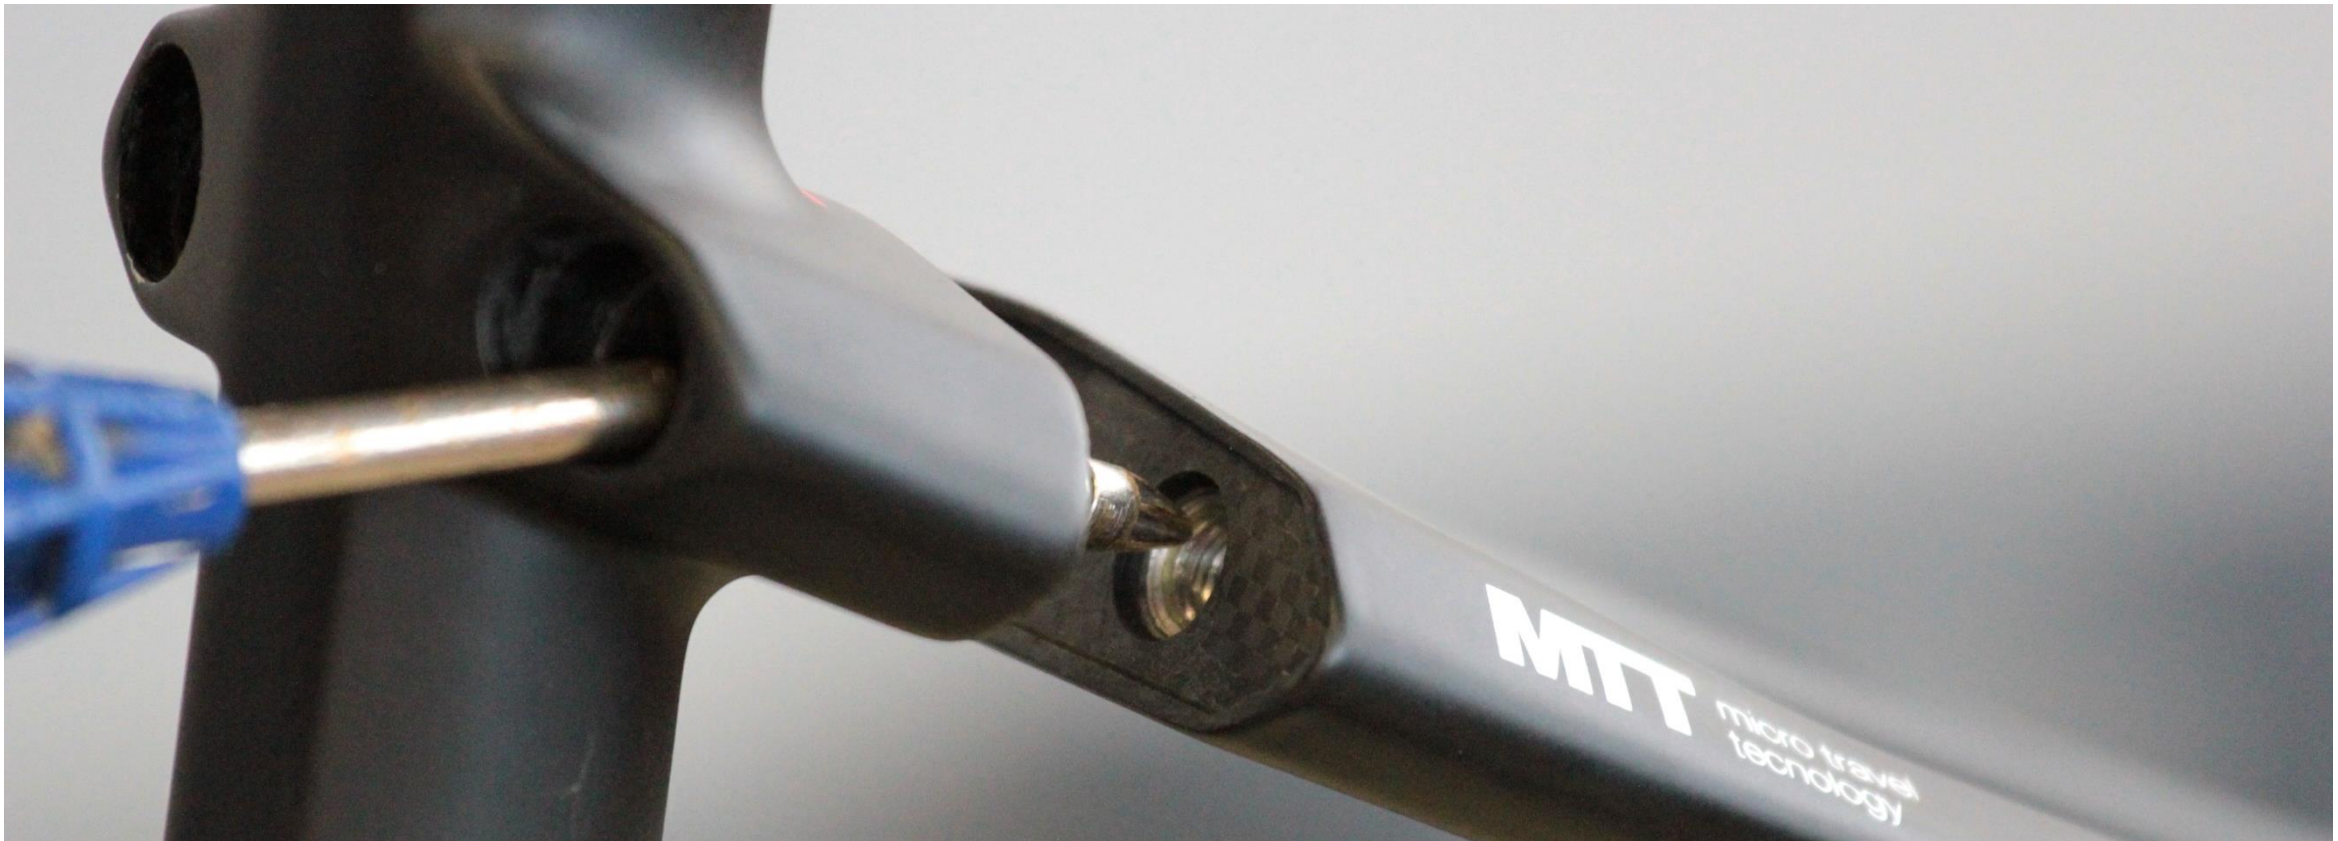
Using compressed air can be beneficial to make sure no debris has fallen into the frame, interfering with the thread engagement when re-installing guides later in the service procedure.

Eye protection is strongly recommended during this portion of the service.

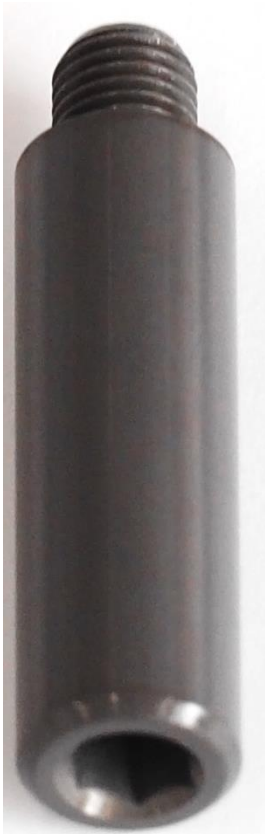
Ride

Guide shafts, even when brand new, often have color variations – this is not a need for replacement.

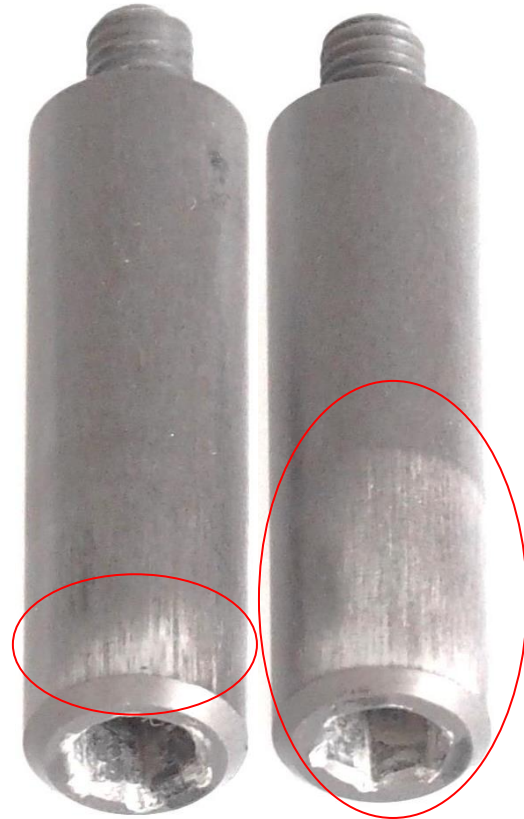
Replace

Worn guide shafts will indicate clearly an area of distress, as seen.

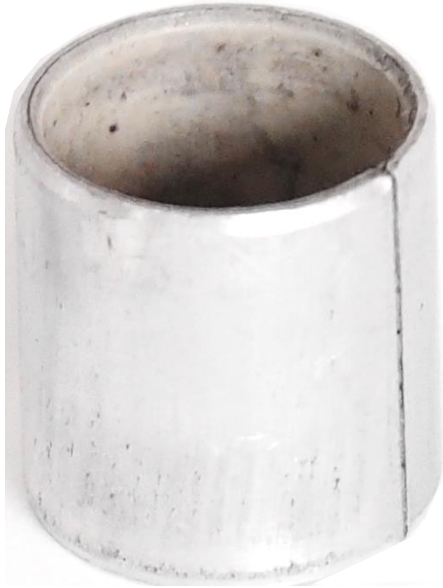
Ride

Bushings have a yellow color when brand new. Slight discoloration of the original color is expected during normal use.

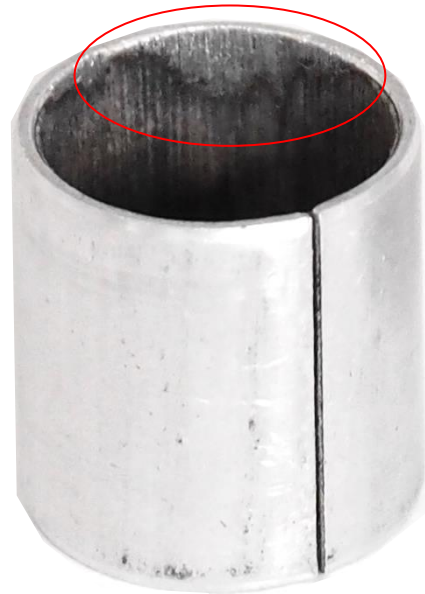
Replace

As seen, once the yellow finish is worn and metal is visible, replace bushings.

If there is uncertainty, it is best to replace.

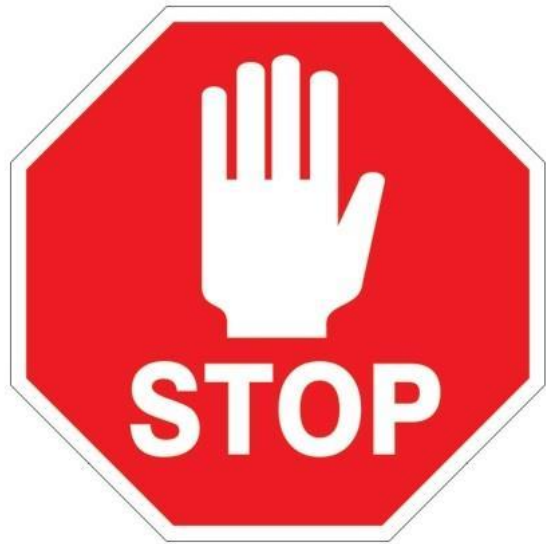
Refer to the **Service Interval Guideline**

If **“Clean and Lube”** is all that is needed, reverse previous steps to finish service.

⚠ Guide shaft tightening torque = 8Nm

If there is a need for **“Shaft / Bushing Replacement”** continue through the remaining steps.

Clean & Lube	Shaft/Bushing Replacement
Initial ride period		
Initial 10hr of riding	X	
Regular maintenance		
Every 25hr of riding	X	
Every 250hr / annual		X

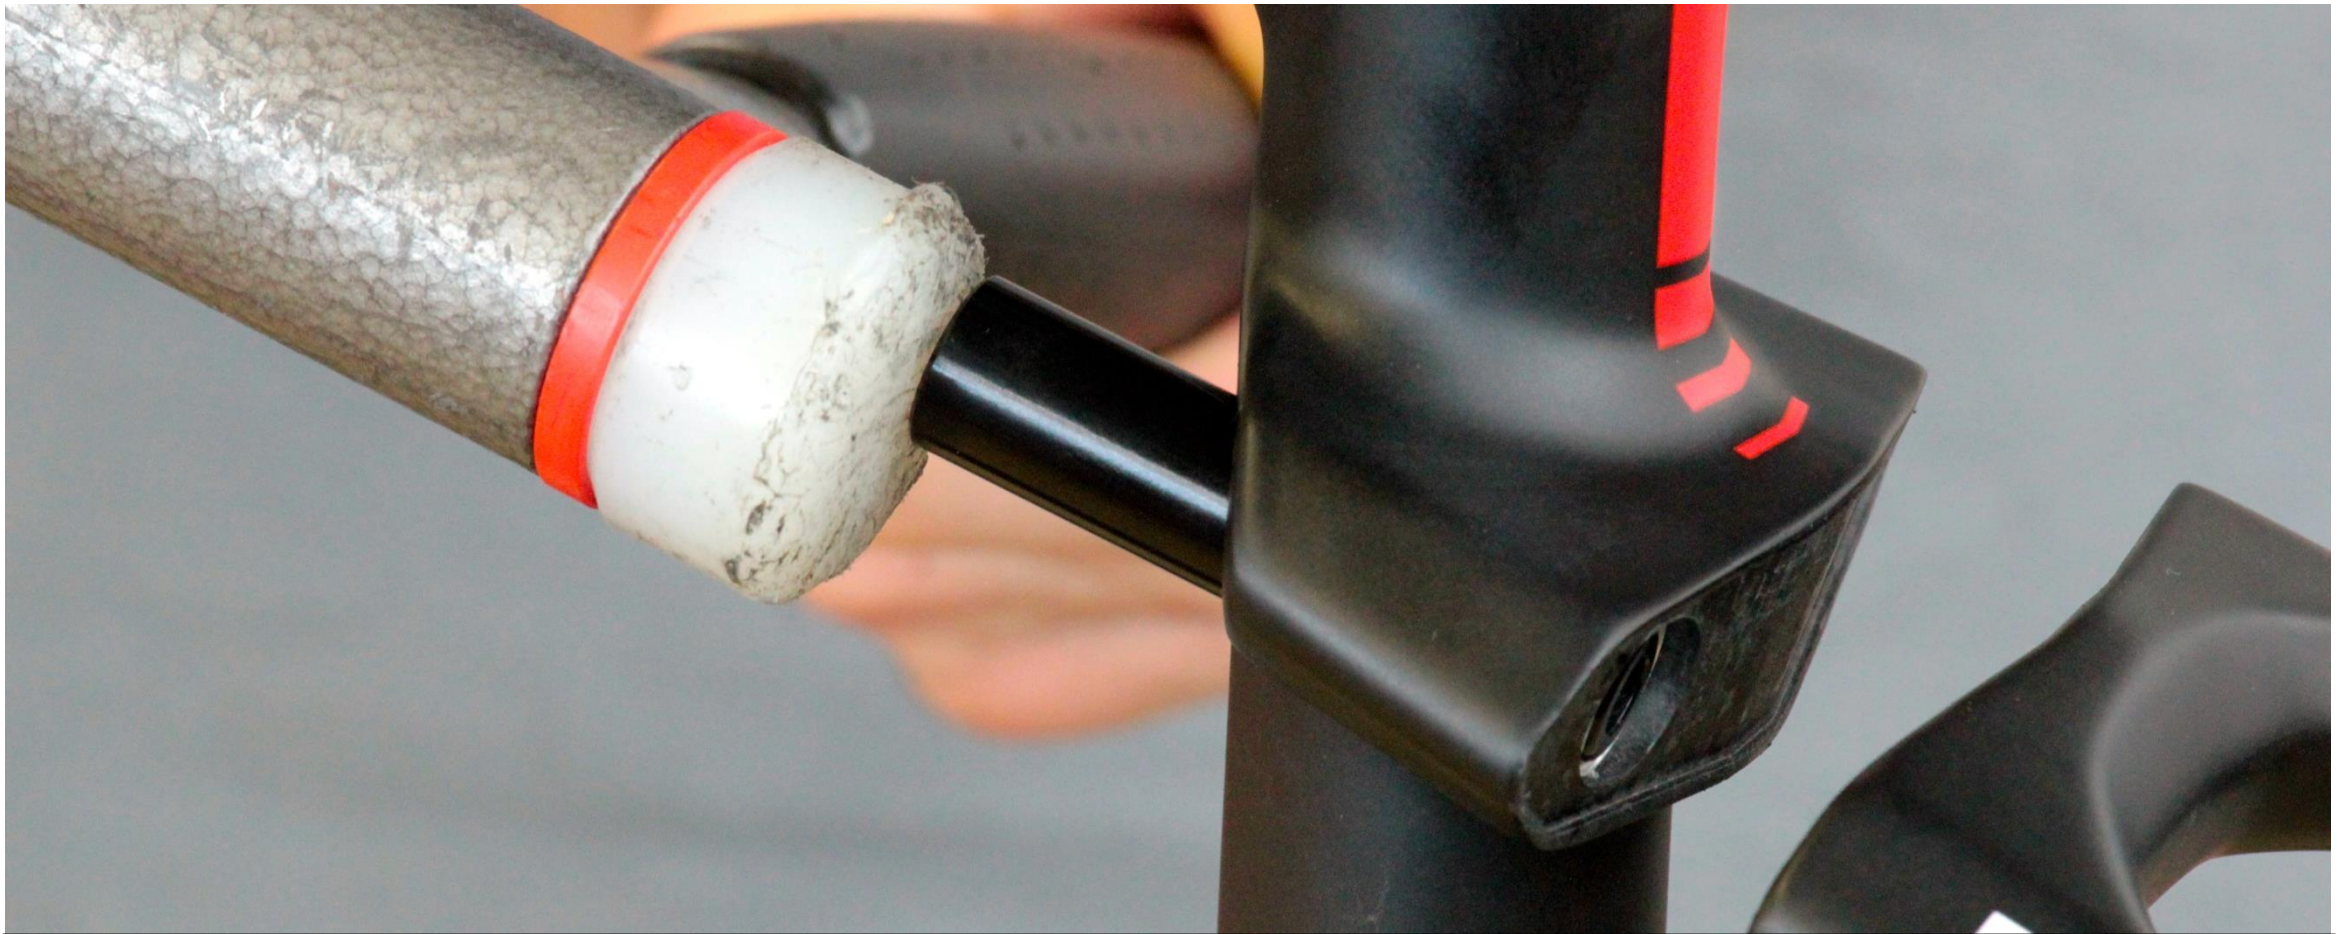
Using the guide bushing removal tool and a non-metal mallet, strike towards the rear axle. Begin with light force, and adjust as necessary. Note: the bushing system does not require excess force for removal.
