MTT MicroTravel Technology

Service and Maintenance Manual

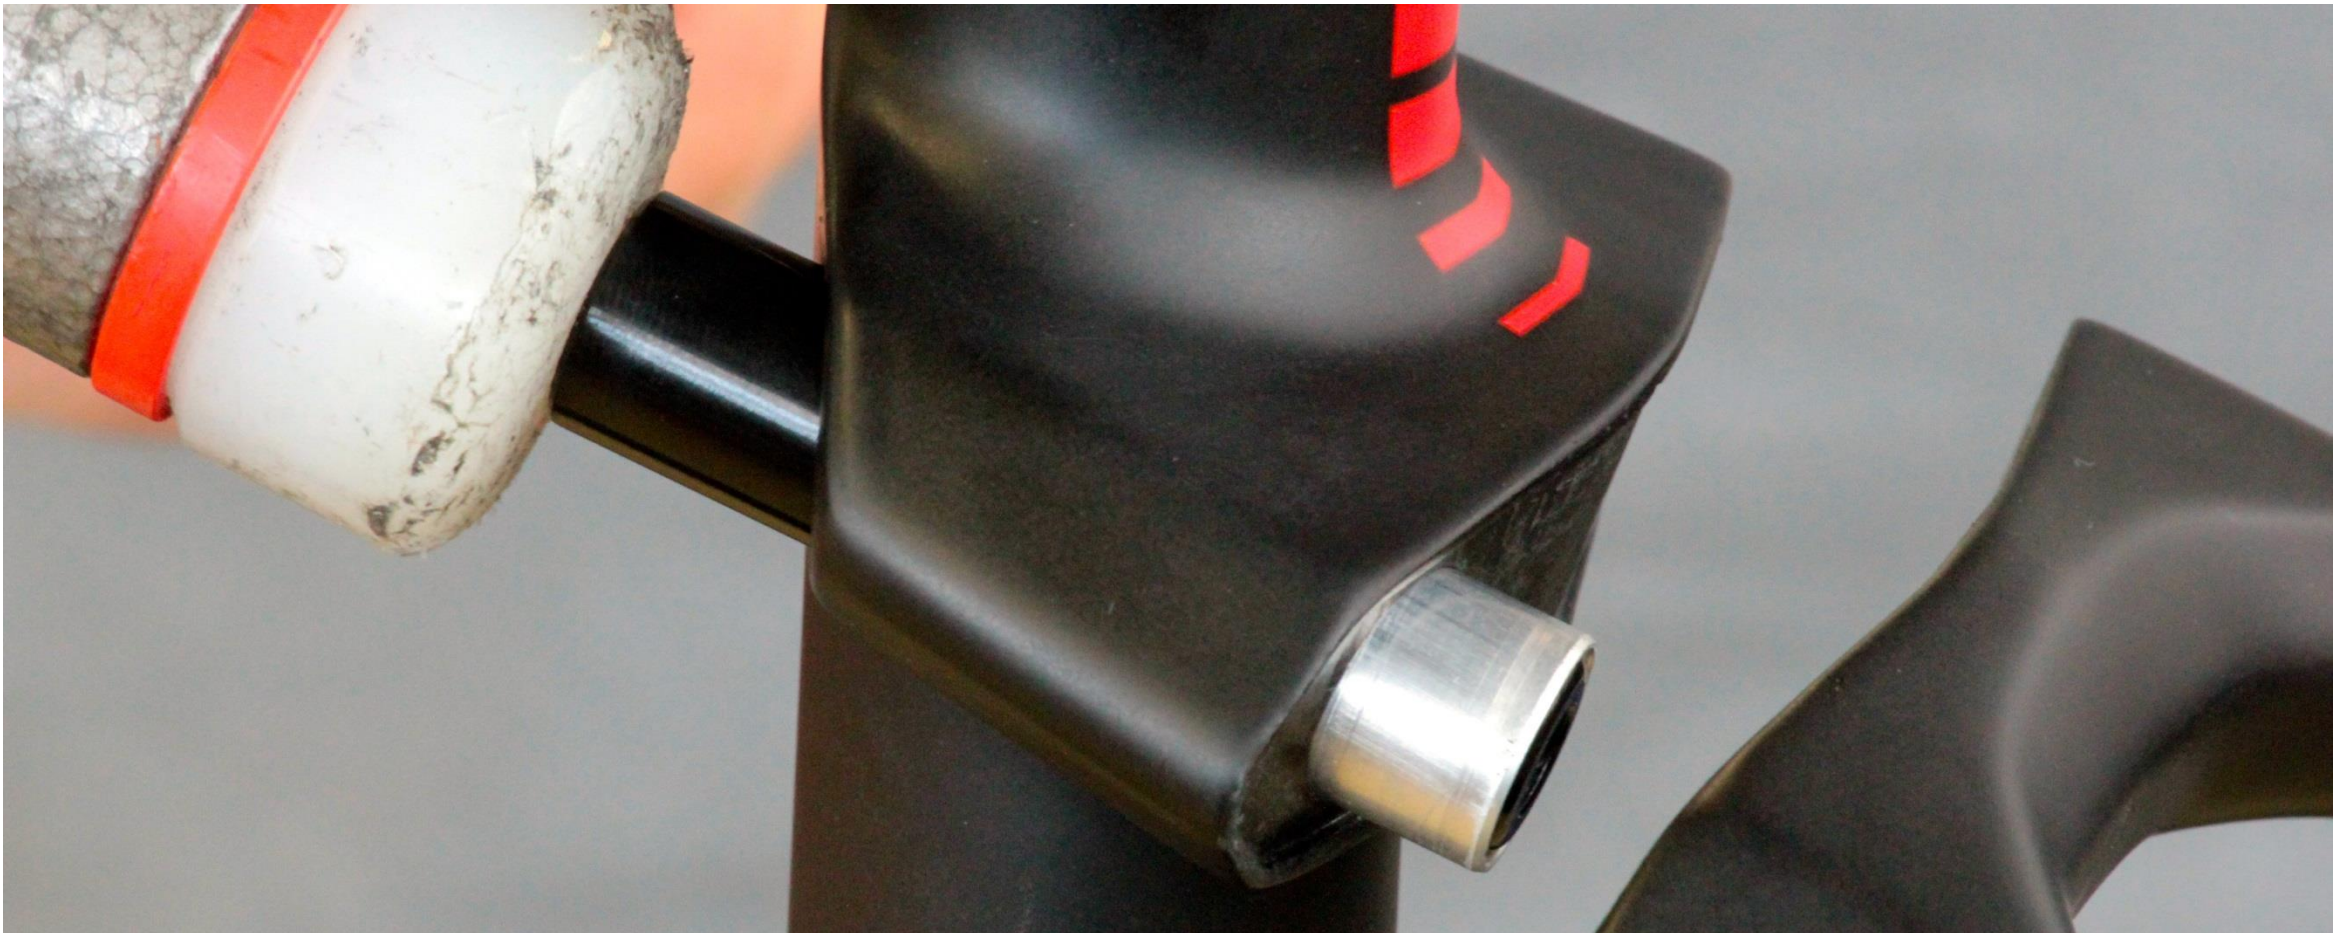
As the guide bushings near the point where they exit the frame, less force is required. Decrease impact force delivered to the guide bushing removal tool to prevent the bushing and tool from hitting the lower seatstay.

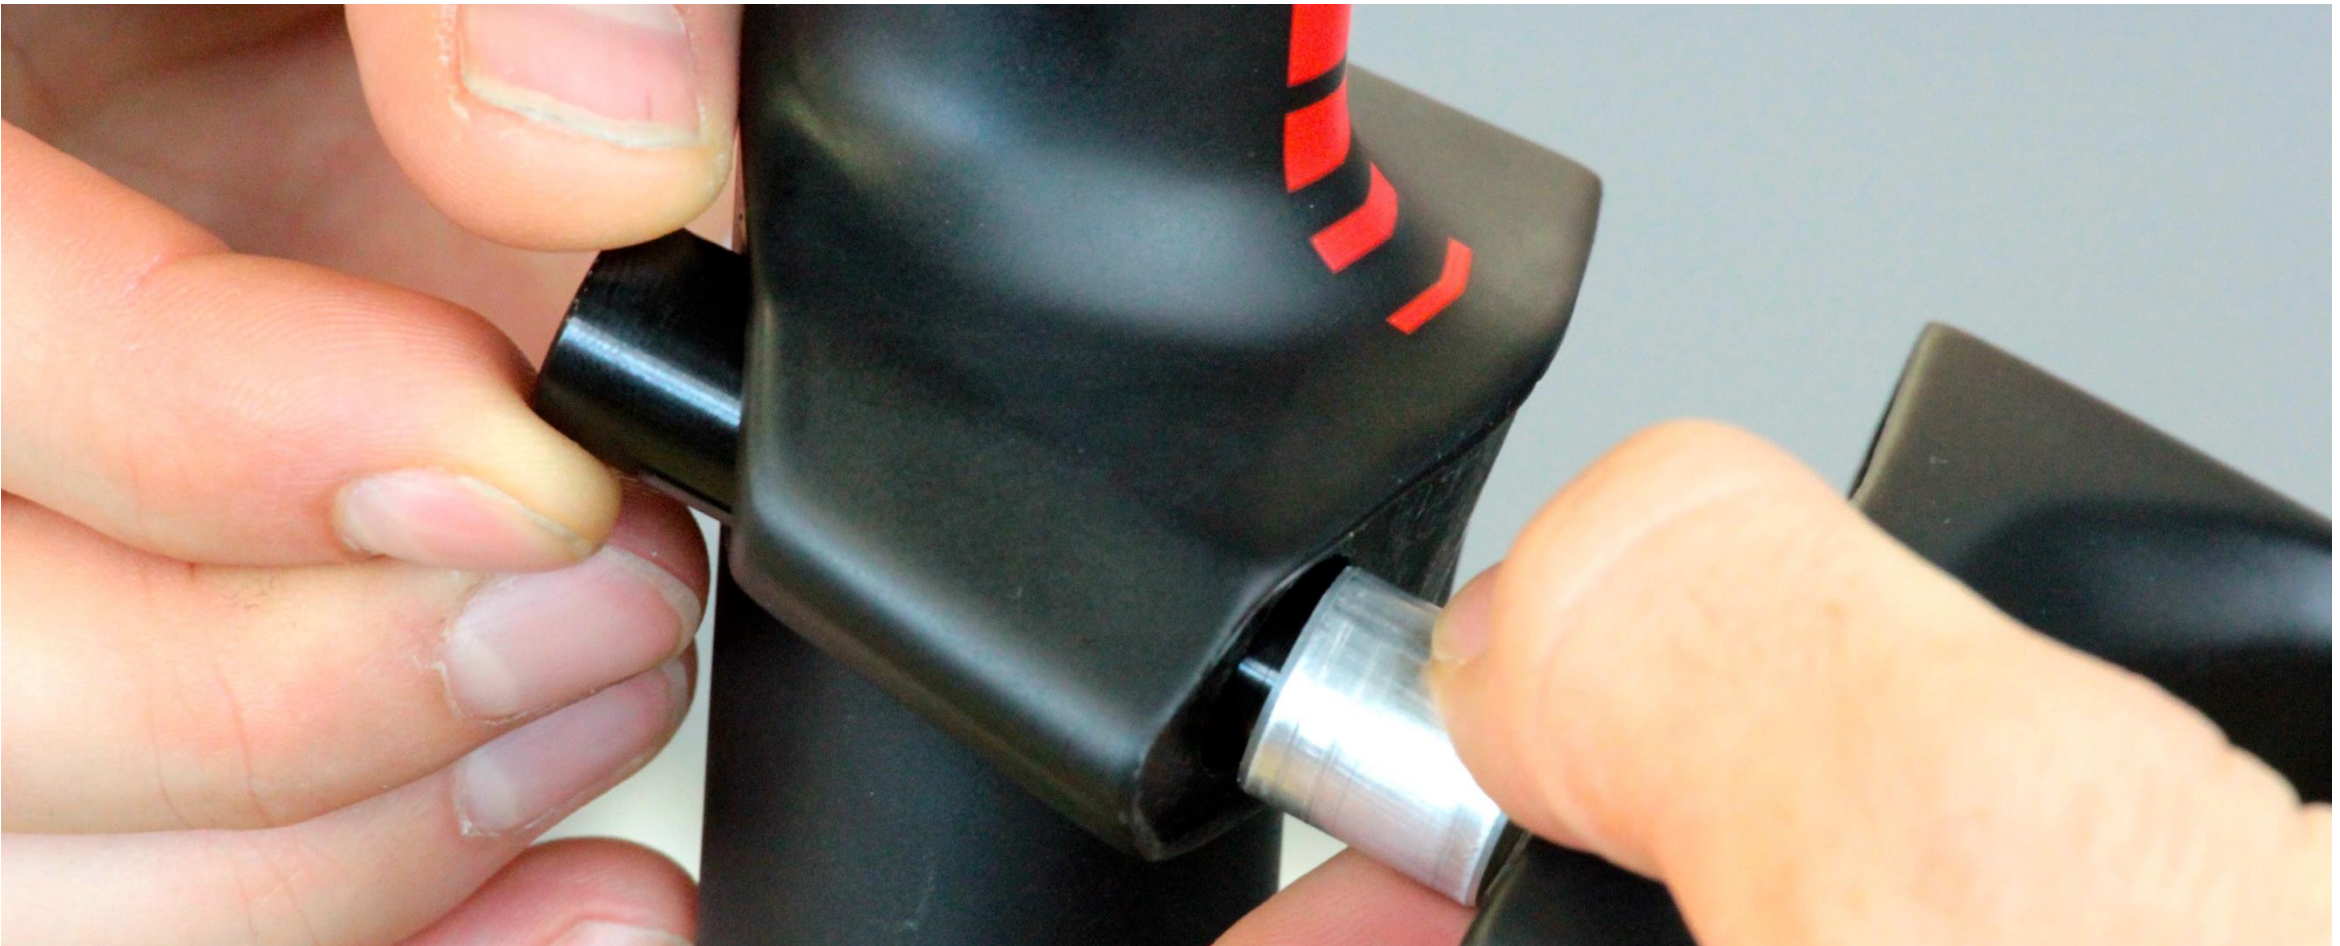
When the guide bushing nears the exit, it is recommended that the service technician hold the bushing during the final removal impacts.

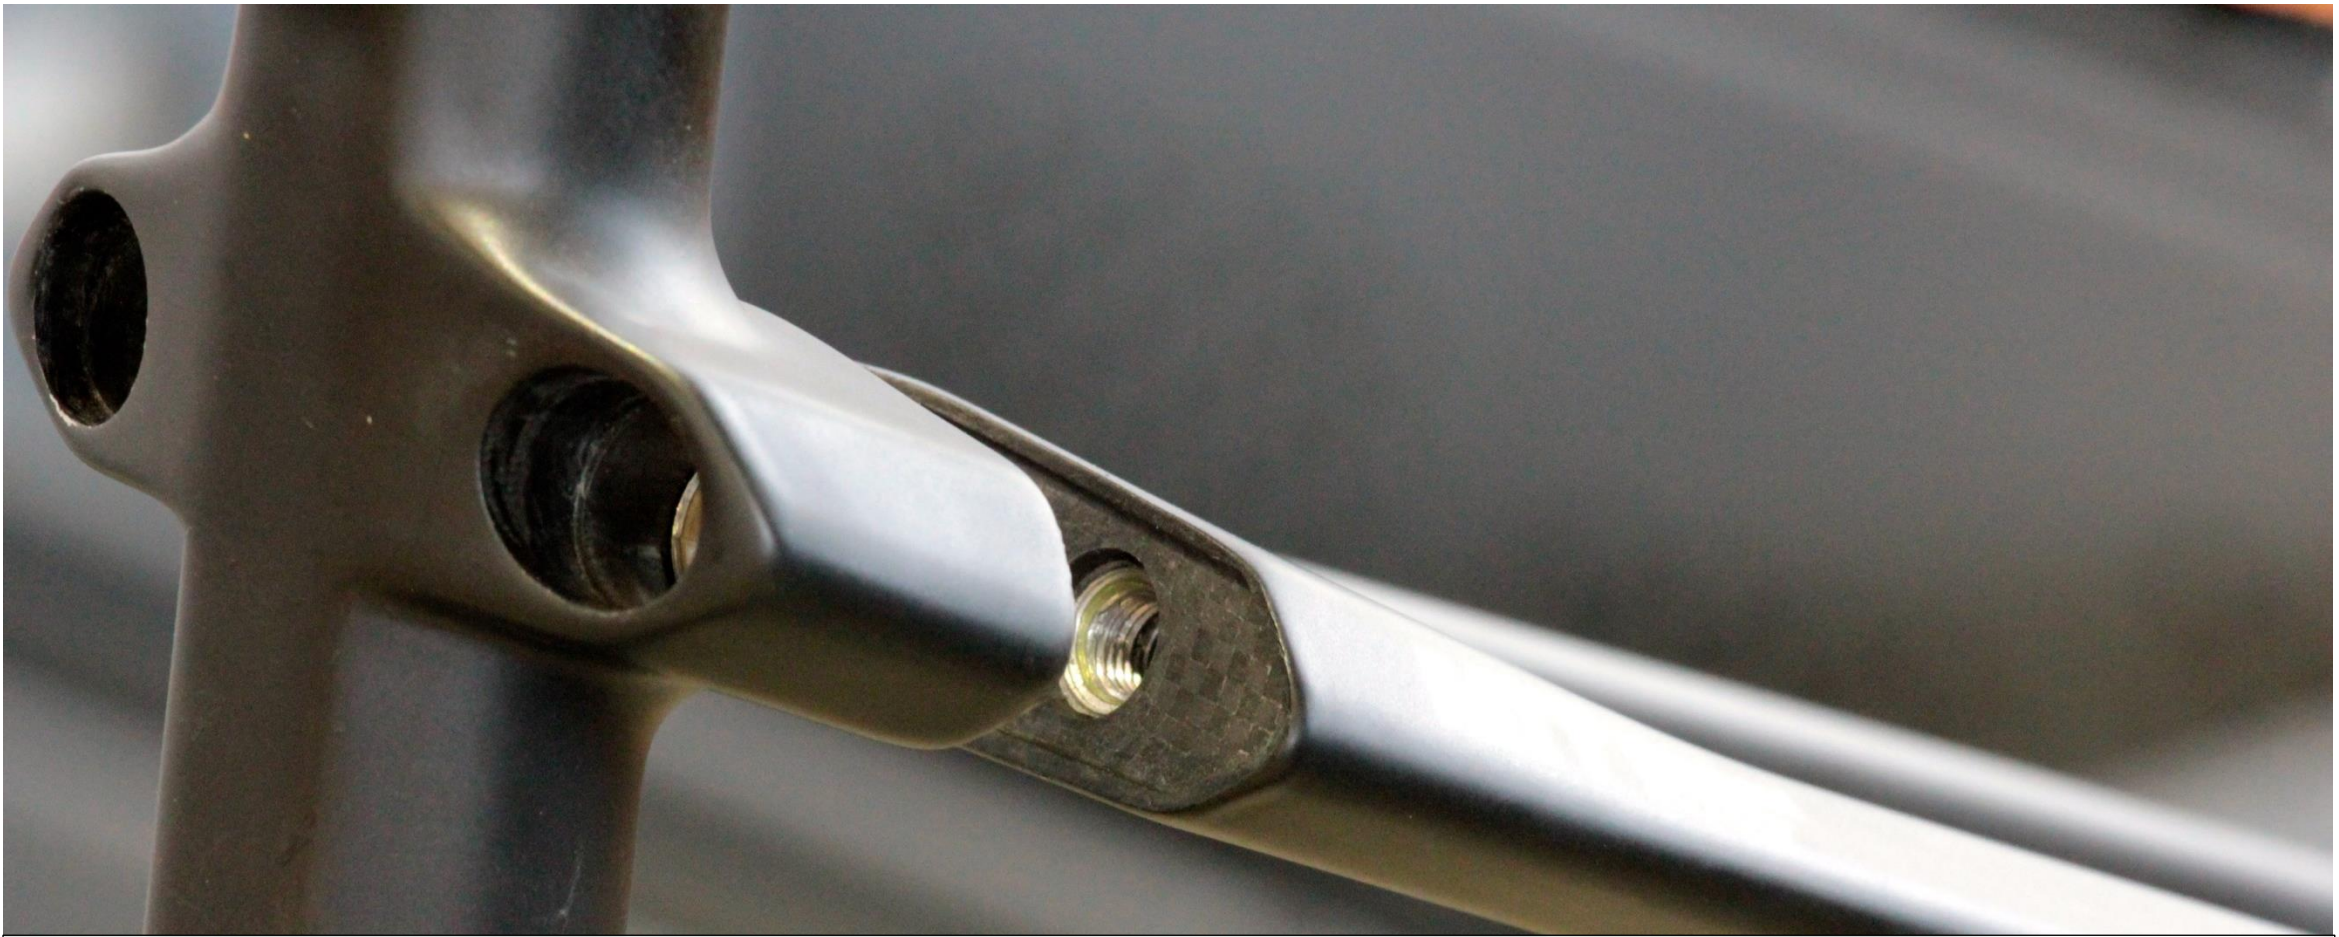
After the removal of left and right guide bushings, it is recommended that each seatstay assembly be visually inspected and cleaned with dry cloth – aerosol degreasers or cleaners are not necessary.

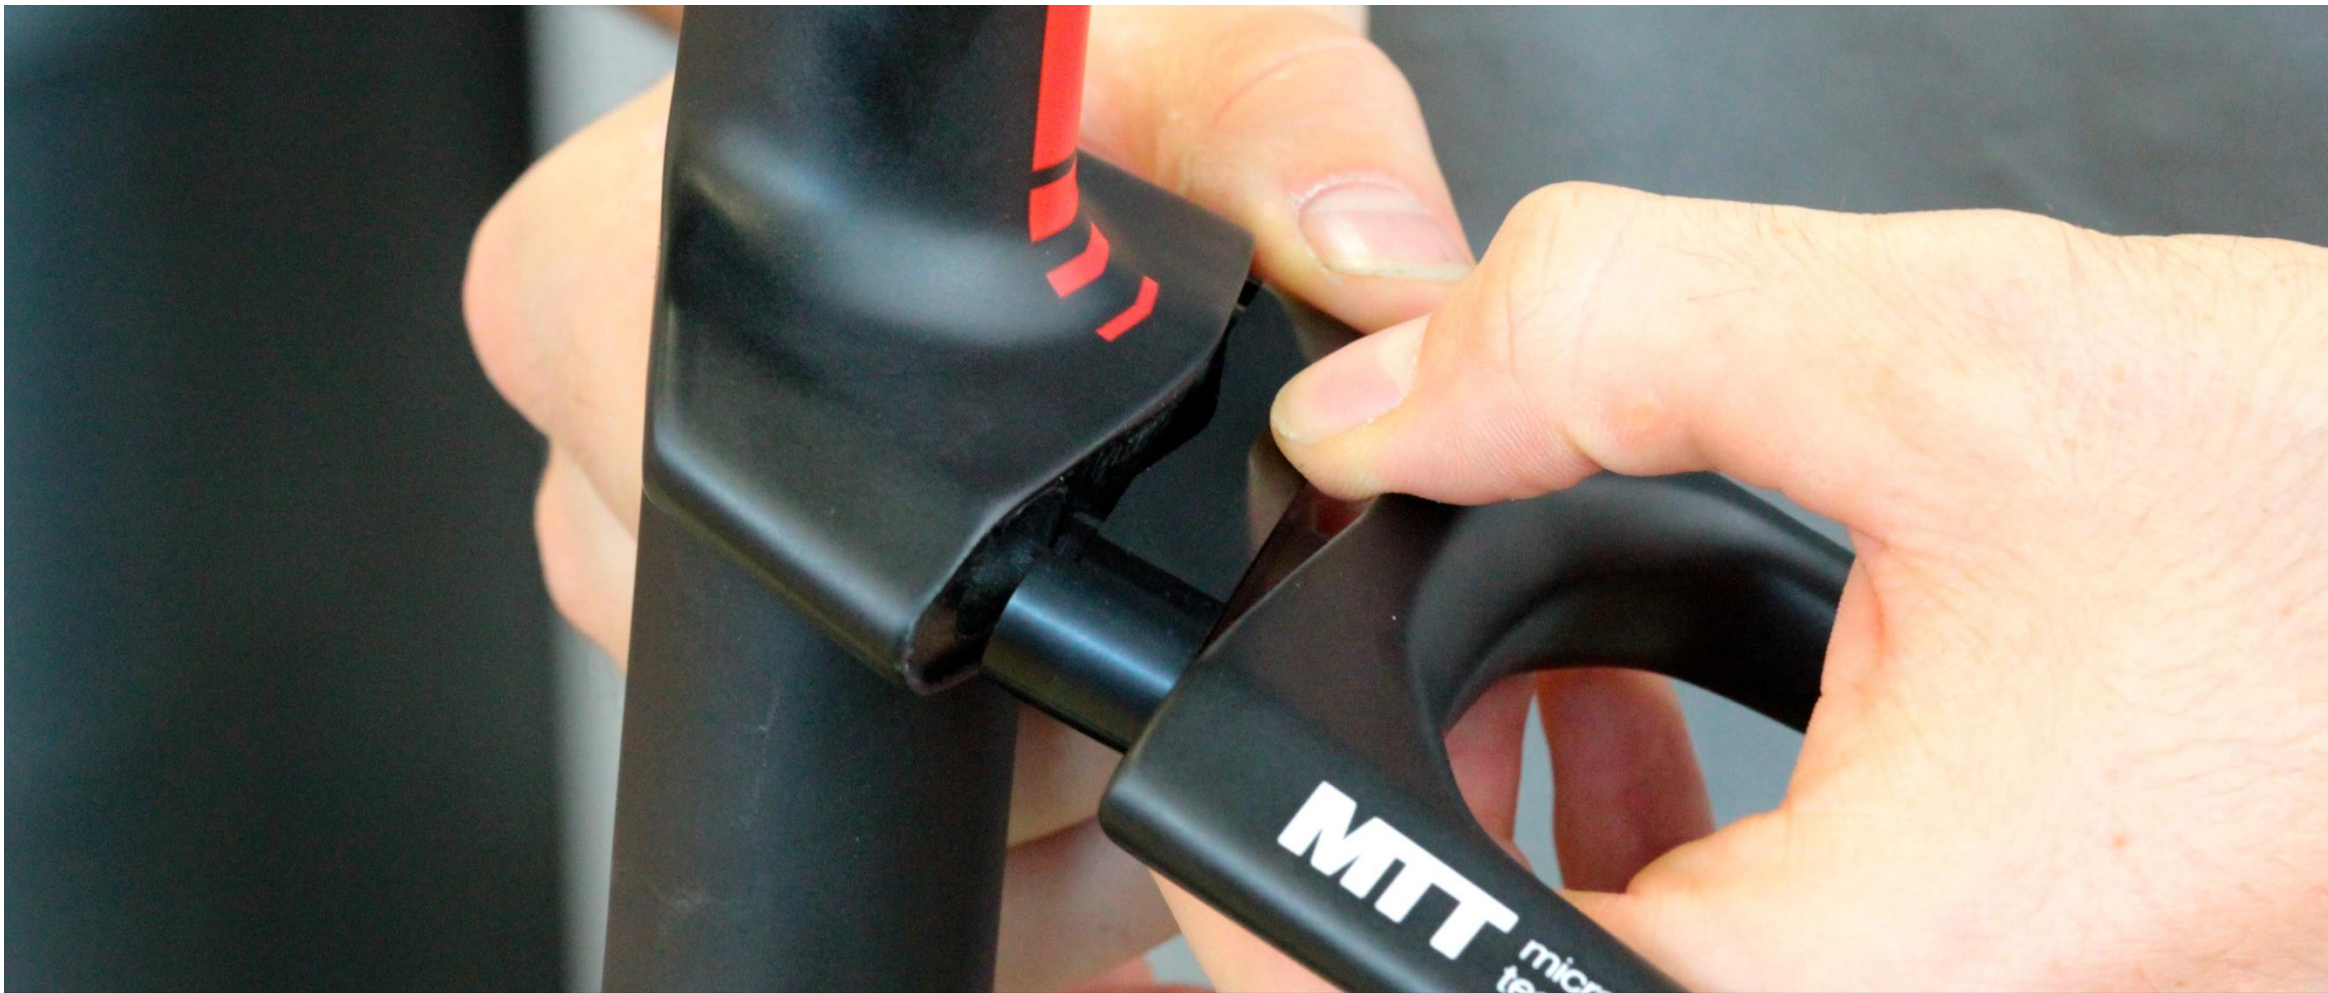
Place the guide bushing installation tool in place.

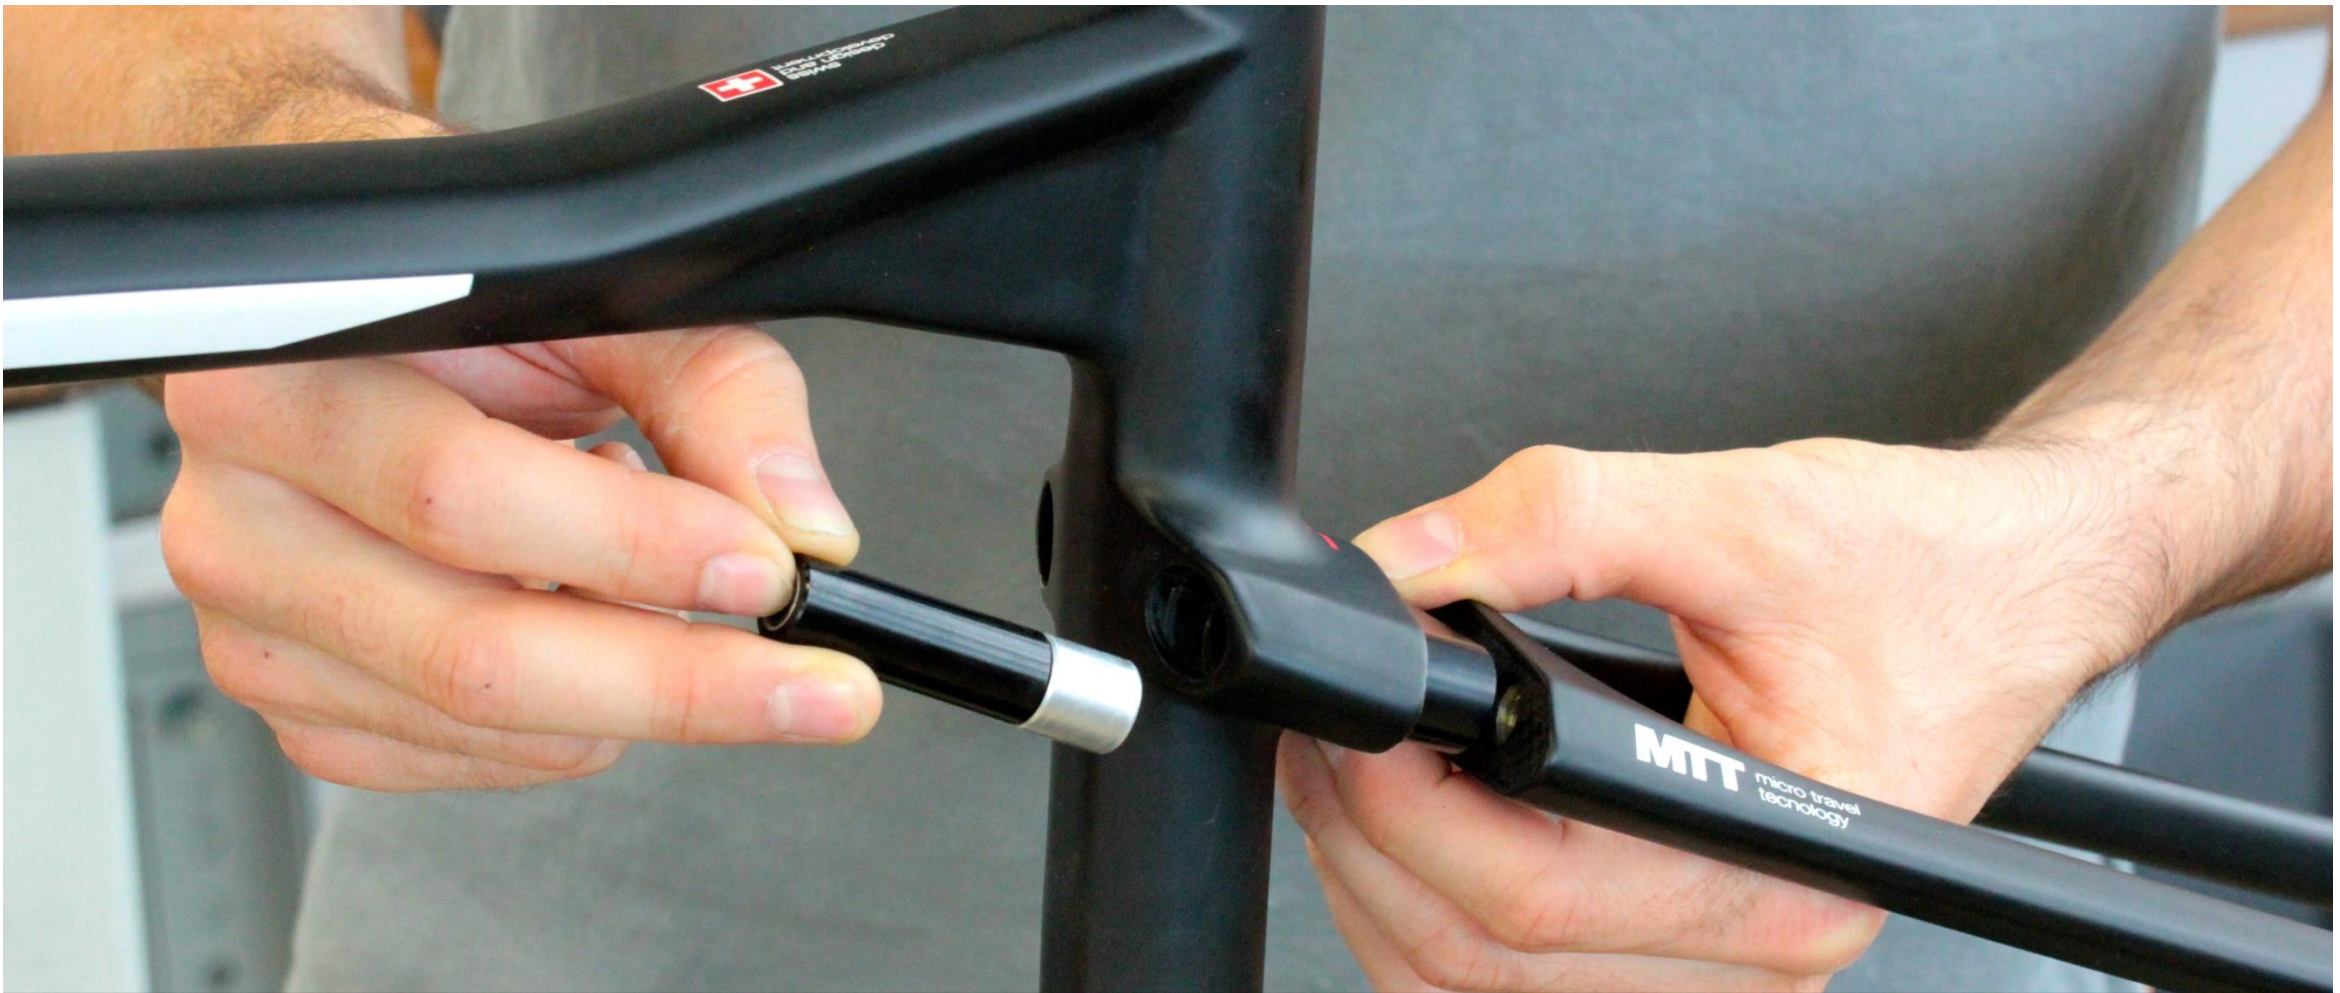
With the guide bushing installation tool held in place, gently guide the bushing into the upper seatstay by hand.

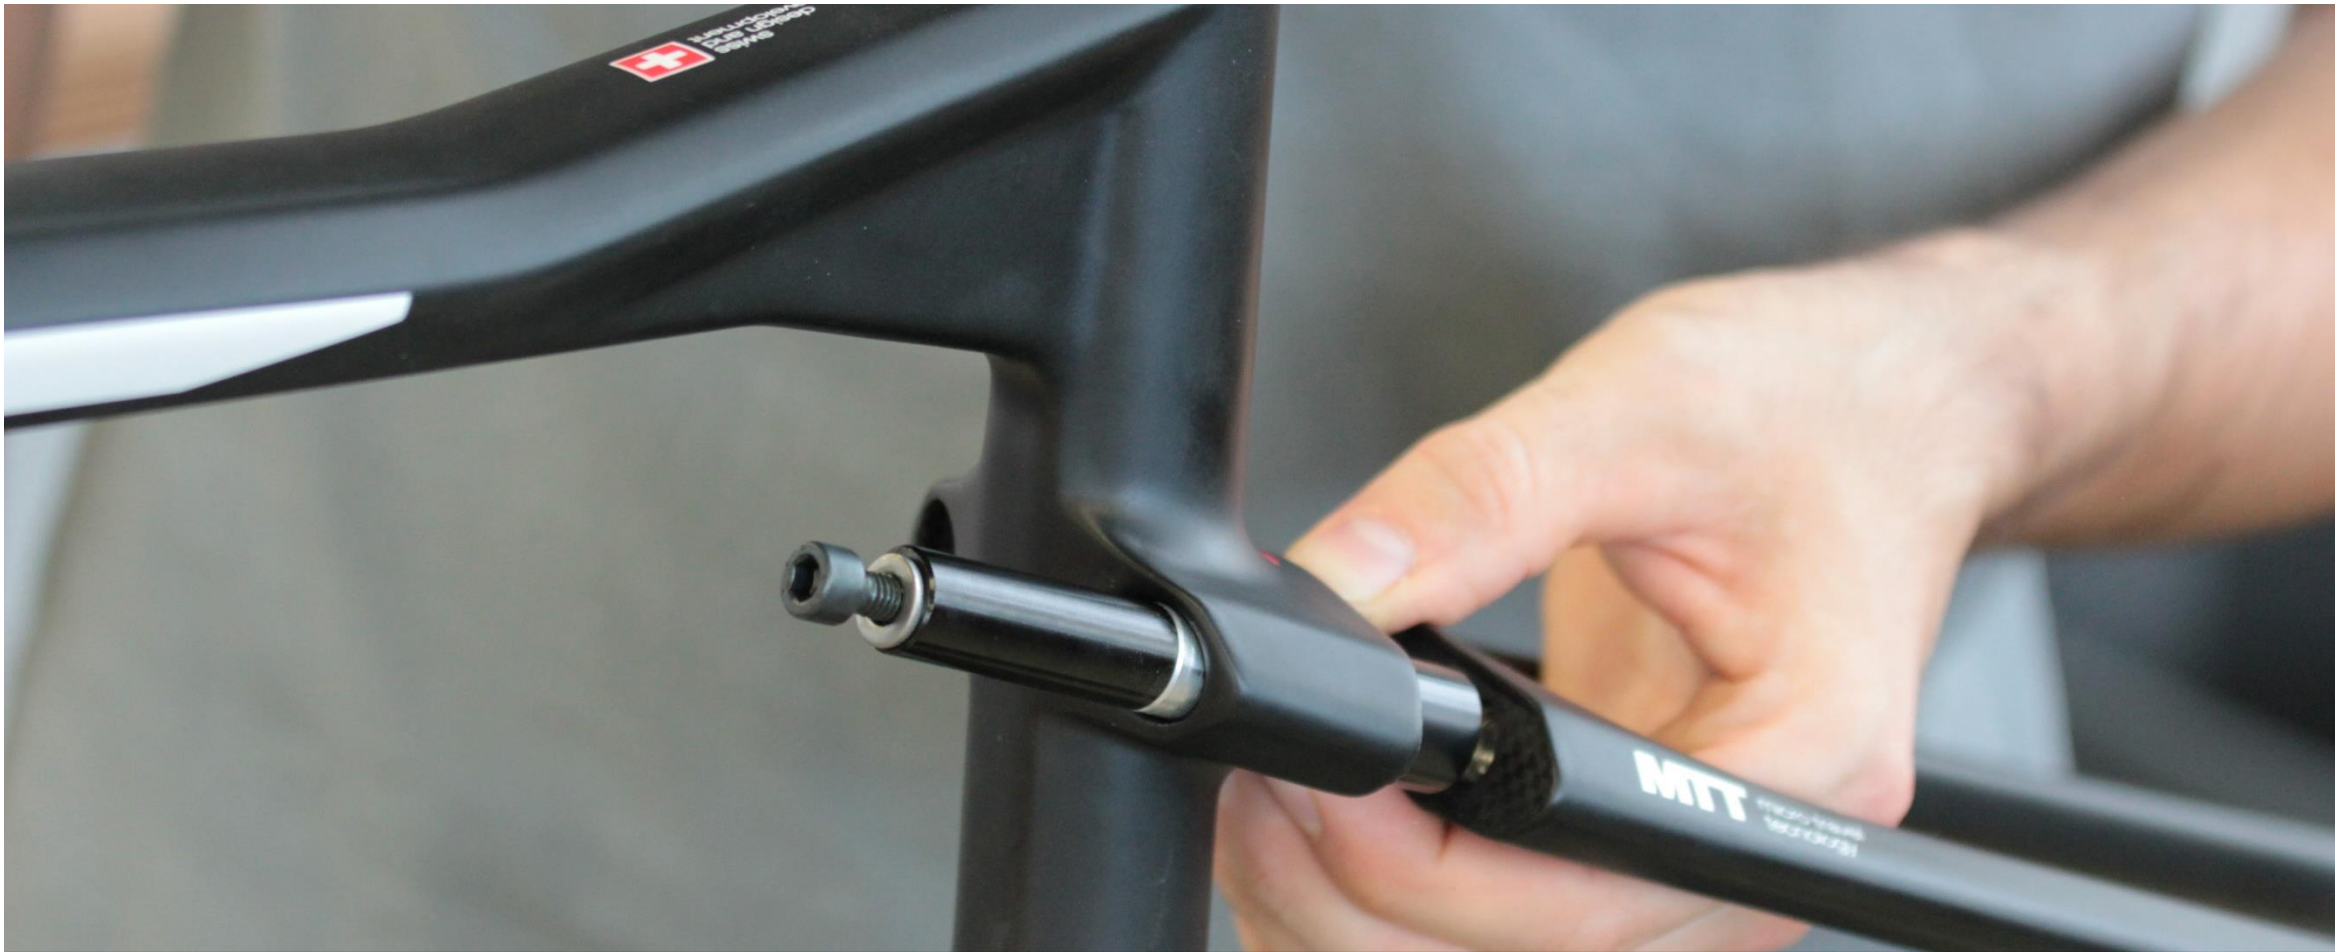
With the guide bushing installation tool in place, use the bushing press assembly to initiate thread engagement by hand.

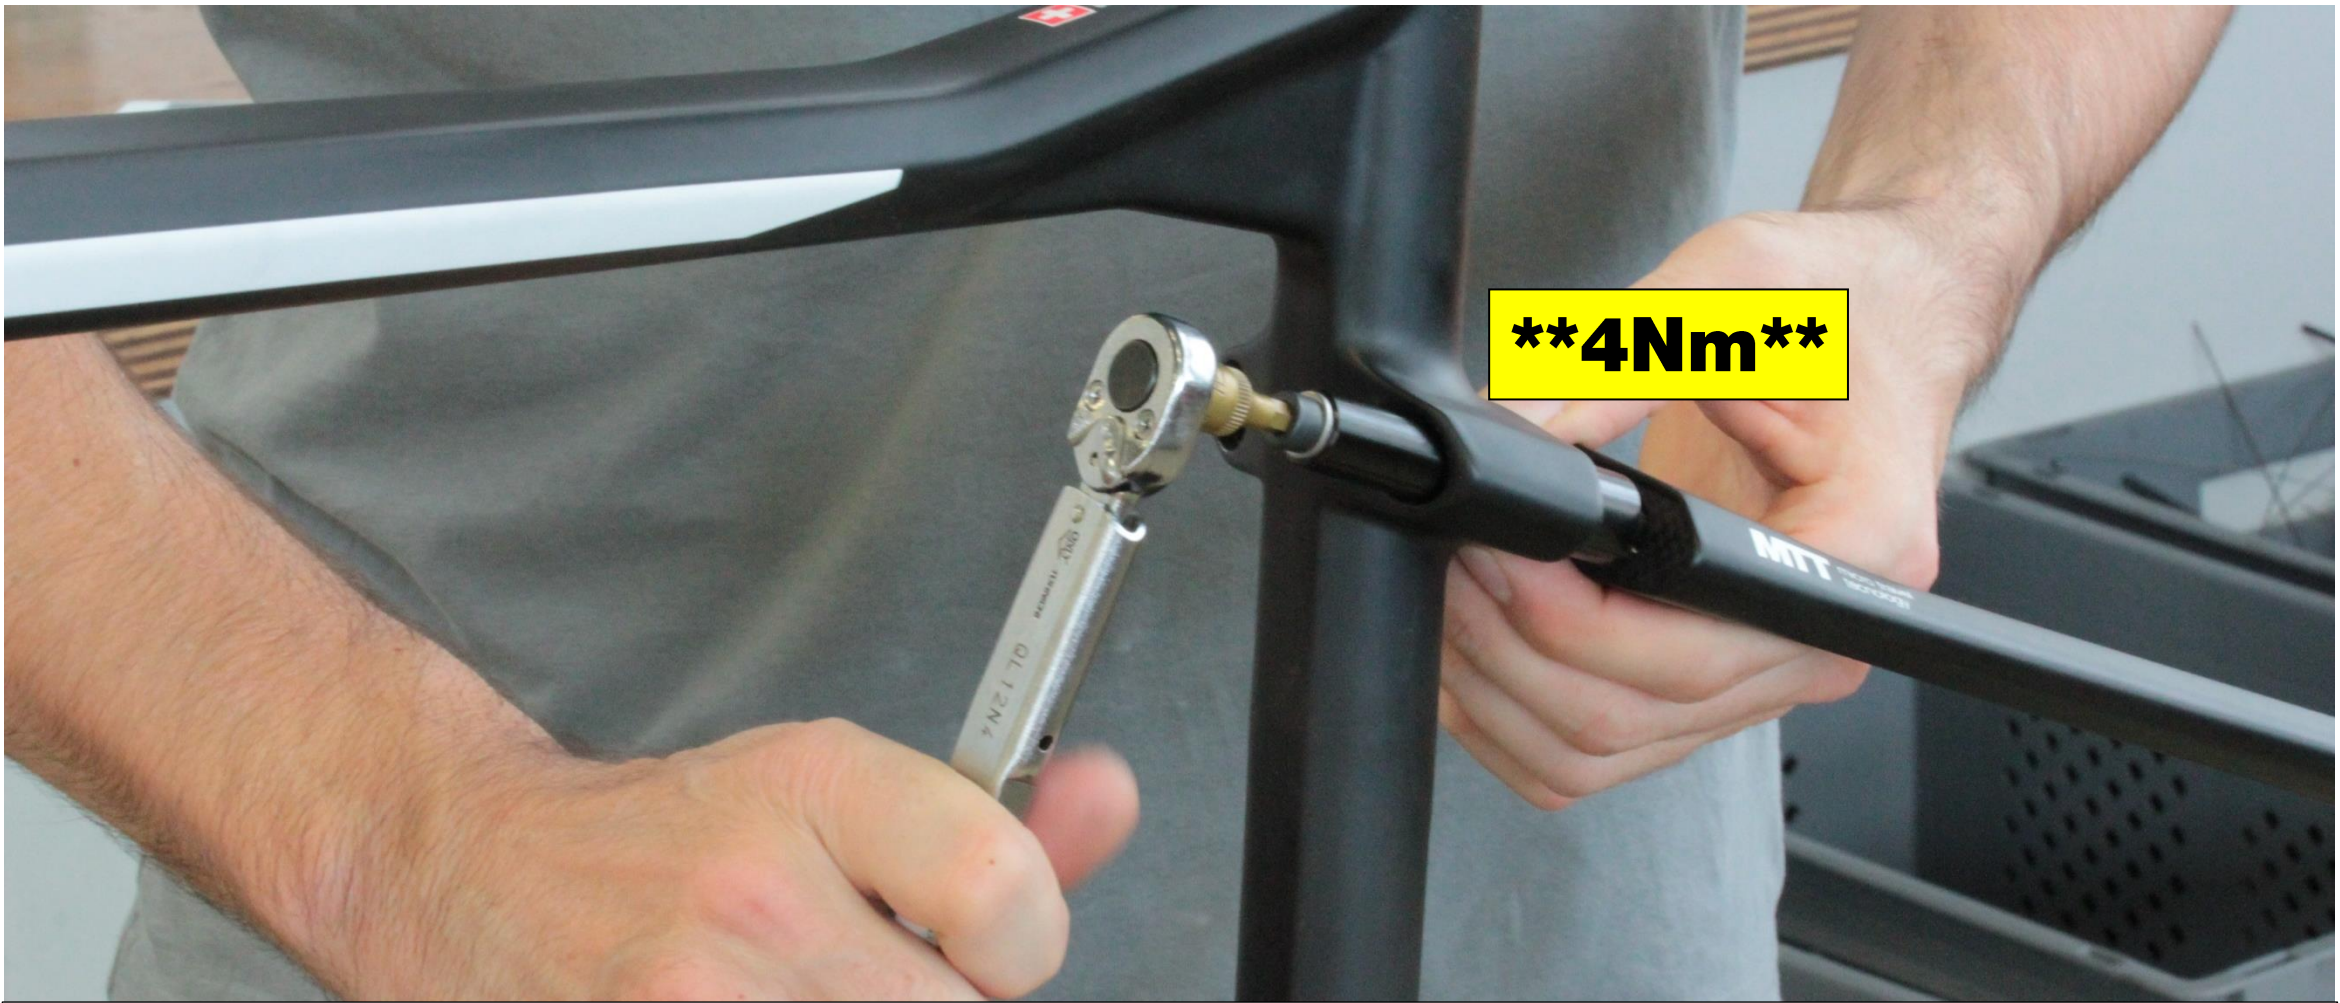
Using a 6mm allen key and torque wrench, tighten the bushing press bolt clockwise to 4Nm of torque

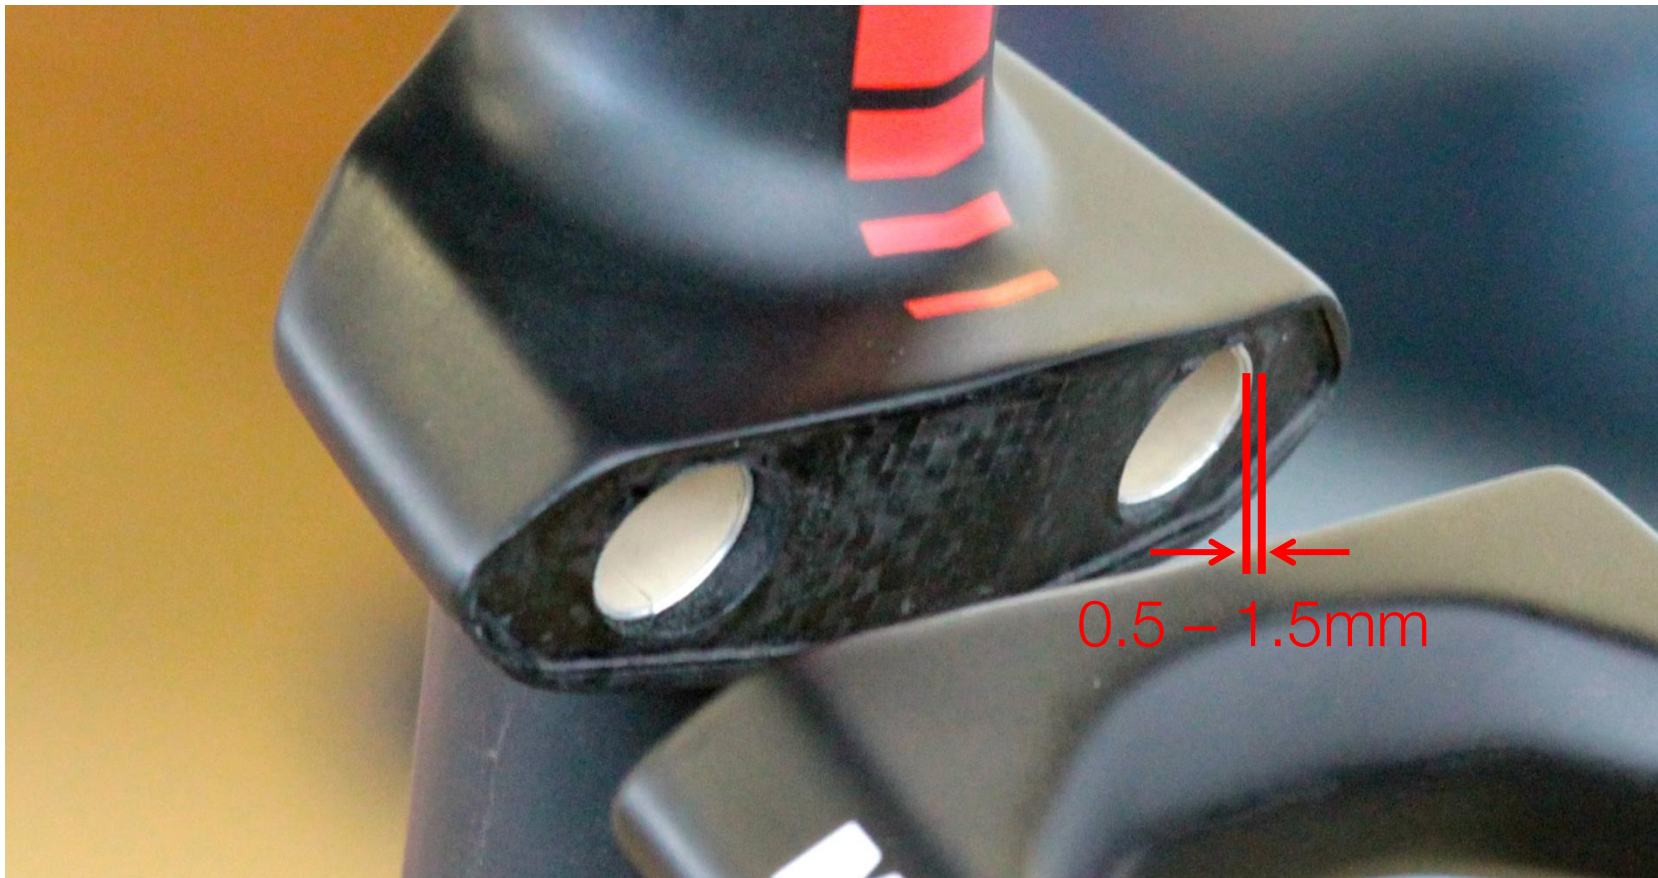
Using the guide bushing installation tool, guide bushing press assembly and proper torque will position the new guide bushings properly in the upper seatstay portion of the MTT system. Visual inspection of the bushing placement will ensure proper MTT function. It is acceptable to use Loctite 680 (retaining compound) if desired.

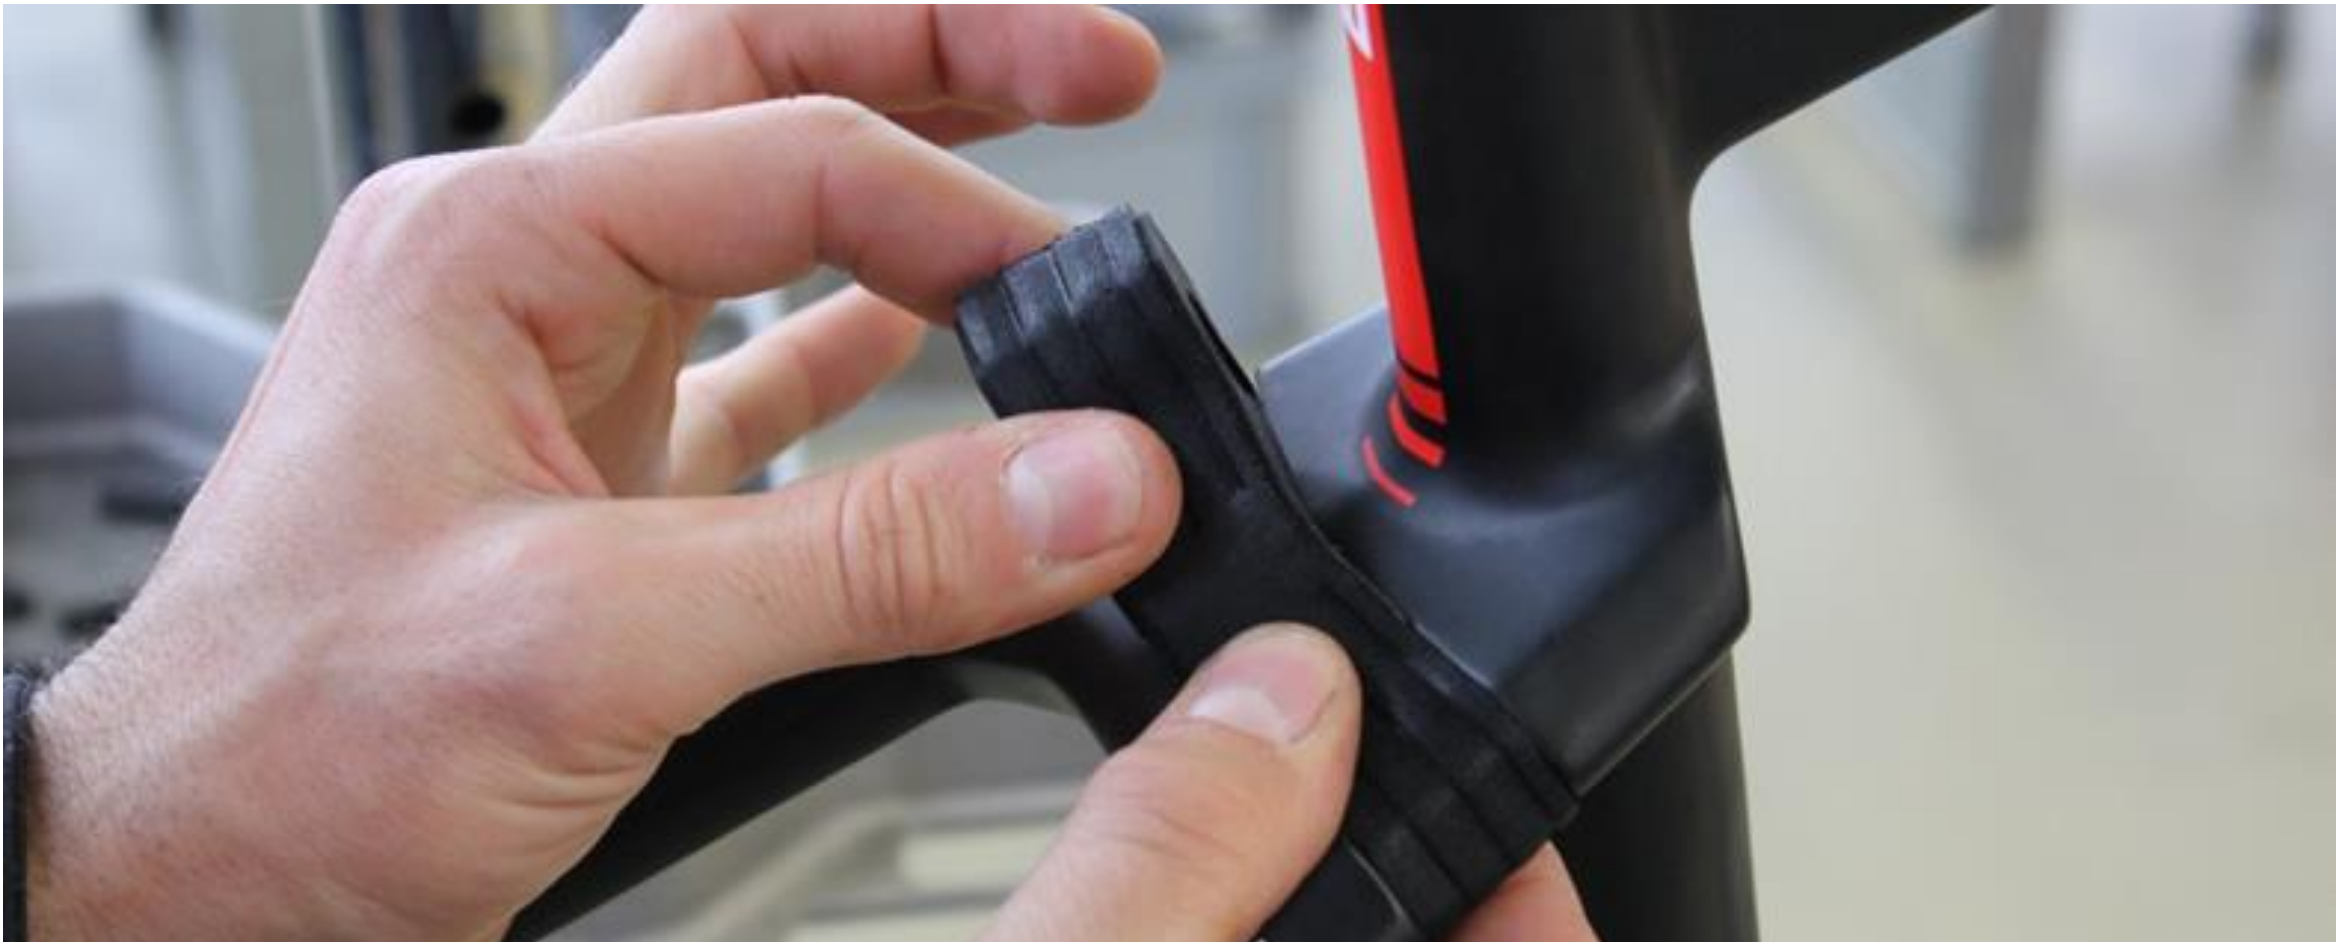
Install the cleaned, or new, **XCell Damper**, making sure to use the same level of damper, unless otherwise indicated by the rider.

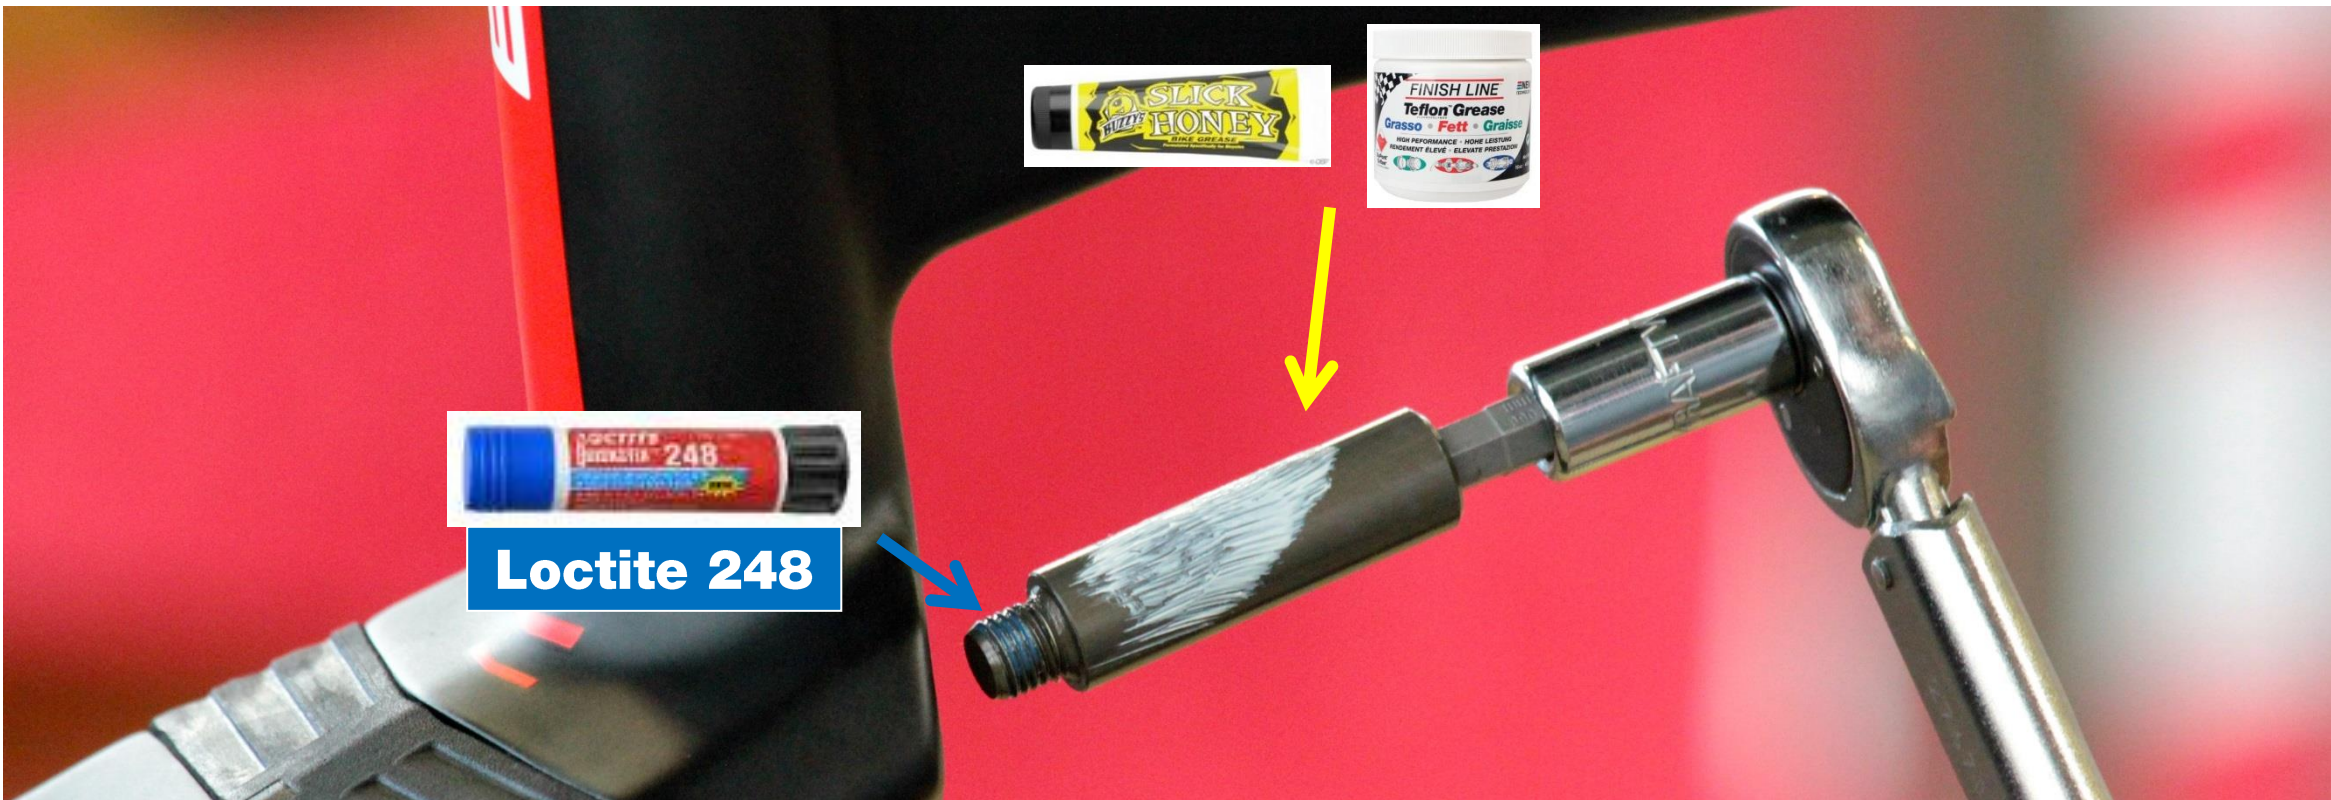
Install the cleaned, or new, guide shafts on both left and right sides.

Make sure there is threadlocker on the threads – if not, use Loctite 248 OR Loctite 242 (blue). It is recommended to use a teflon-based grease on the guides. We recommend Buzzy's Slick Honey™ or Finish Line Teflon® Grease (use of lithium-based grease is discouraged).

Tighten the guide shafts, alternating between sides as torque increases. Tighten guide shaft bolts to 8Nm.

Note: Over- or under-tightening of the guide shaft bolts can compromise MTT performance and result in premature wear of MTT parts, or potential frame damage. Use of a calibrated torque wrench is strongly recommended.
