MTT MicroTravel Technology

Service and Maintenance Manual

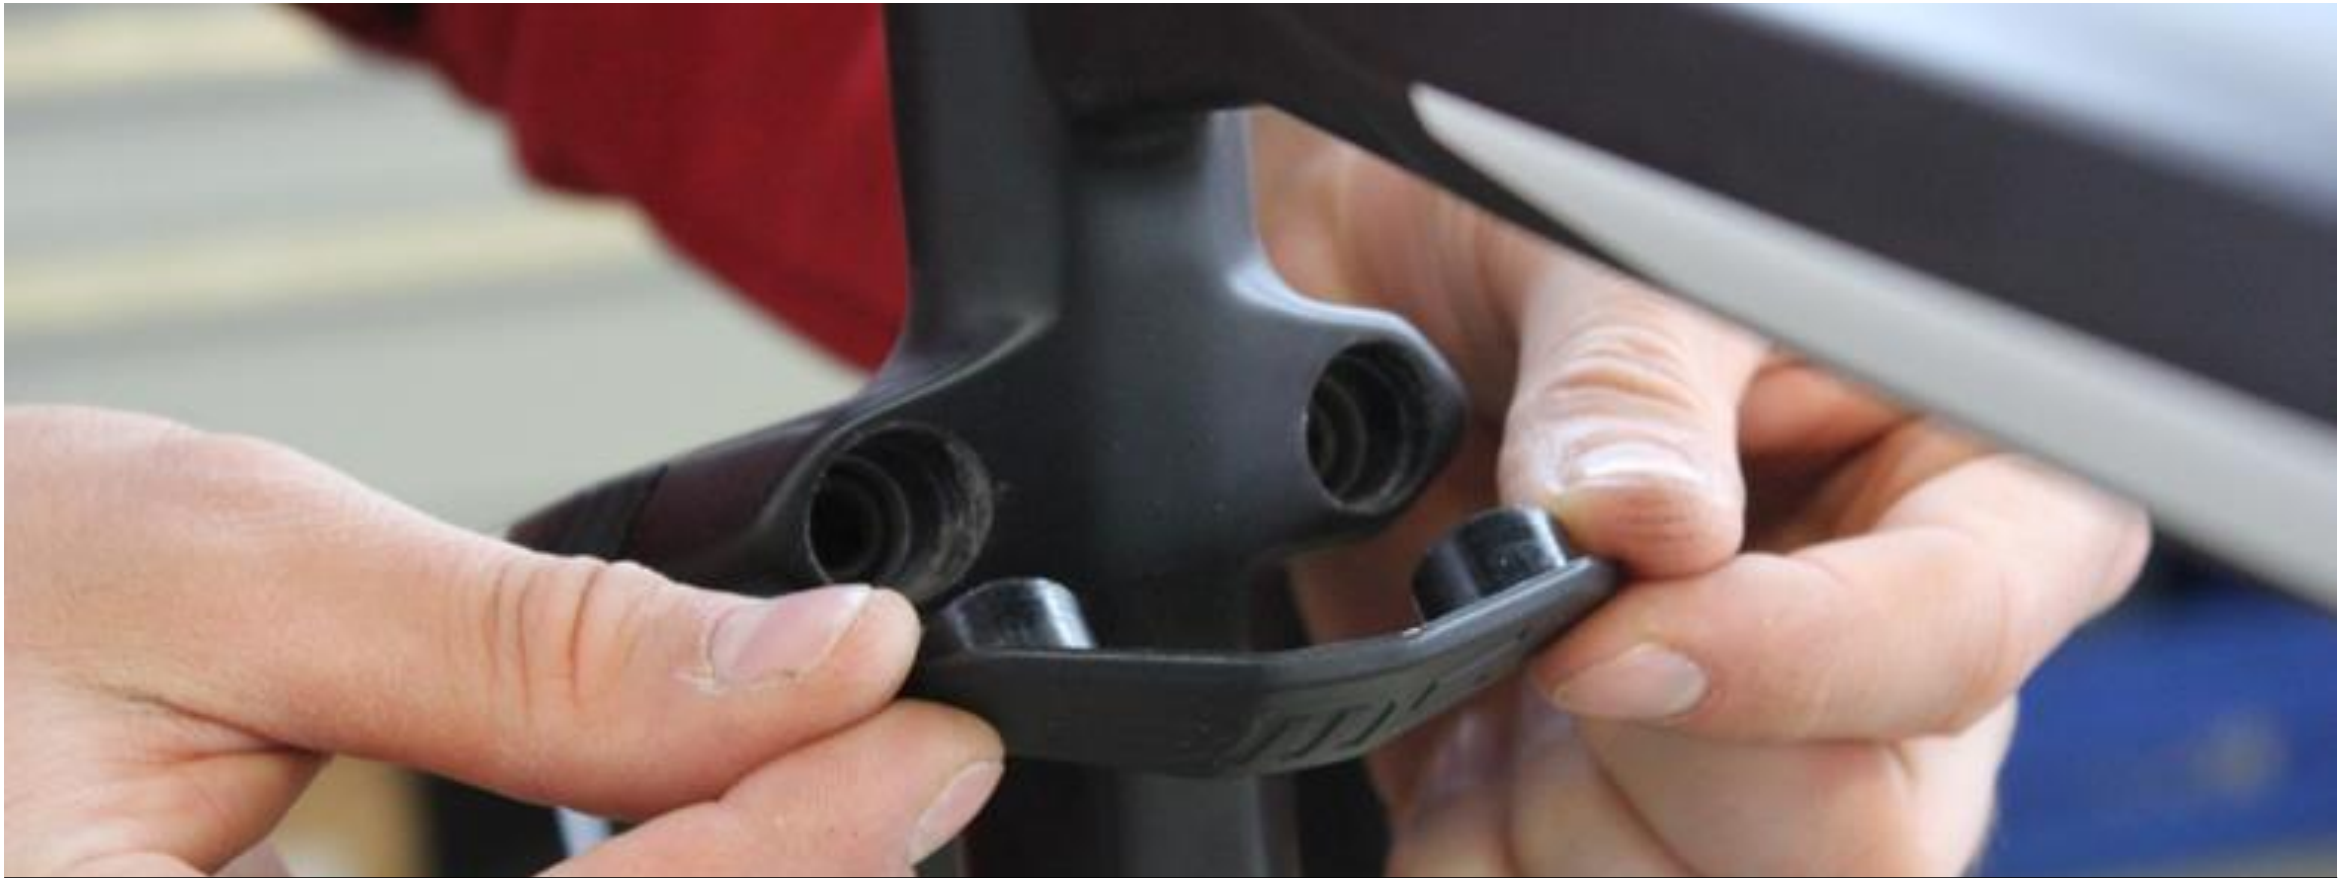
Install the cleaned, or new, dust cover – pressing firmly over each port simultaneously makes for the most thorough installation. Frequent removal can result in wear of the fitting – double-sided tape placed in the middle of the cover can prevent loss.
