# Olympic Challenge

# Scanning London's Olympic Stadium

The Olympic Stadium is built from prefabricated steelwork components in a demanding workflow where the final design of successive components is adjusted to fit the verified deformation of each previously installed component. A team of experienced surveyors met this challenge, along with tight deadlines, to keep construction moving.

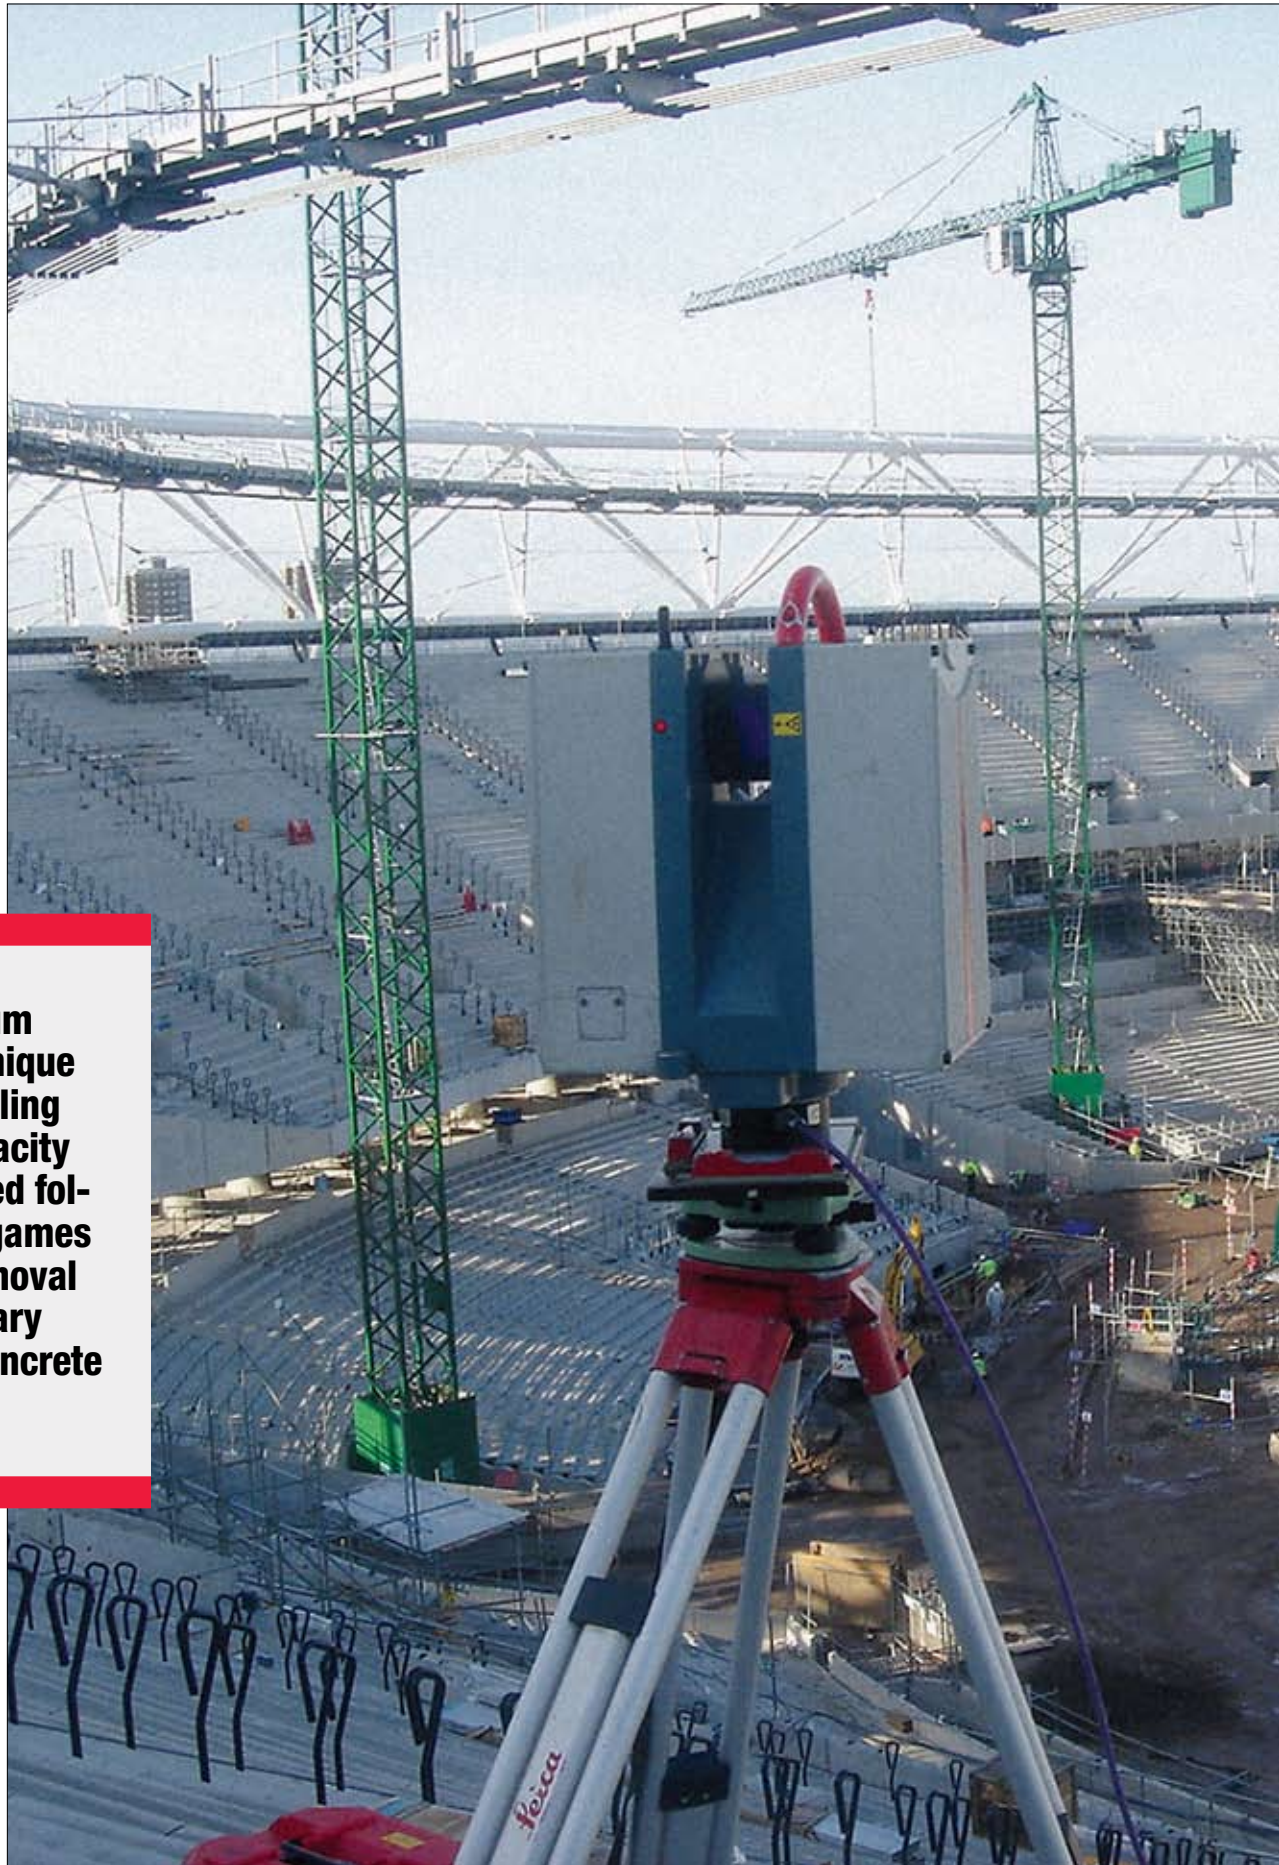
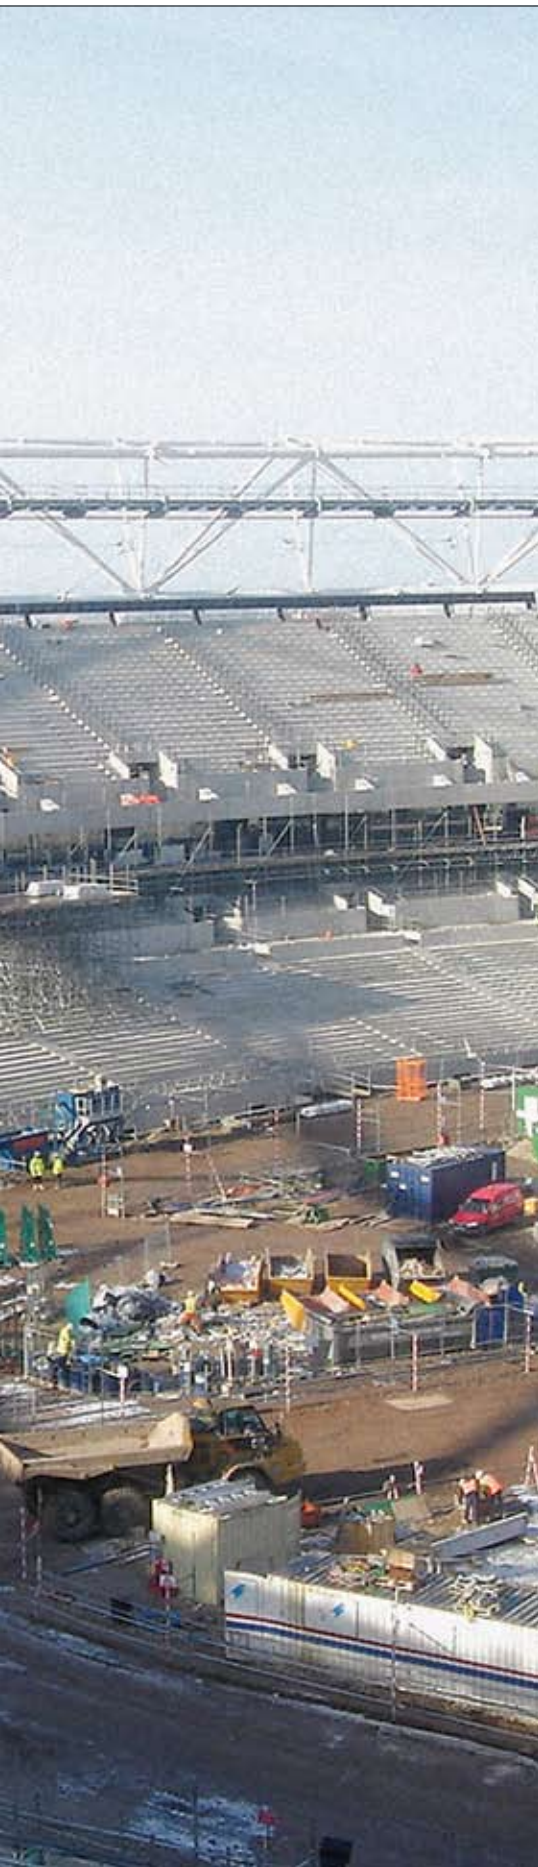
The upper tier terrace and roof-supporting structure are constructed from pre-fabricated compression truss and roof-column connections with cables supporting a roof structure of PVC fabric.

**Team Stadium created a unique design enabling seating capacity to be reduced following the games with the removal of a temporary steel and concrete upper tier.**

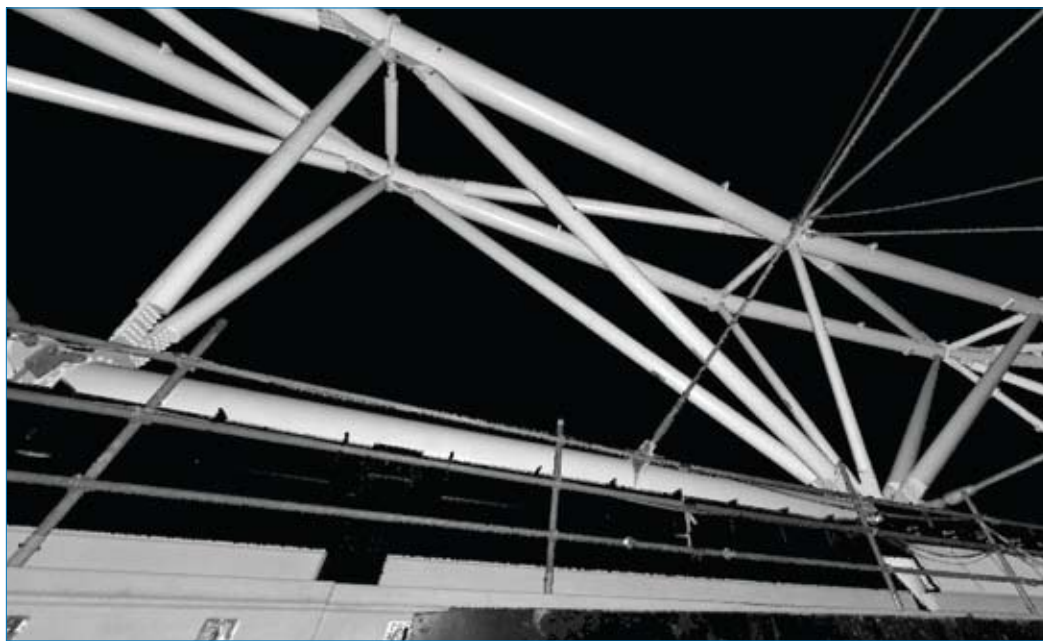
This high-resolution scan of the roof-supporting structure was taken using a high-speed phase-based 3D laser scanner. The point cloud is displayed in grey-scale intensity mapping, with locating holes and individual rivets visible.
