SERVICE BULLETIN

| Classification: AT15-005h | Reference: NTB15-015h | Date: April 27, 2017 |

PATHFINDER, QUEST, MURANO, MAXIMA, ALTIMA V6; CVT JUDDER AND DTC P17F0 OR P17F1 STORED

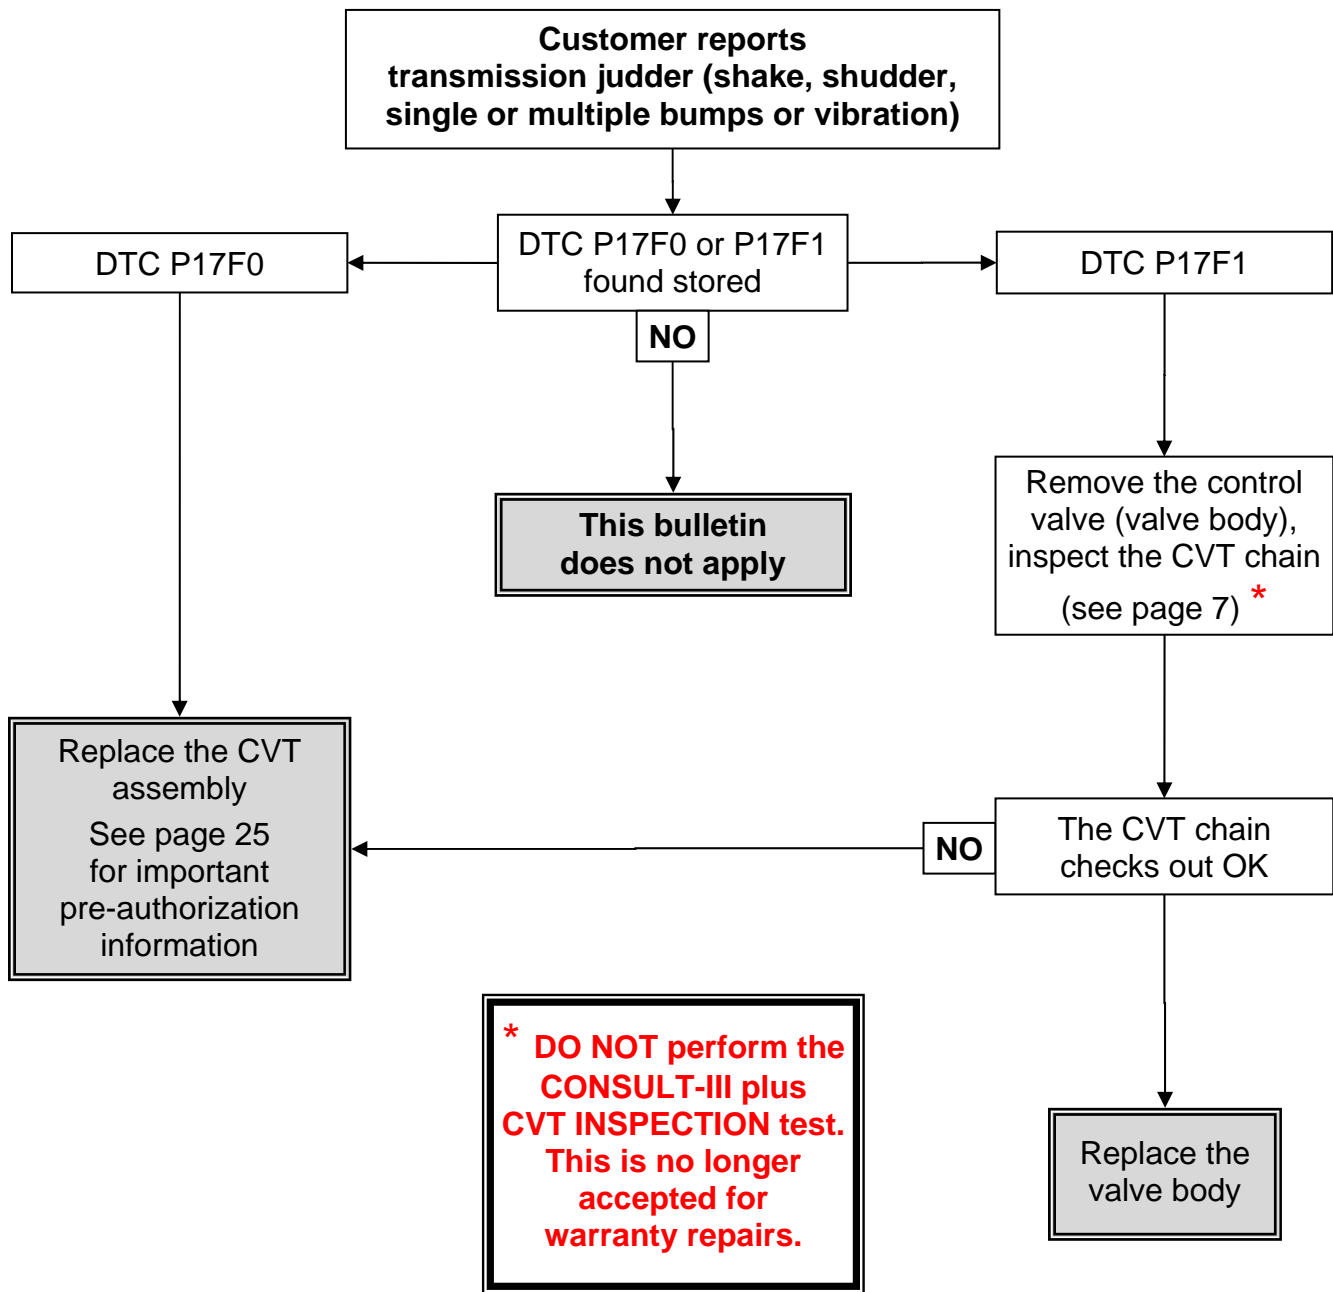
Repair Flow Chart

- Review the **Repair Flow Chart** on this page.

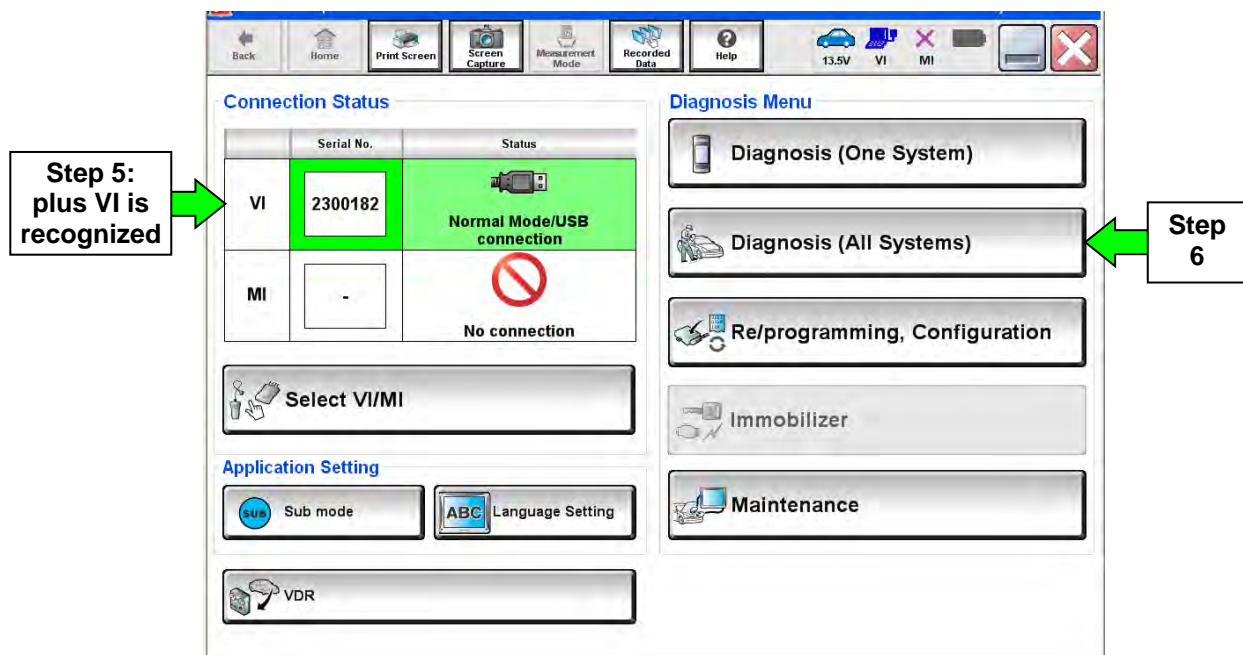
Figure 1

1. Before starting, it is **IMPORTANT** to make sure:
 - ASIST on the CONSULT PC has been freshly synchronized (updated).
 - All CONSULT related software updates (if any) have been installed.
2. Once all ASIST and CONSULT related updates have been performed, attach the CONSULT PC to the vehicle.
 - Connect the plus VI to the vehicle.
 - Connect the AC adapter to the CONSULT PC.
3. Turn ON the CONSULT PC, and then open CONSULT III plus (C-III plus).
NOTE: Make sure all applications other than C-III plus are closed.
4. Press the ignition switch twice without depressing the brake pedal.
 - The meter and gauges will illuminate.
 - Do Not start the engine.
 - Make sure ALL accessories are turned OFF.
5. Wait for the plus VI to be recognized.
 - The serial number will display when the plus VI is recognized.
6. Go to **Diagnosis (All Systems)**.

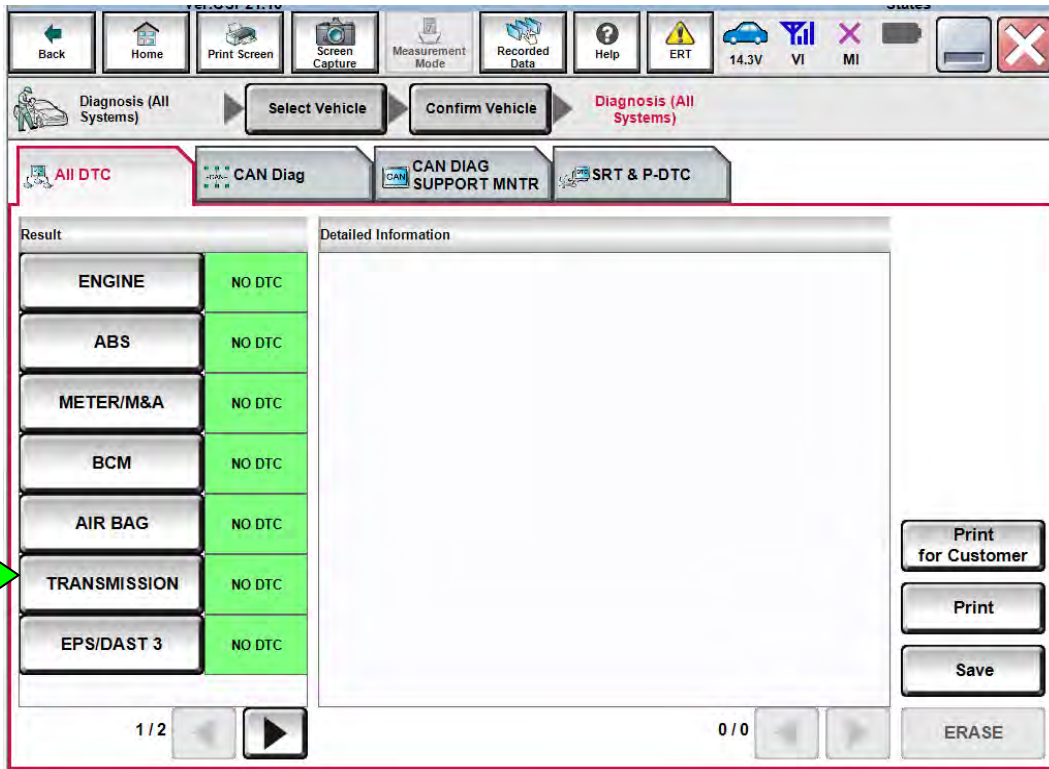
Figure 2

7. Select **TRANSMISSION**.

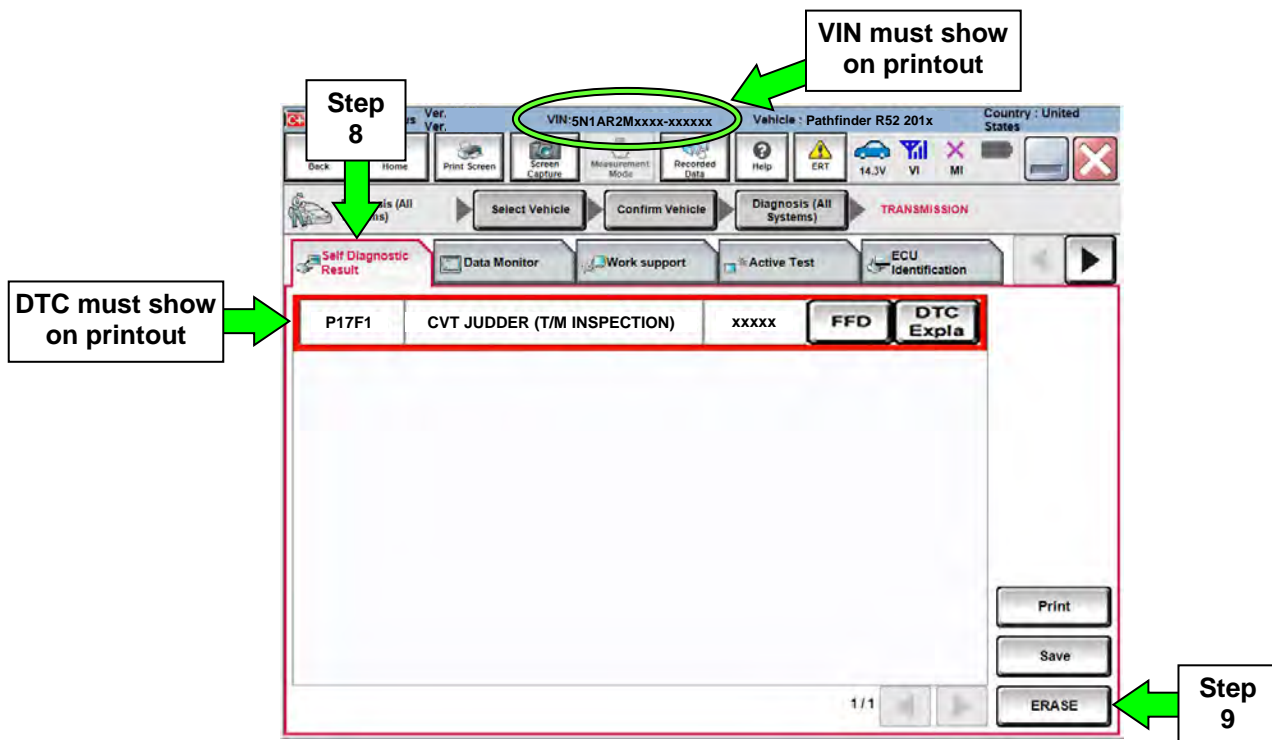
Figure 3

9. Select **ERASE**.

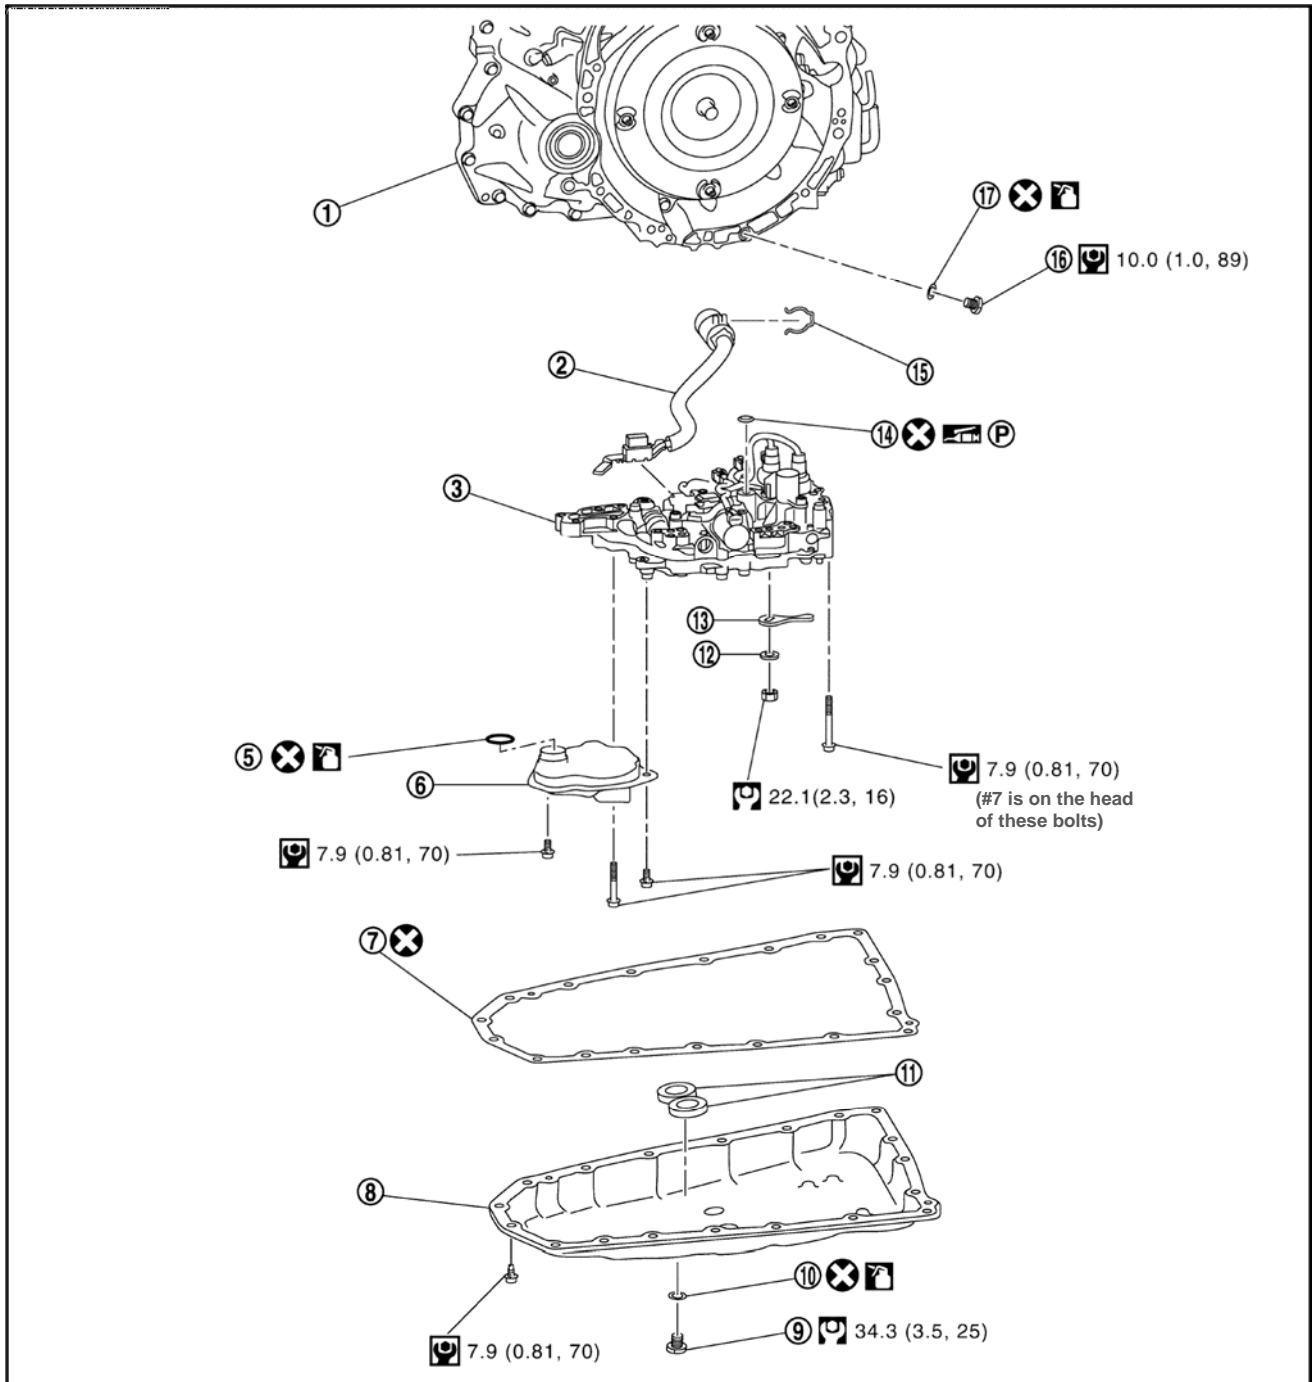
Figure 4

Example: Exploded View of Control Valve (valve body)

| ① | Transaxle (CVT) assembly | ② | Terminal cord assembly | ③ | Control valve (valve body) |
| ④ | | ⑤ | O-ring | ⑥ | Oil strainer assembly |
| ⑦ | Oil pan gasket | ⑧ | Oil pan | ⑨ | Drain plug |
| ⑩ | Drain plug gasket | ⑪ | Two magnets | ⑫ | Spring washer |
| ⑬ | Manual plate | ⑭ | Lip seal | ⑮ | Snap ring |
| ⑯ | Overflow plug | ⑰ | O-ring | | |

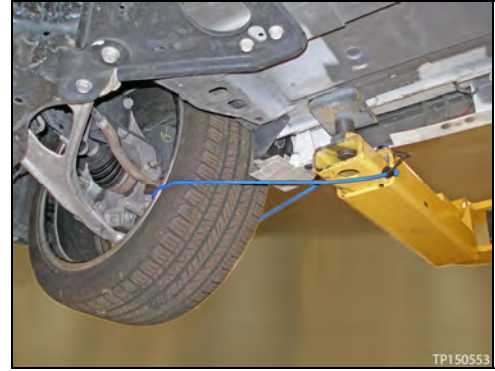
Figure 5

2. Secure the right front tire with a suitable strap.
 - This will assist in making the chain turn.
3. Mark the left front tire with a suitable marking.
 - This will assure all 360° of the chain is inspected.

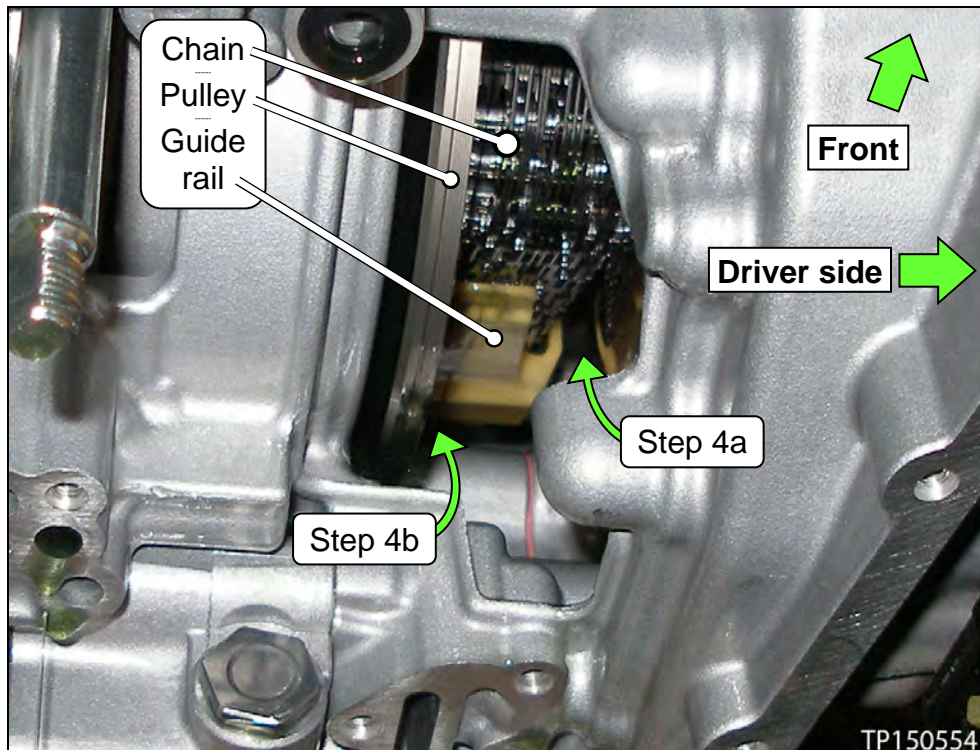
- Insert the camera lens behind the pulley between the guide rail and the pulley where shown in Figure 6 (also see page 9-10, Figure 7-10).
- Insert the lens approximately 8-9 inches, and then view the side of the chain that contacts the pulley.

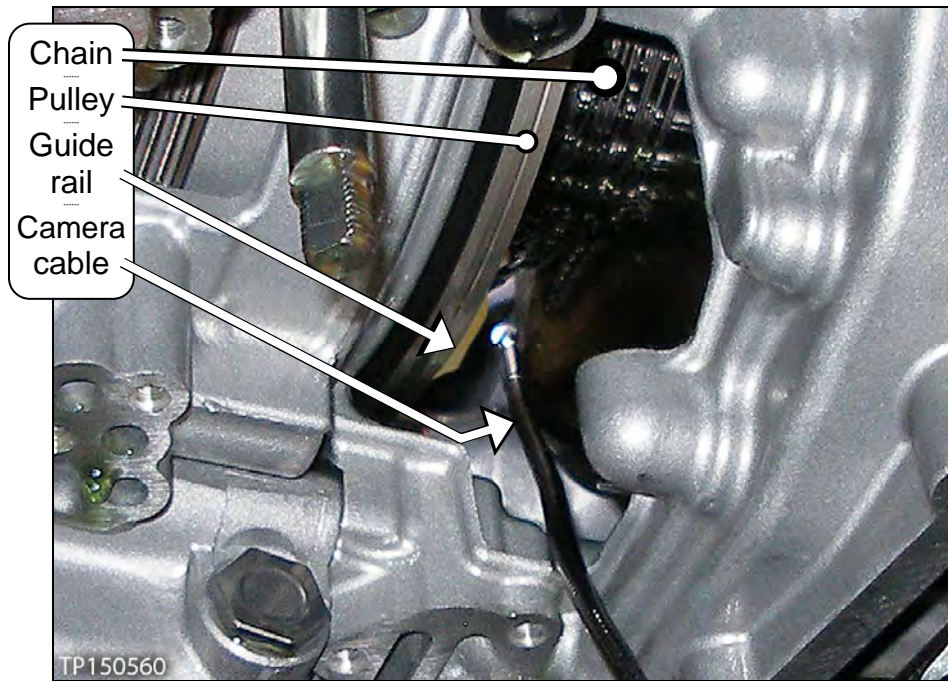
Figure 7

- Figure 8 shows where to insert the camera lens on the driver side of the chain.

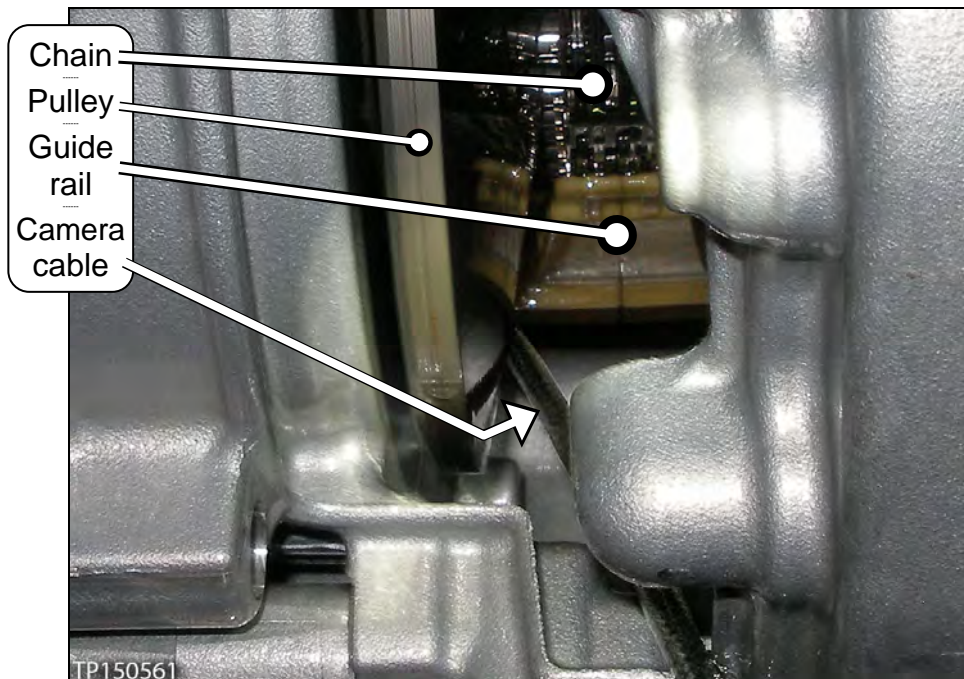
Figure 8

- Figure 9 shows where to insert the camera lens on the passenger side of the chain.

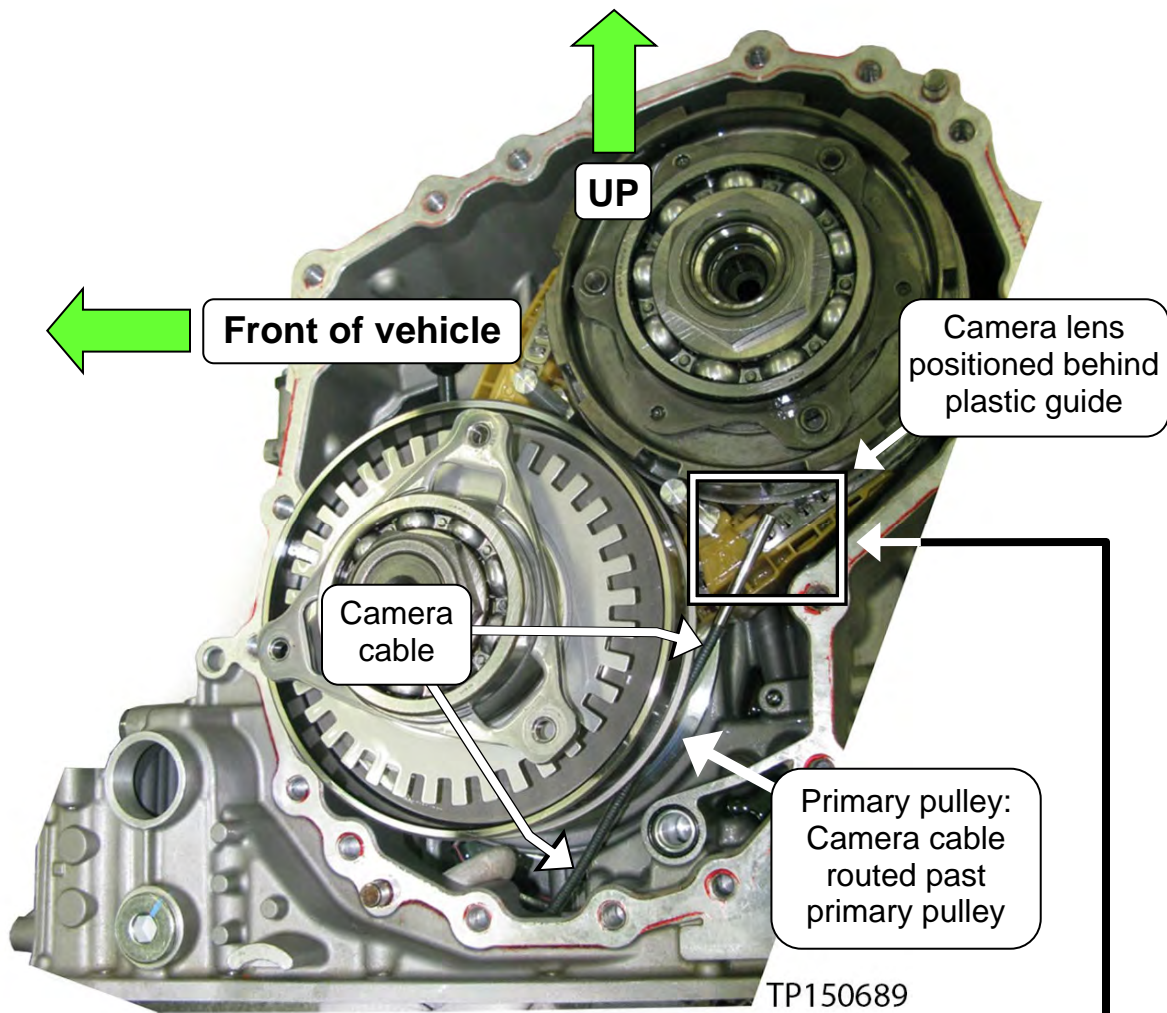
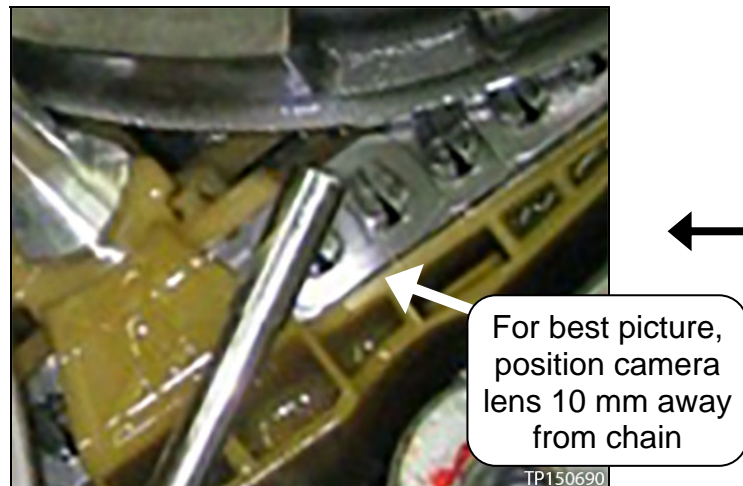
- Figures 9 and 10 shows the routing and location of the camera.

NOTE: The CVT's side cover was removed for easier viewing of camera location. The side cover is not to be removed at any time during this procedure.

4. Using borescope J-51951 with mirror attachment, visually inspect the side of the chain that comes in contact with the pulley:
 - a. First inspect the entirety (360°) of the driver side of the chain that comes in contact with the pulley (see page 10, Figure 9 and 10, and page 12, Figure 13).
 - b. If the inspection result is OK on all 360°, inspect all 360° of the passenger side of the chain.

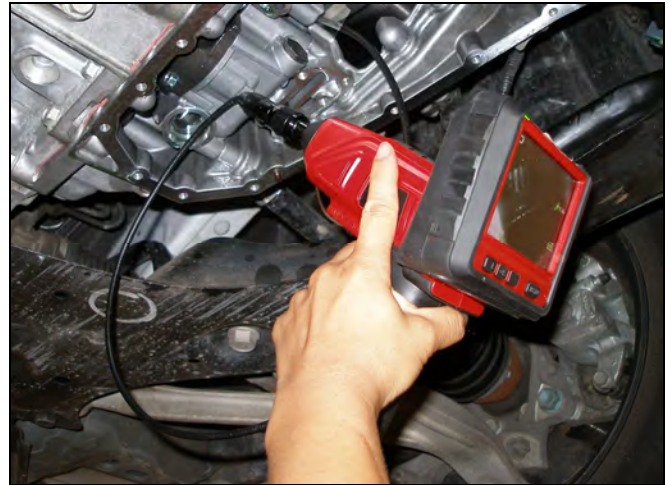
Figure 11

- Holding the borescope with one hand allows for turning the tire with the other hand (see Figure 11).

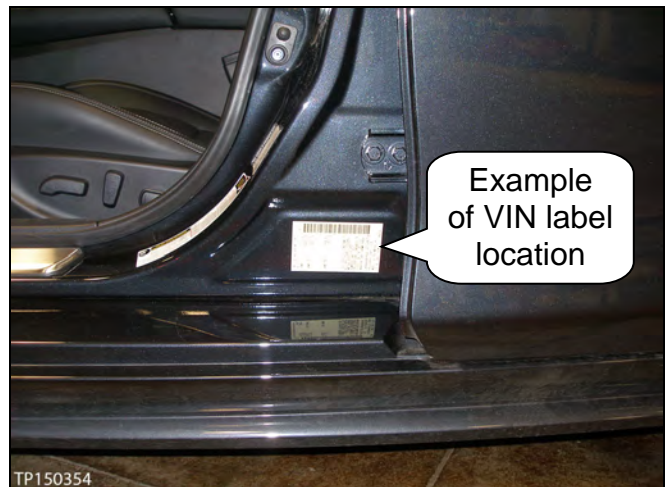
Figure 12

e. Once CVT replacement is determined as required, use borescope J-51951 to record a 15 second or less continuous video of the most severe evidence of chain slip and the VIN on the F.M.V.S.S. certification label (VIN label). See example in Figure 12.

- For best picture, the camera lens should be about 10 mm away from the object being recorded.

- Before starting to record, make sure the camera handle's AA batteries are fresh and the LCD monitor's battery is charged.
- The whole video will show as backward, or reversed mirror image. This is okay.
- The required video must show clear evidence of chain slippage and be 15 seconds or less.

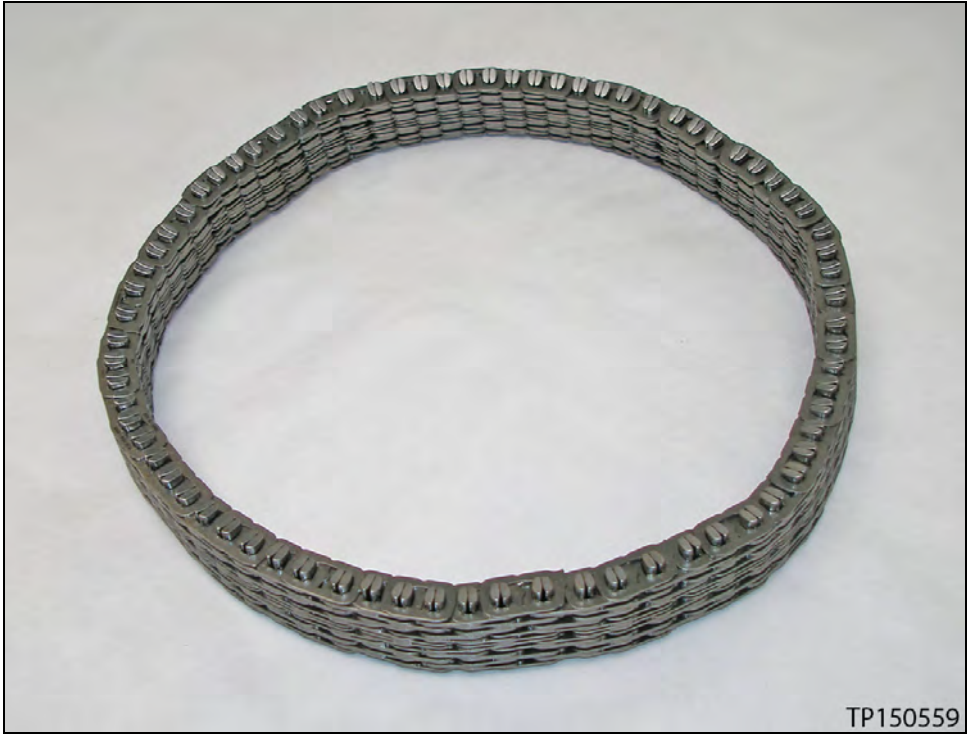
TP150559

Figure 14: CVT chain

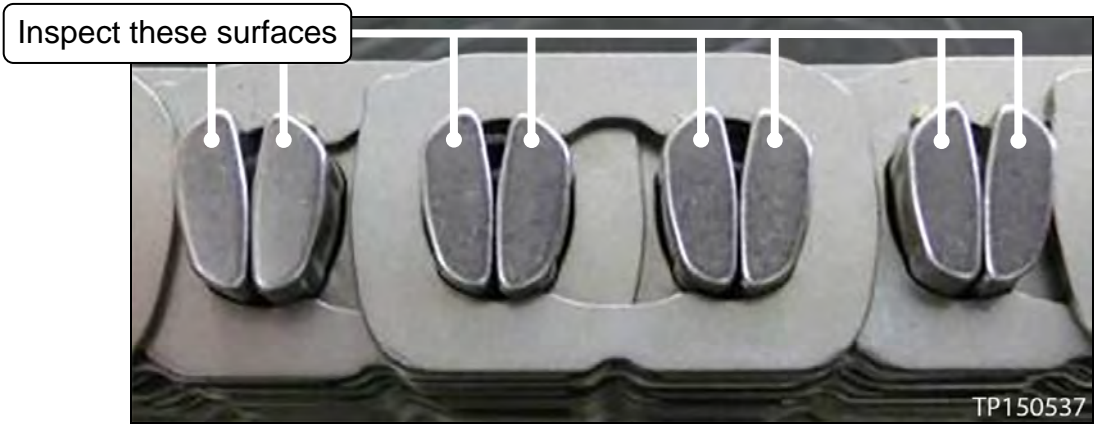
TP150537

Figure 15: Close-up of area to be inspected

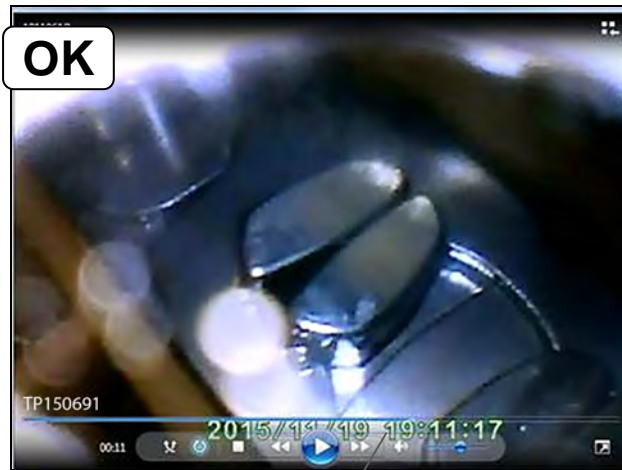
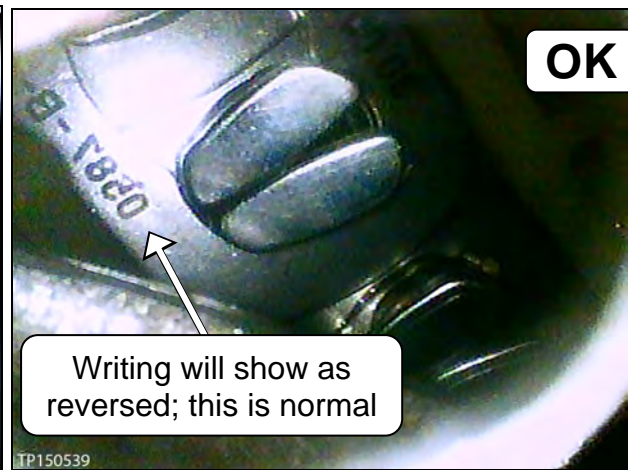
Pictures in Figure 16 and 17 were taken with borescope J-51951.

NOTE: Reference the pictures on page 13-15 for comparison.

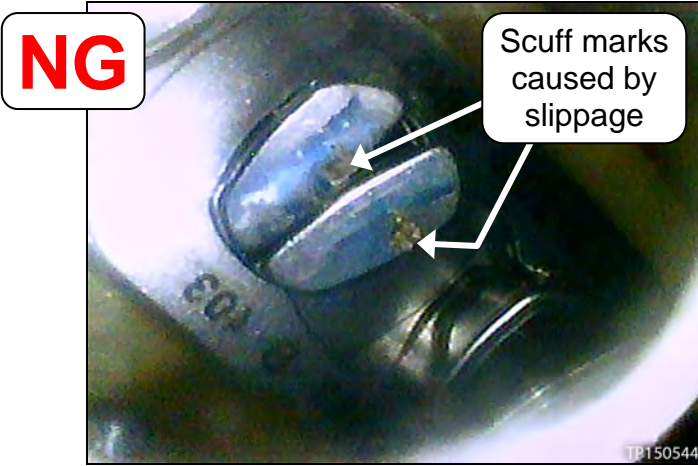
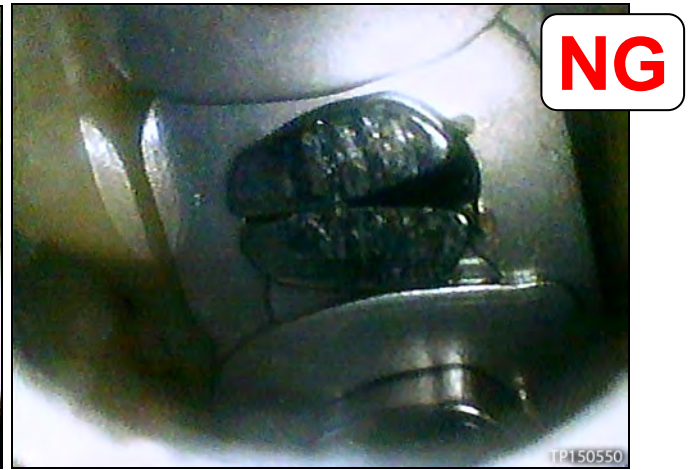
Pictures in Figure 20-21 were taken with borescope J-51951.

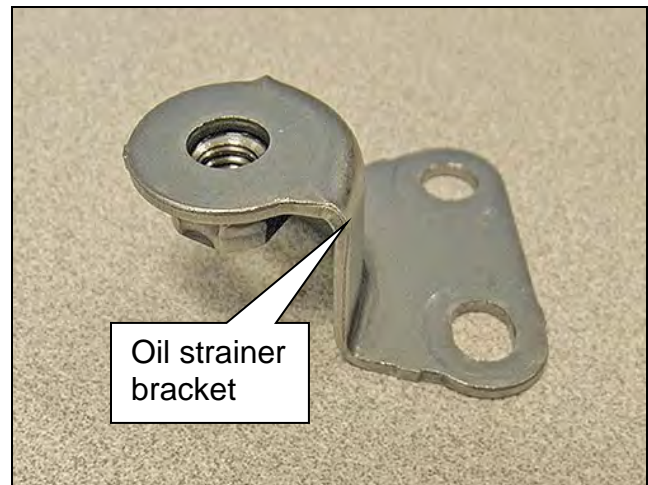
Figure 25

1. Discard the oil strainer bracket (Figure 25).

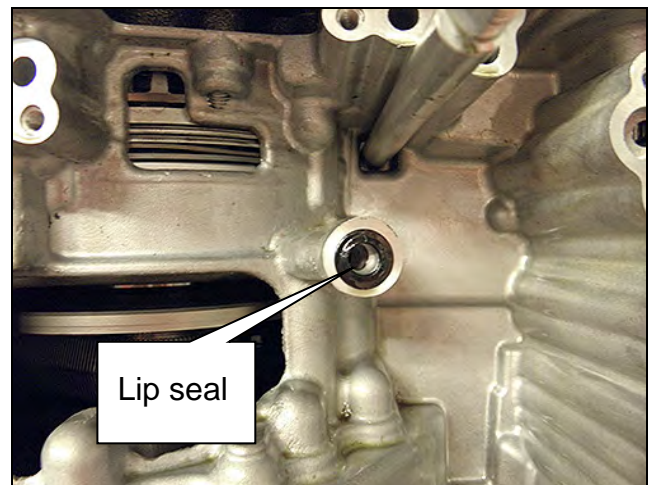
Figure 26

2. Install a new lip seal. Do **NOT** reuse the old lip seal (Figure 26).

NOTE: Apply a small amount of petroleum jelly to the lip seal to keep it in place on the CVT.

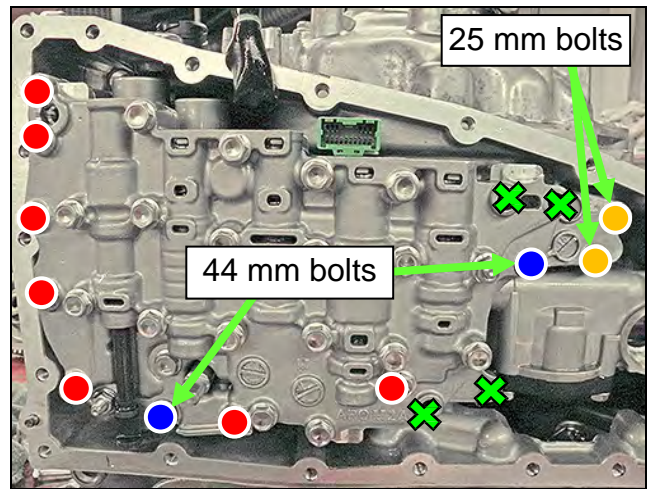
Figure 27

3. Install the Control Valve with eleven (11) mounting bolts (Figure 27).

IMPORTANT: Leave Four (4) ✘ bolt holes blank at this step.

- 54 mm long bolt ● – 7 pieces
- 44 mm long bolt ● – 2 piece
- 25 mm long bolt ● – 2 piece

CAUTION: The two 25 mm bolts are installed WITHOUT the strainer bracket.

- Bolt torque: 7.9 N•m (0.81 kg-m, 70 in-lb.)

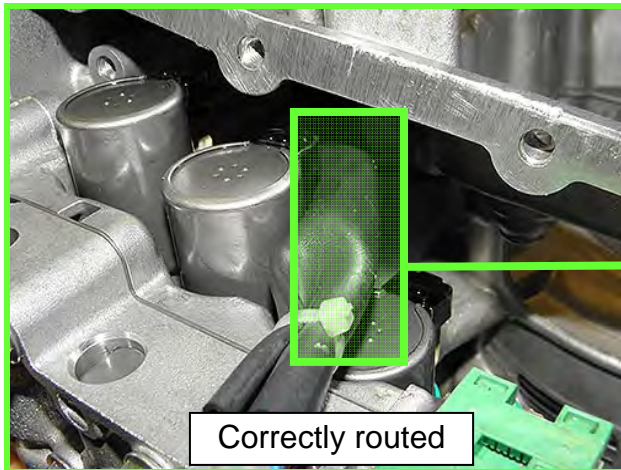
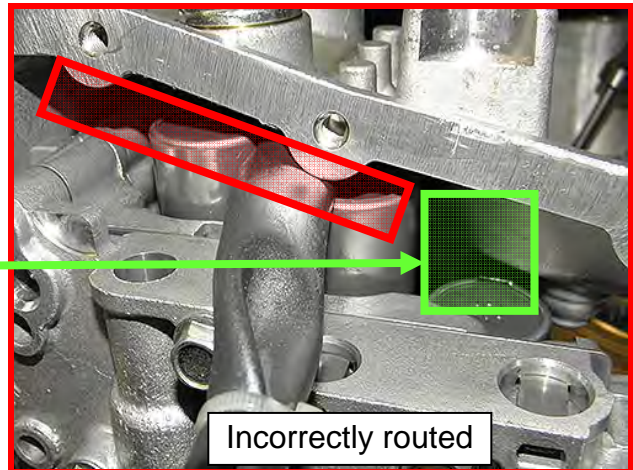
CAUTION: Make sure the wiring harness does not get pinched (see Figures 28 and 29 for correct routing).

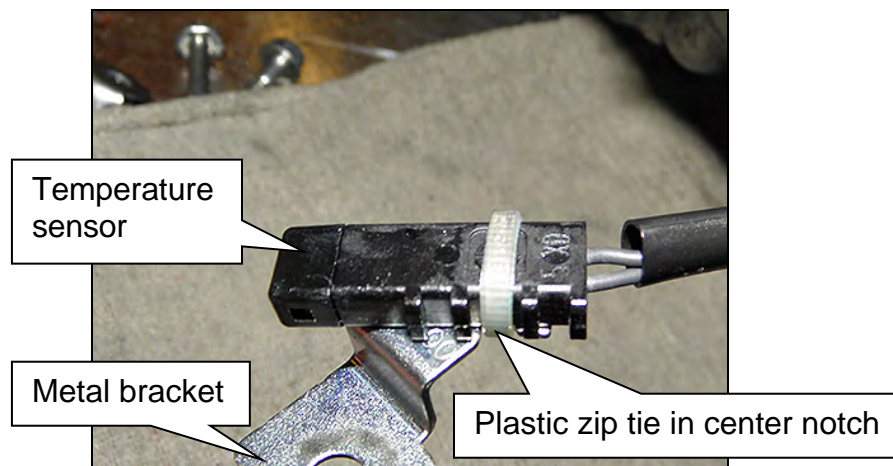
Figure 30

- a. Cut the plastic zip tie with an appropriate tool to remove the temperature sensor bracket from the terminal harness assembly. (Figure 30).

CAUTION: Cut the plastic zip tie over the metal bracket to avoid damage to the temperature sensor.

IMPORTANT: Locate the plastic zip tie at the **center notch** of three notches on the temperature sensor.

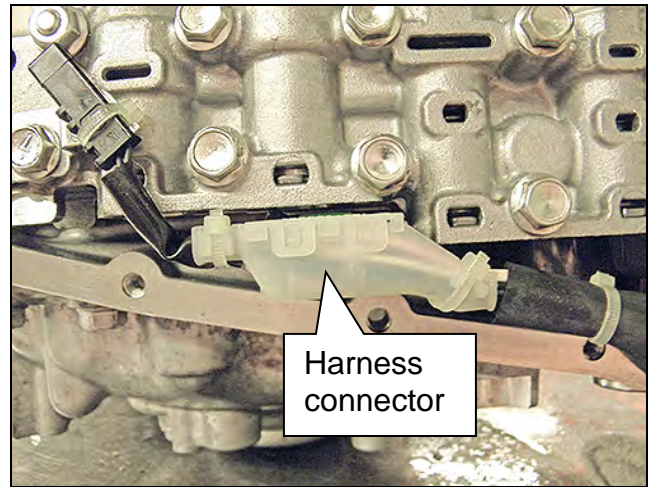
Figure 31

5. Connect the electrical harness connector (Figure 31).

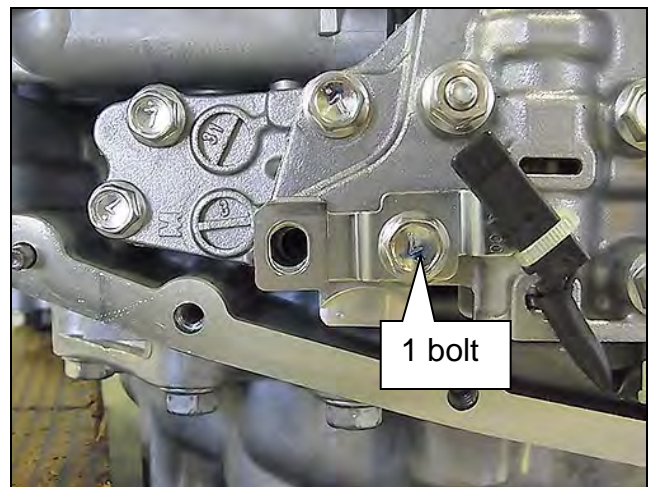
Figure 32

6. Install the CVT fluid temperature sensor bracket to the valve body with one (1) bolt (Figure 32).

NOTE: Leave one (1) bolt hole blank as it will be used to secure the oil strainer at a later step.

- Bolt torque: 7.9 N•m (0.81 kg-m, **70 in-lb.**)
- Bolt length: 54 mm

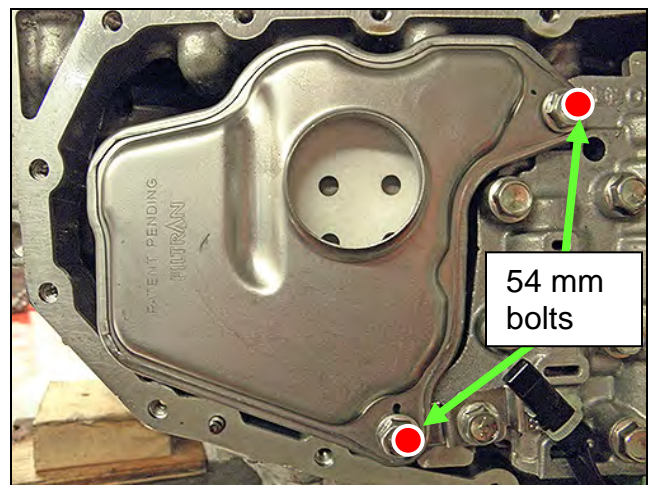
Figure 33

7. Install the new oil strainer with its new O-ring seal with two (2) bolts (Figure 33).

NOTE: replacement strainer maybe a different shape.

- Bolt torque: 7.9 N•m (0.81 kg-m, **70 in-lb.**)
- 54 mm long bolt

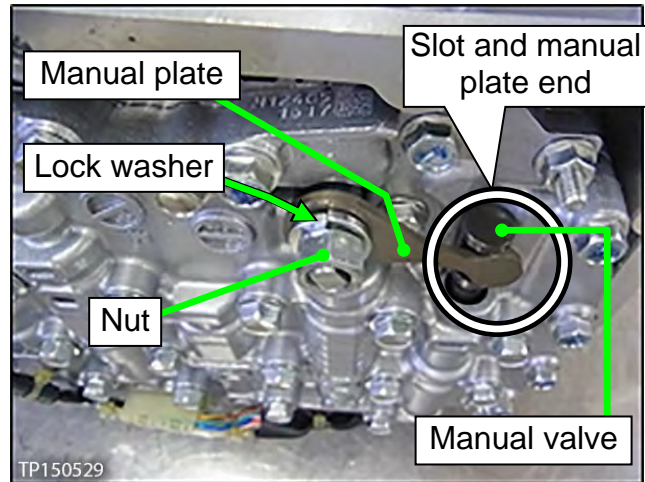
Figure 34

8. Install the manual plate, lock washer, and nut (Figure 34).

NOTE: Make sure the manual plate fits into the slot of the manual valve before applying torque to the nut.

- Reuse the existing manual plate, lock washer, and nut.
- Nut torque: 22.1 N•m (2.3 Kg-m, **16 ft-lb.**)

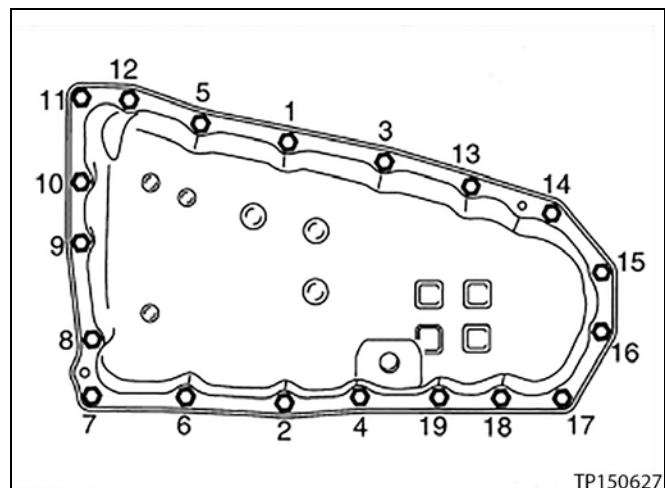
Figure 35

12. Install the oil pan bolts (see Figure 35).

- Reuse the existing pan bolts.
 - Oil pan bolts torque: 7.9 N•m (0.81 kg-m, **70 in-lb.**)

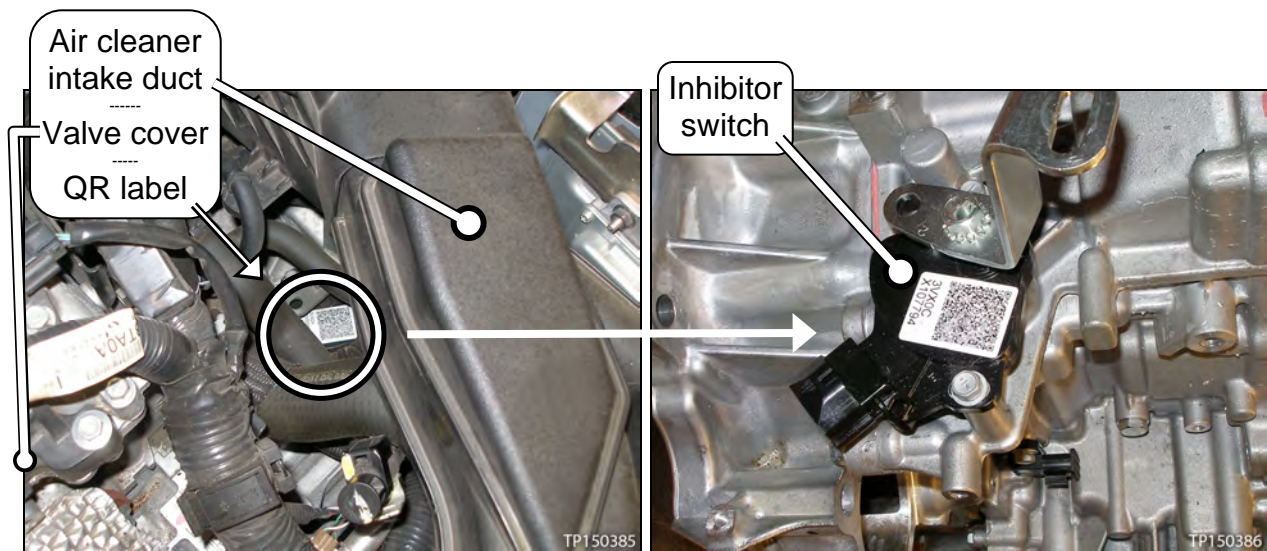
- Refer to **TM – Transaxle & Transmission / BASIC INSPECTION**.
 - Check for fluid leakage.
 - Install Write IP Characteristics to the TCM.
 - Perform Clutch Point Learning
 - Perform Select Learning (Drive/Reverse Learning)
 - Erase CVT Fluid Degradation Level Data
 - Attach the QR label with the new calibration data onto the transmission range switch (inhibitor switch)
 - See Figure 36 and 37 below.
 - A QR Label and CD-R are included with the replacement valve body.

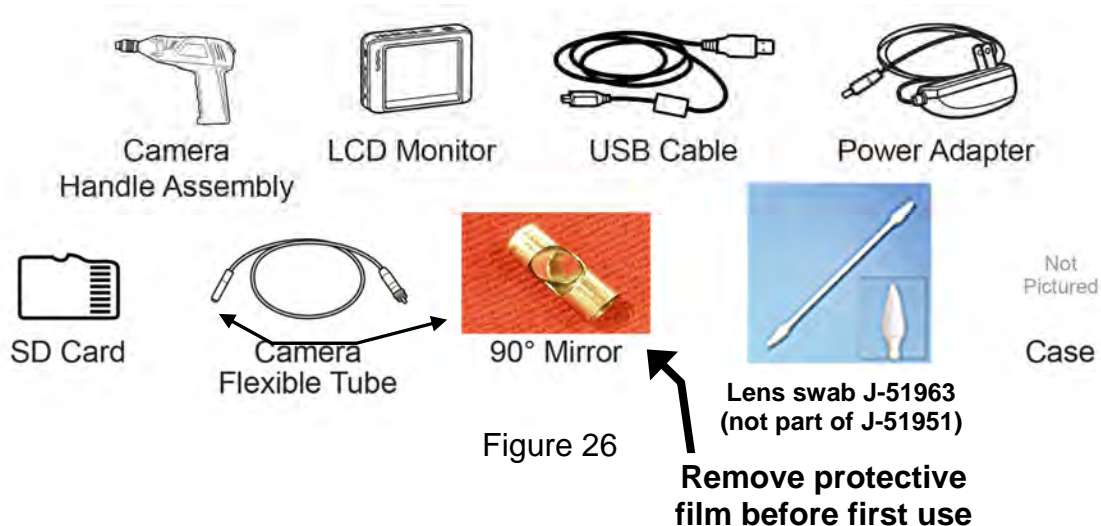
Tech Cam J-51951

NOTE: Essential Tool Tech Cam (borescope) J-51951 has been sent to dealers. This tool's attachments make CVT inspection possible.
