# SAFETY RECALL NOTICE

## IMPORTANT SAFETY RECALL RVXX1507 NHTSA RECALL # 15V-643 – 2nd

Subject: Service Bulletin - Ultra LT Fifth Wheel Damage Caused by Improper Coupling

# W TECHNICAL BULLETIN

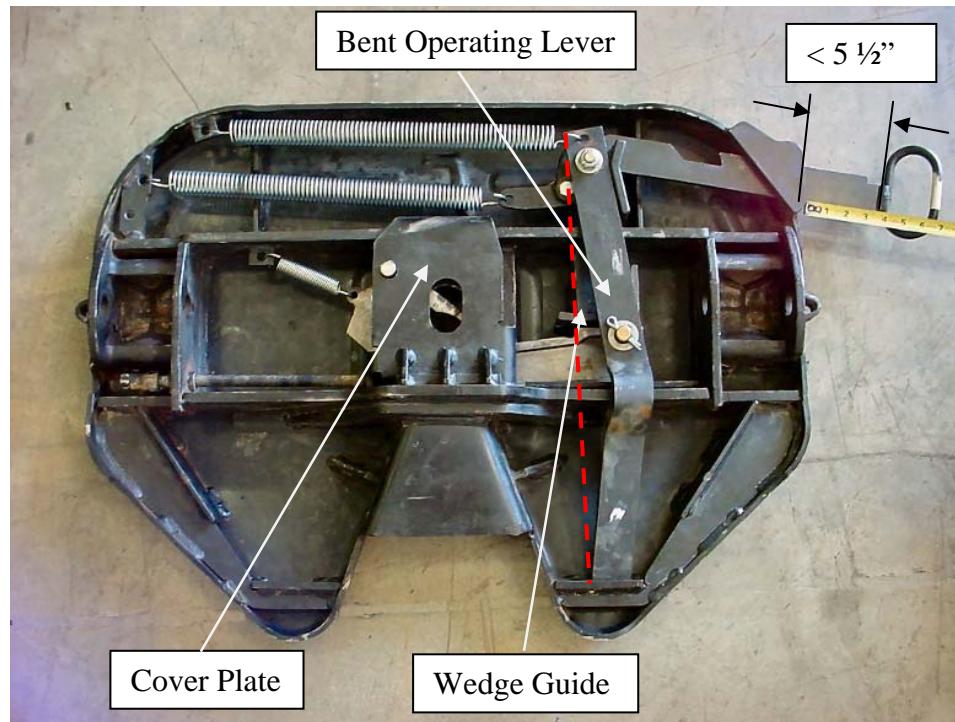
Figure 1

Bent Operating Lever – Pull Handle Dimension  $< 5 \frac{1}{2}''$

1) Perform a thorough visual inspection of the fifth wheel, including underneath, looking for bent or damaged components. Pay particular attention to the operating lever (Figures 1 &2), the rotating jaw and cover plate (Figures 3, 4, & 5), and the wedge guide (Figure 6). If any components are bent or damaged replace the fifth wheel.

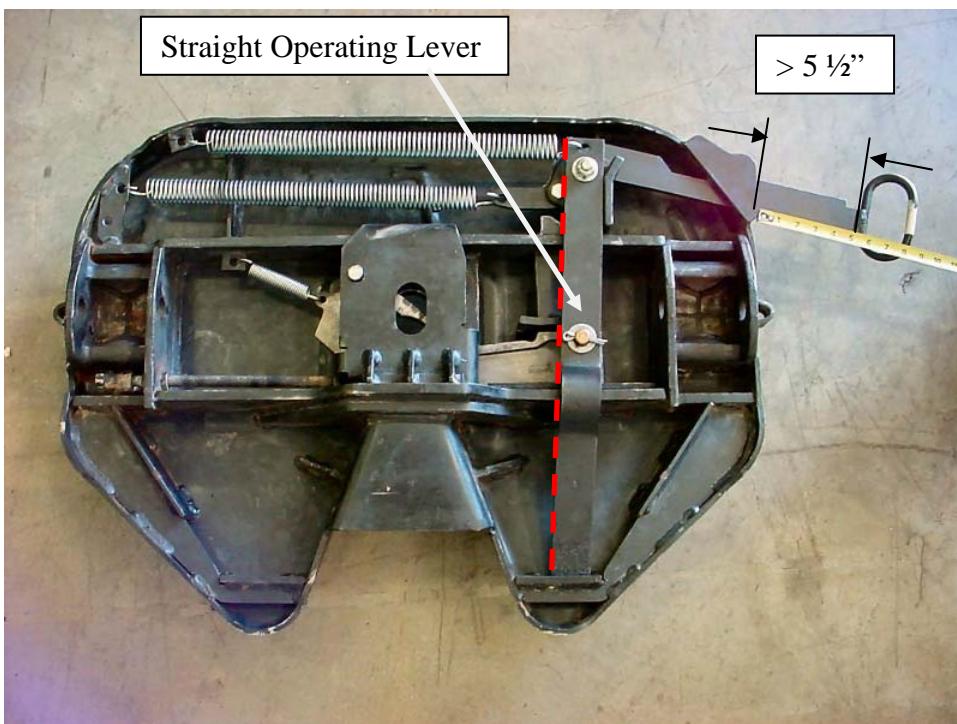
Figure 2

Undamaged Operating Lever – Pull Handle Dimension  $> 5 \frac{1}{2}''$

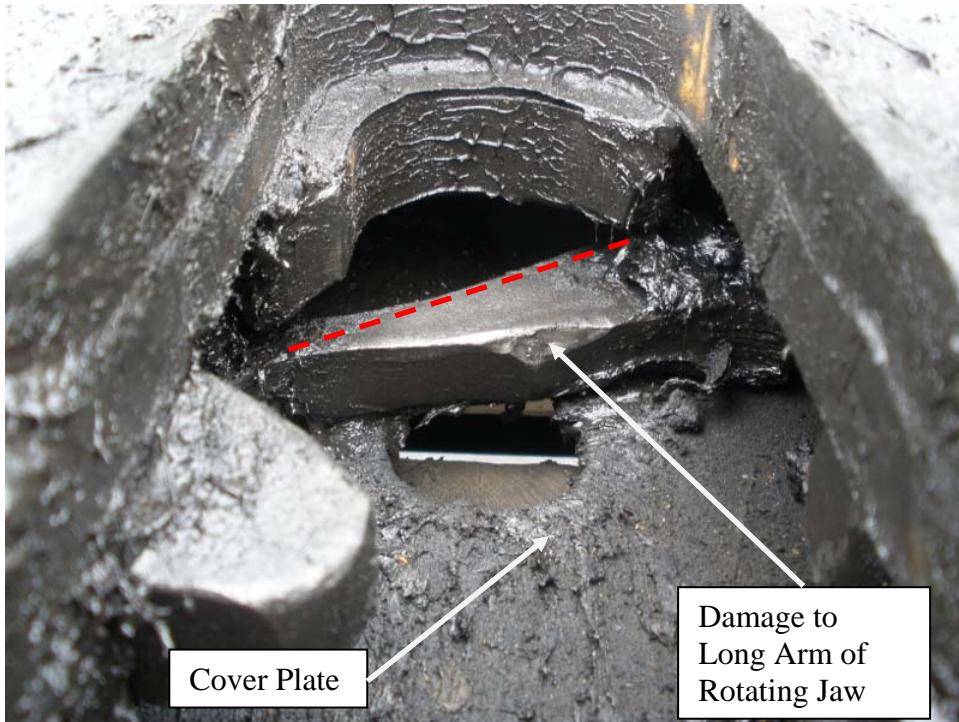
Damage to Rotating Jaw Caused By High Coupling, Resulting in a Bent Cover Plate  
Figure 3

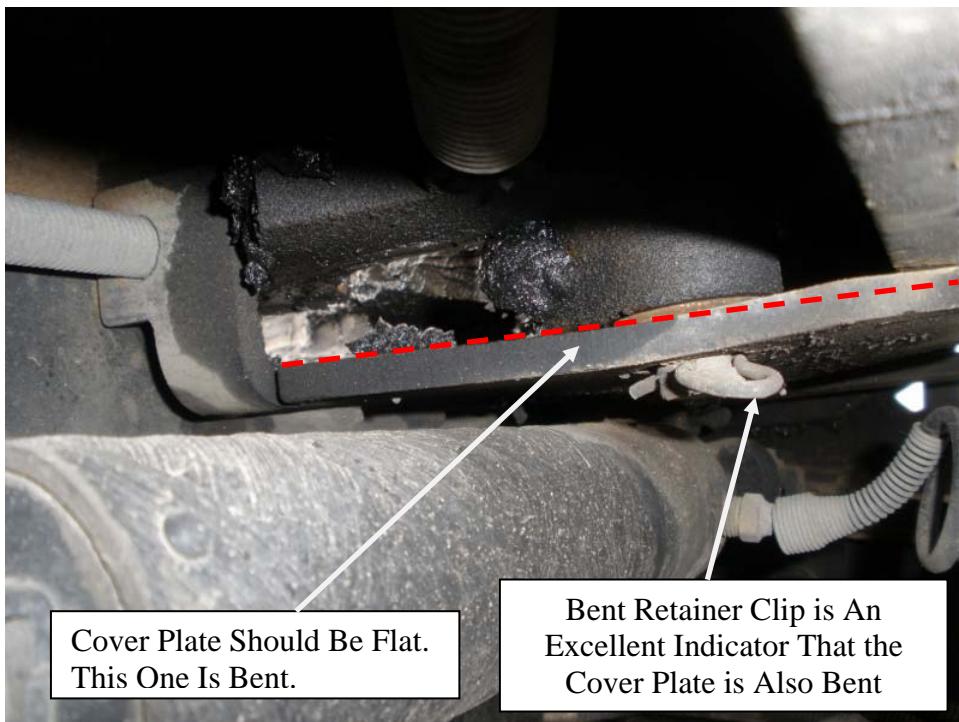
Bent Cover Plate  
Figure 4

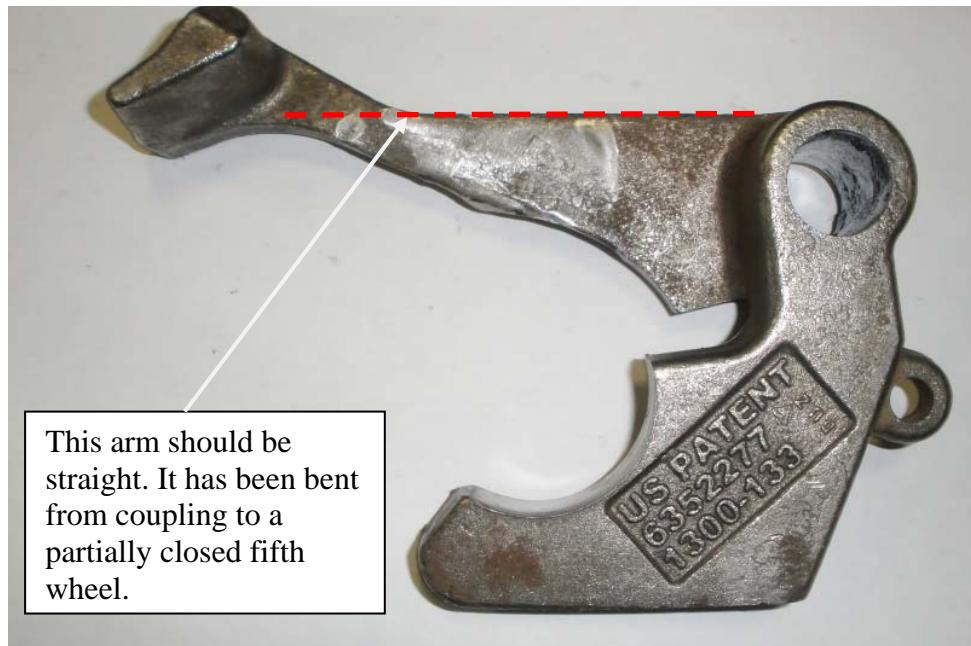
Damaged Rotating Jaw Caused By Improper Coupling  
Figure 5

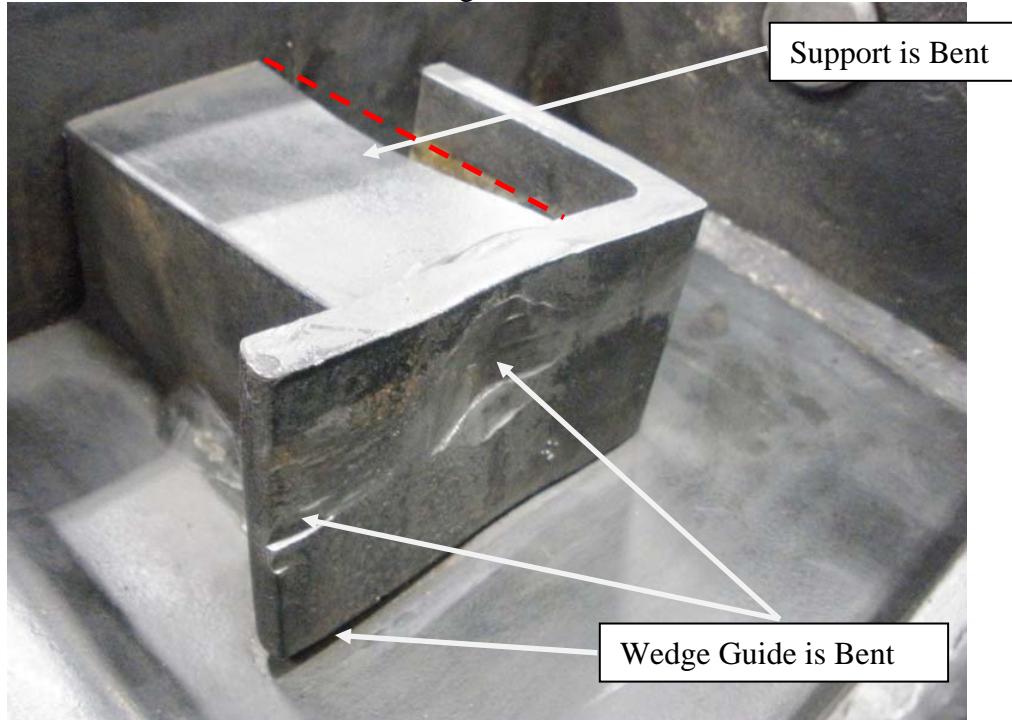
Wedge Guide Damage  
Figure 6

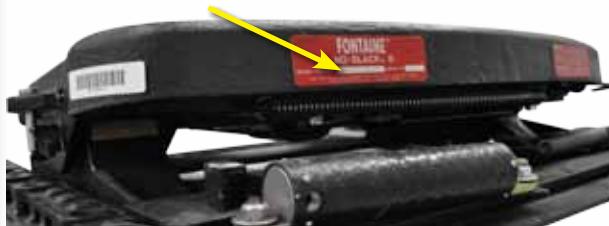
*Model number location*

If the model number identified using method 1 is on this list, you have an Ultra LT Fifth Wheel.
