Vintage Radio

The 1948 Healing L502E 5-valve radio

Boasting excellent performance, the Healing L502E was released in 1948 and is a fairly conventional 5-valve superhet receiver. A number of different models share the same cabinet design, with some unusual mechanical linkages used for the on/off switch and tone controls.

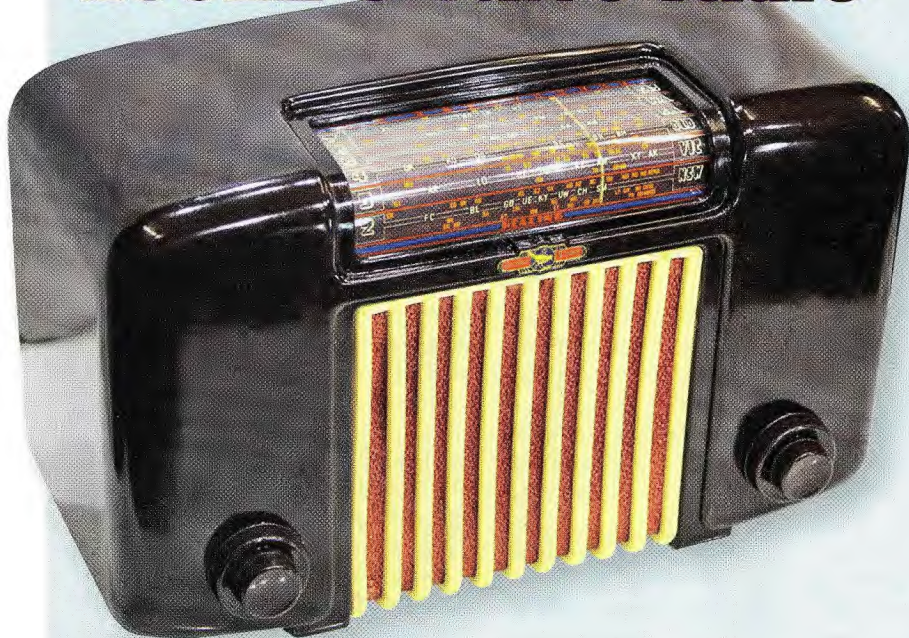
The attractive singing canary emblem on the Healing receivers is made of enamelled brass.

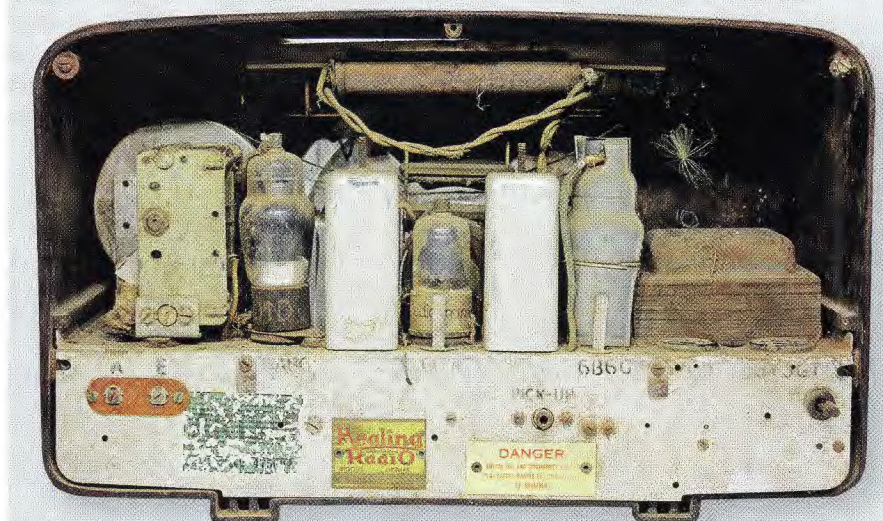
The author's L502E receiver prior to restoration. It was covered in dust, had missing knobs and valves, and came with spider webs and a wasp nest.

When I acquired it, the L502E was missing all its knobs but came complete with spider webs and a rock-like mud-wasp nest between the tuning gang and the chassis. This wasp's nest had penetrated between the vanes of the tuning gang but I was able to remove it using a stiff wire brush.

Unfortunately, the set's exposed steel surfaces all showed significant rust, including on the tuning gang, the dial light enclosure and the mains transformer casing. These rusted surfaces were all abrasively cleaned and painted to match the original finish.

The folded metal chassis didn't have any rust because it is made of aluminium. However, the aluminium had degraded in many places to either an oxide or salts of aluminium. A good clean-up using scrapers and steel wool restored a gleam to most of this metalwork.

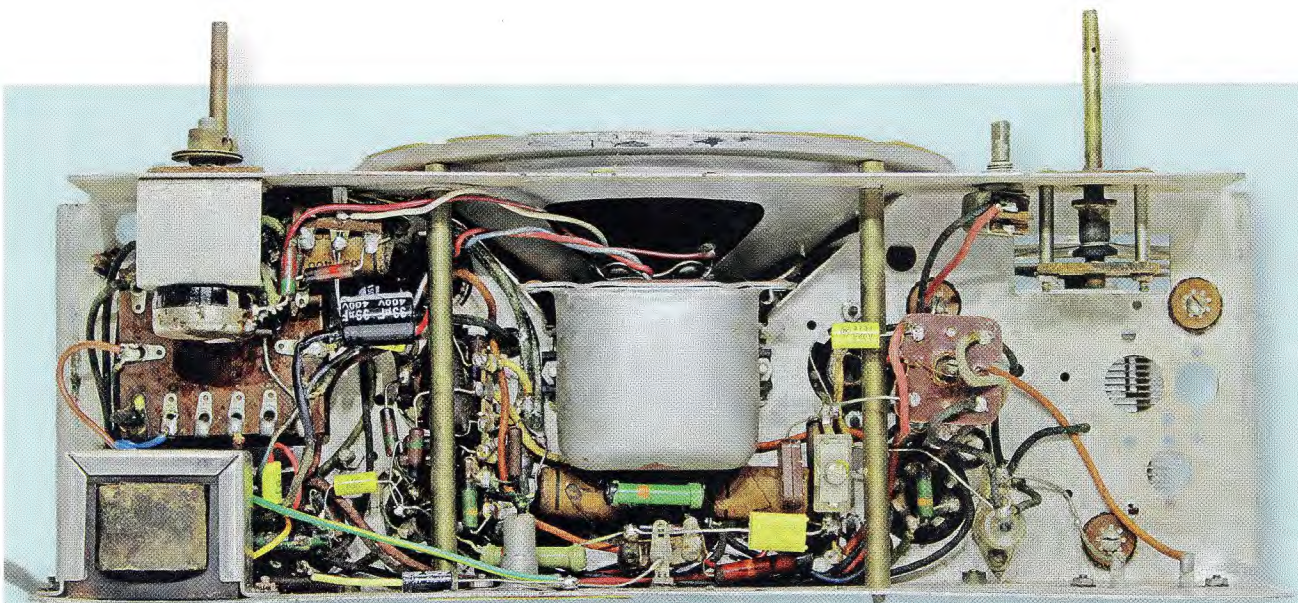
This view shows the 502E after the under-chassis restoration work had been completed. Some parts are difficult to access as they are buried under other components.

A look under the chassis soon reinforced this latter theory. The under-chassis layout is crowded and this makes it difficult to replace certain parts. In particular, the HT filter choke (L5) blocks access to components

around the 6V6 and 5Y3 valves, so I removed it for the duration of the restoration. That choke was clearly stamped with the date "22 OCT 1948".

Once it was out, the cause of the two valve failures could be readily ex-

plained by the state of paper capacitors C12 ($0.01\mu\text{F}$) and C21 ($0.02\mu\text{F}$). C12, in particular, had been deformed by heat into an almost unrecognisable blob with fly leads extending from it.

This capacitor is paralleled across the output transformer's primary, its role being to bypass high frequencies beyond the normal audible range. Because C12 and T2 form an LC circuit, I suspect that, as the capacitor deteriorated, it caused the 6V6 audio output stage to oscillate, resulting in high power dissipation. However, C21 was probably the main reason the two valves failed.

C21's failure is unremarkable, since it's used as a coupling capacitor between the 6B6 preamplifier and the 6V6 output stage and is subjected to a high DC voltage. In fact, any paper capacitor used in this role should be routinely replaced due to the high probability of DC leakage.

The evident failure of C21 in this Healing set would have resulted in a high positive grid bias on the 6V6. This in turn led to the destruction of both the 6V6 and the 5Y3 rectifier which supplies the current. Fortunately, when the 6V6 failed, the output transformer remained intact.

C22 had deteriorated so badly that it had lost its outer wrapping and so its value was no longer visible. This capacitor functions as a cathode bypass on the 6V6 and so a new $22\mu\text{F}$

40V electrolytic was installed in this location. The two HT filter electrolytics were also replaced with new capacitors.

Paper capacitors C20, C8 and C19 all showed signs of failure at their pitch-filled ends and so these too were replaced. The remaining capacitors were buried under wiring and other components and were left in place for the time being. The idea was to replace individual capacitors later only if that proved necessary.

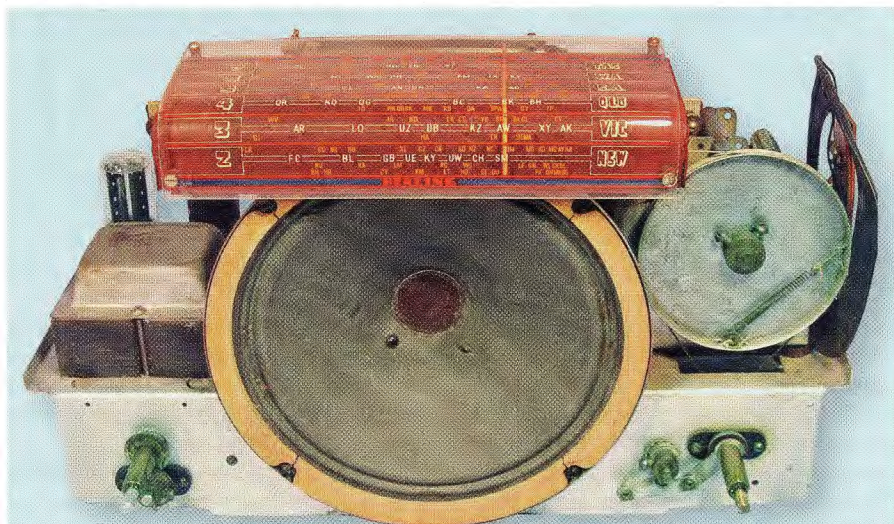
This front view of a 502E chassis shows the unusual curved dial-face and the mechanical linkages used for the on/off switch (right) and the tone control (left).

lated linkage to connect the rotary outer righthand control shaft to a rotary switch for the mains power. The righthand central control shaft is used for tuning.

A mechanical linkage is also present on the lefthand side, with the outer control shaft fitted with a friction wheel. This in turn drives a wheel on the shaft of the separate tone control pot. The lefthand central shaft controls the volume pot. Basically, the engineering techniques used for these controls were driven by the aesthetics of the case design.

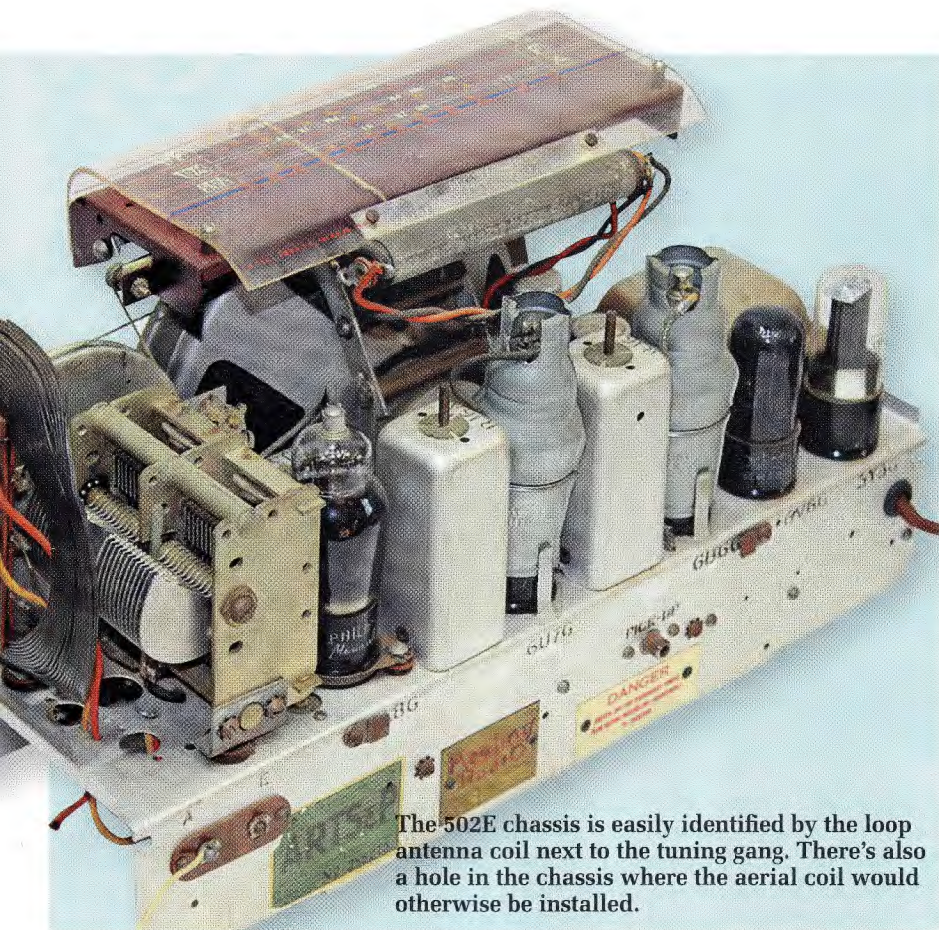
The 502E chassis is easily identified by the loop antenna coil next to the tuning gang. There's also a hole in the chassis where the aerial coil would otherwise be installed.

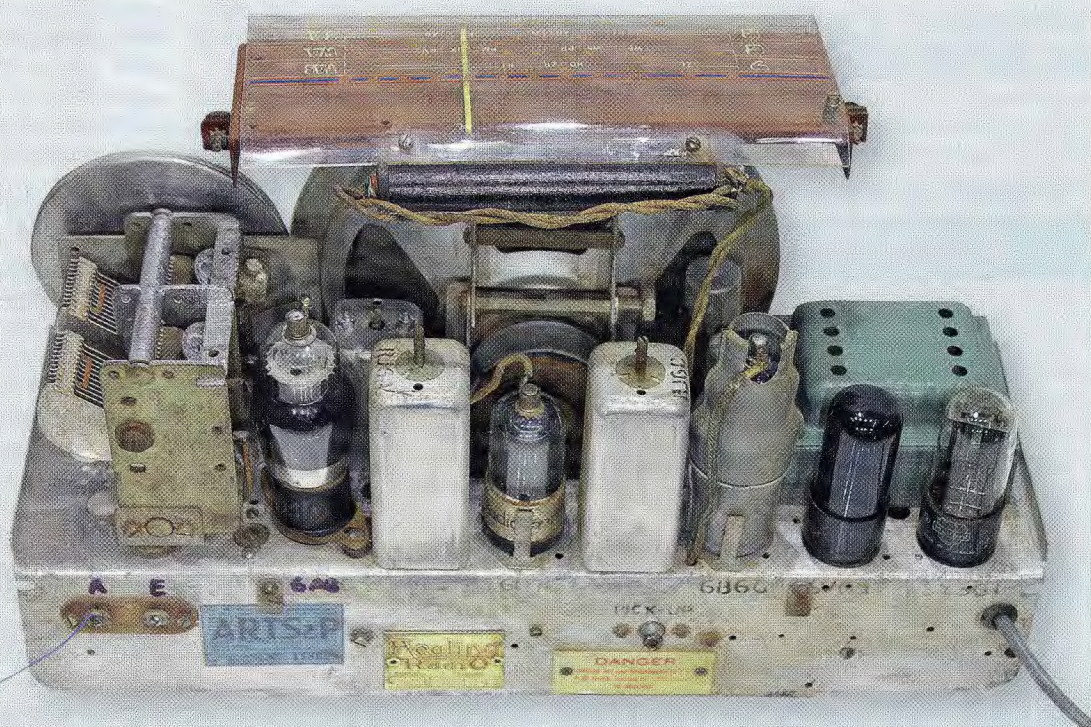
The model L502E uses a conventional aerial coil instead of the loop antenna coil used in the 502E. It's shown here nestled between the first IF coil and the loudspeaker (ie, immediately behind the tuning condenser and the 6A8 mixer-oscillator valve).

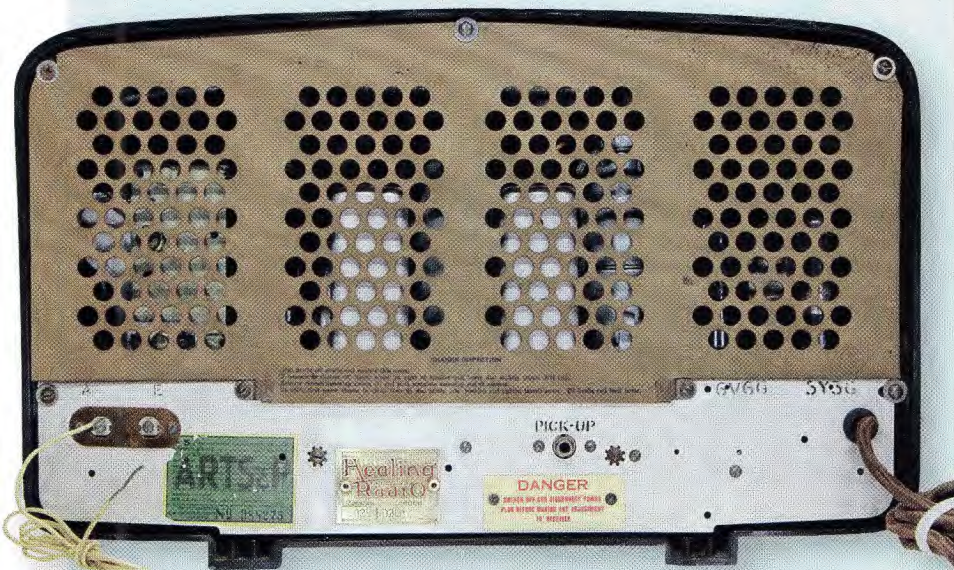
The Healing 502E & L502E sets carried a "Pick-Up" socket on the rear of the chassis so that a turntable could be plugged in. There was no provision to mute the radio section when this was done though.

As with many similar sets, the 502E has a gramophone "pick-up", with the signal fed in via an RCA-type socket in the middle-rear of the chassis to the top of the volume control pot. There is no provision to mute the radio section when it is used with a gramophone pick-up though, so presumably it was just a matter of the user tuning off-station, to a quiet part of the dial.
